H.M.A. NAVAL DOCKYARD, GARDEN ISLAND: A BUILDING CONSERVATION STUDY OF THE HISTORIC BUILDINGS

ERIC J. MARTIN  
M. B. ENV. 1980,  
U.N.S.W.

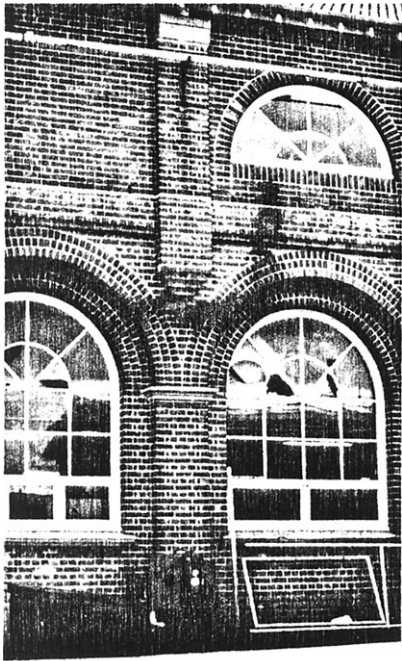
Figure 70 Building 7 & 8  
Detail of East Side  
South End

- (c) Windows - the frames are basically sound although paint is peeling off in many areas. Many panes of glass are cracked and several windows have glazing smashed and removed (especially on the east side, southern end).
- (d) Doors - there is minor damage to the doors and the paintwork is in only fair condition.
- (e) Roof - the tiles are in good condition although minor sagging

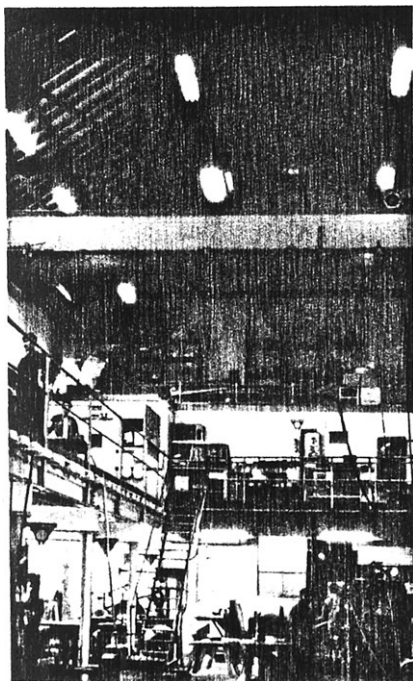
Figure 71 Internal View  
of Building 8

(f) Interior - in quite good condition, although there is some evidence of rain penetration through the smashed windows.

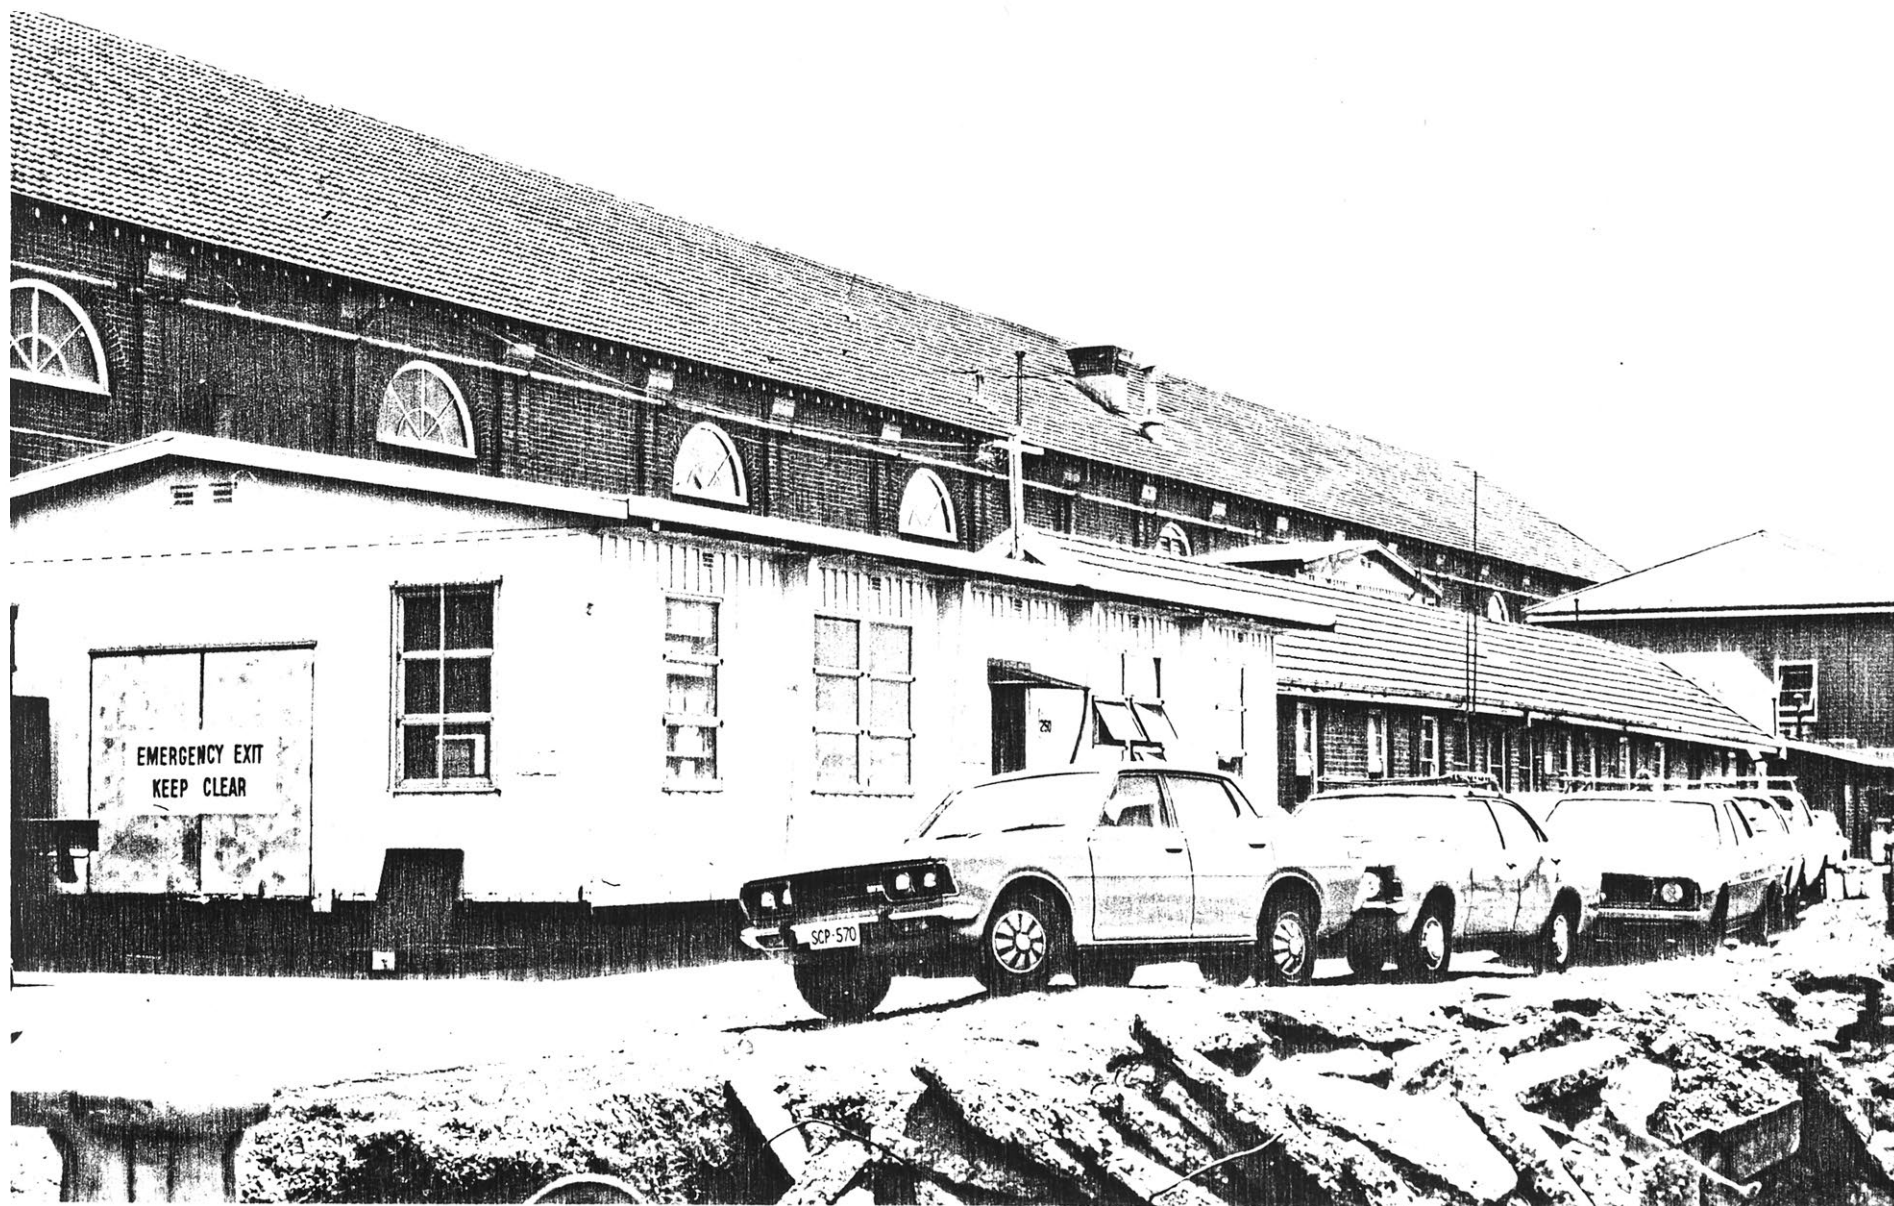
Figure 72 Building 7 & 8 from the South East

Building 7 & 8 is in quite good condition and requires low to medium maintenance for its preservation. It is structurally sound and would be suitable for medium duty workshop for some time.

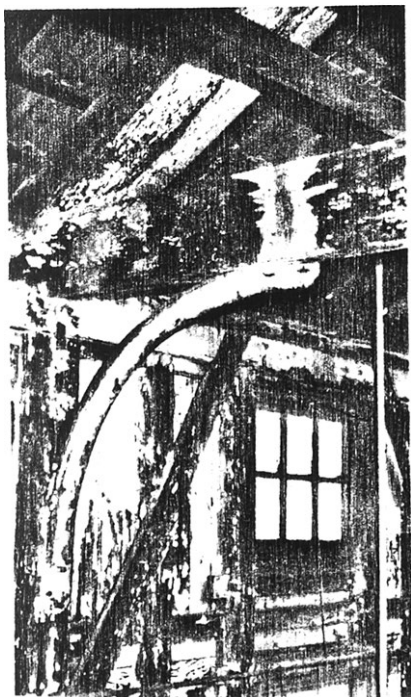
Figure 81 Internal  
Detail of Building 25

- (c) Windows - in reasonable condition, paintwork fair. 3 panes of glass on the west side (1 in nth.sect., 2 in older sect.) smashed.
- (d) Doors - in reasonable condition with minor surface damage and the paintwork in fair condition.
- (e) Roof - the tiled and corrugated asbestos cement roofs, cast iron and copper gutters, and copper and asbestos cement downpipes are in acceptable condition. External roof timbers are well weathered but in fair condition.
- (f) Interior - the timber structure is in good condition except for the limewashing which has largely worn away.

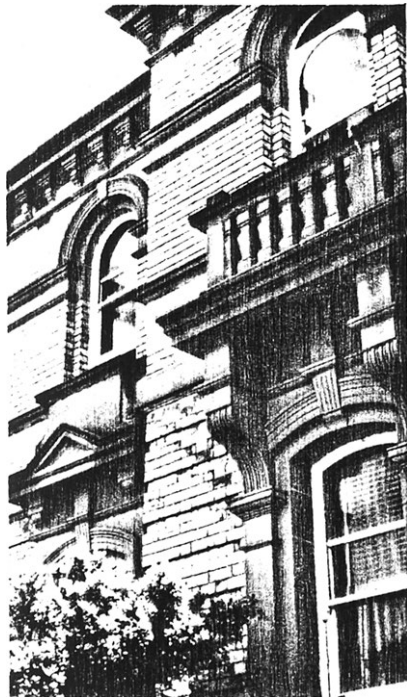
All the deterioration to the sandstone, outlined below, (refer also Figure 86), is an aesthetic problem and presents no hazard to the building or to users at the present time.

- (a) Sandstone has spalled off up to 25mm on the underside of the pediment coping and in the pediments. Decay is least in the pediment over the main entrance.
- (b) Spalling on the underside of the sandstone string course level with first floor window sill is quite extensive along the entire length of the string course.
- (c) The underside of string course at the level of the first floor shows little spalling.
- (d) Sandstone is spalling in the coffers between the corbels of the corbel table.
- (e) The underside of the small balcony has extensive spalling especially near the outer edge. This has resulted in complete loss of detail.
- (f) The underside of main horizontal projections in the clock tower

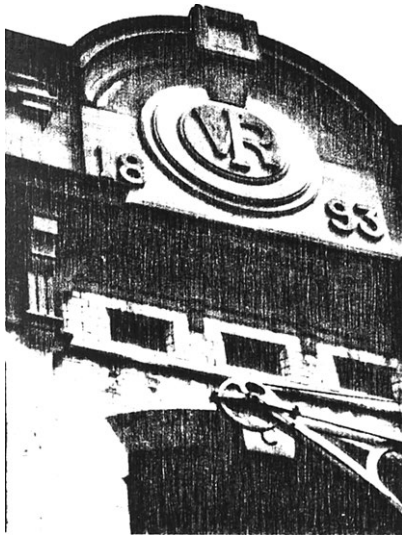
Figure 98 Building 89  
Deteriorated Sandstone

- (f) Interior - walls in good condition except for peeling paint, and surface marks in the water affected areas.
- (g) Floors - except for a general unevenness, the timber floors are in good condition.
- (h) Ceilings - in good condition.
- (i) Other Comments - a detailed structural report and analysis is provided in Appendix 7(c). All floors have a live load capacity of 15kPa.

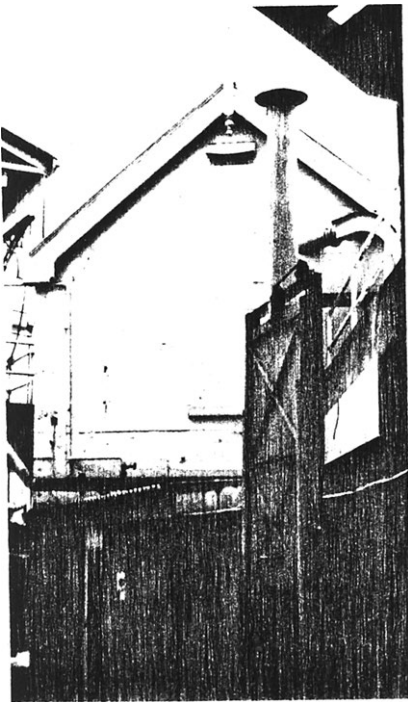
Figure 107 Building 98  
from the South East

- (a) Foundations and Walls - good condition.
- (b) Windows and Doors - one window is smashed and a sandstone sill on the south west side has been damaged. The remainder of the building is in reasonable condition.
- (c) Roof - the tiles are in good condition although one is missing near south east gable end. The galvanised iron gutter on the north east side is rusted through in many areas. Downpipes, timber barge boards and fascias are in reasonable condition.
- (d) Interior - in reasonable condition.
