**YAMBA HILL GROUNDWATER LEVEL MONITORING
ASSESSMENT TO MID-2007**

Technical Report 2007/32
December 2007

THE UNIVERSITY OF NEW SOUTH WALES
SCHOOL OF CIVIL AND ENVIRONMENTAL ENGINEERING
WATER RESEARCH LABORATORY
in association with
JEFFERY AND KATAUSKAS PTY LTD
and
GROUNDWATER DATA COLLECTION SERVICES

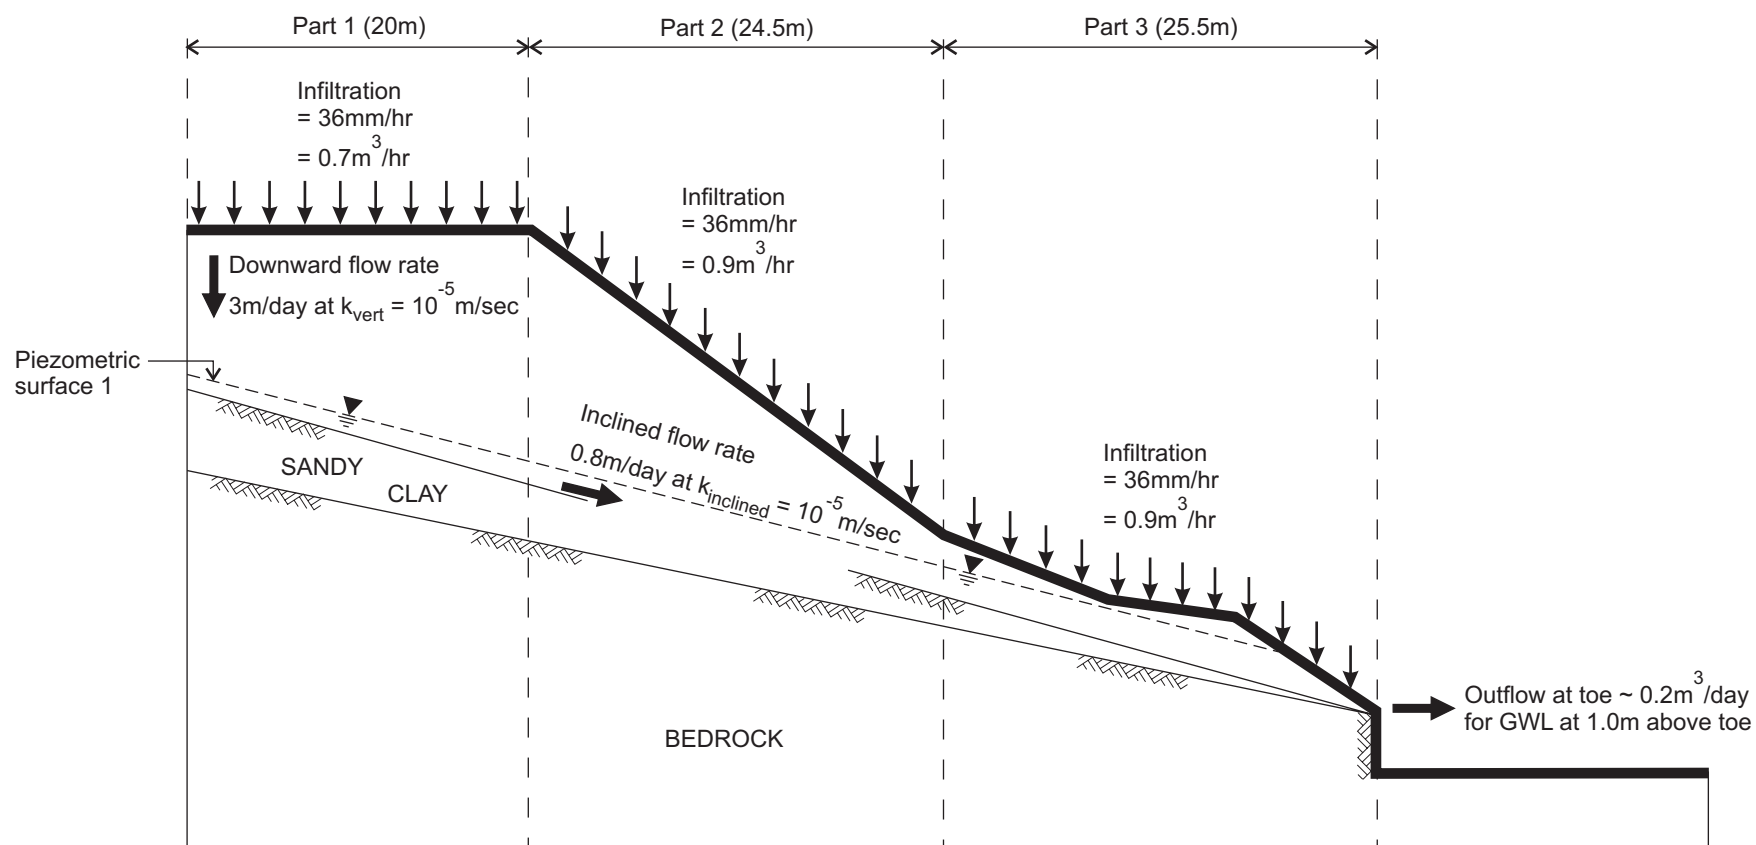
Lateral groundwater flow rates for Transect 1 were calculated to be $0.18 \text{ m}^3/\text{day}$ (Table 6), similar to the $0.2 \text{ m}^3/\text{day}$ projected by the hydrogeological model (Figure 10). These flow rates assumed a saturated hydraulic conductivity value of 10^{-5} m/s or 36 mm/hr (Douglas Partners, 1996). These values are considered to be realistic for silty sand, and are unlikely to be improved by site specific testing. It is noted that infiltration of rainfall is determined by vertical hydraulic conductivity of semi-saturated sands (i.e. below the soil zone), which may be 1-2 orders of magnitude less than saturated hydraulic conductivity.

- Infiltration volumes are per unit width.
- Approximate time to flow from centre of part 1 to outflow at toe = $60\text{m} \times 0.8\text{m/day} = 75\text{ days}$.
- Inclined flow may vary by an order of magnitude or more due to layering within the subsurface soil.
- Revised model based on J & K (2000).

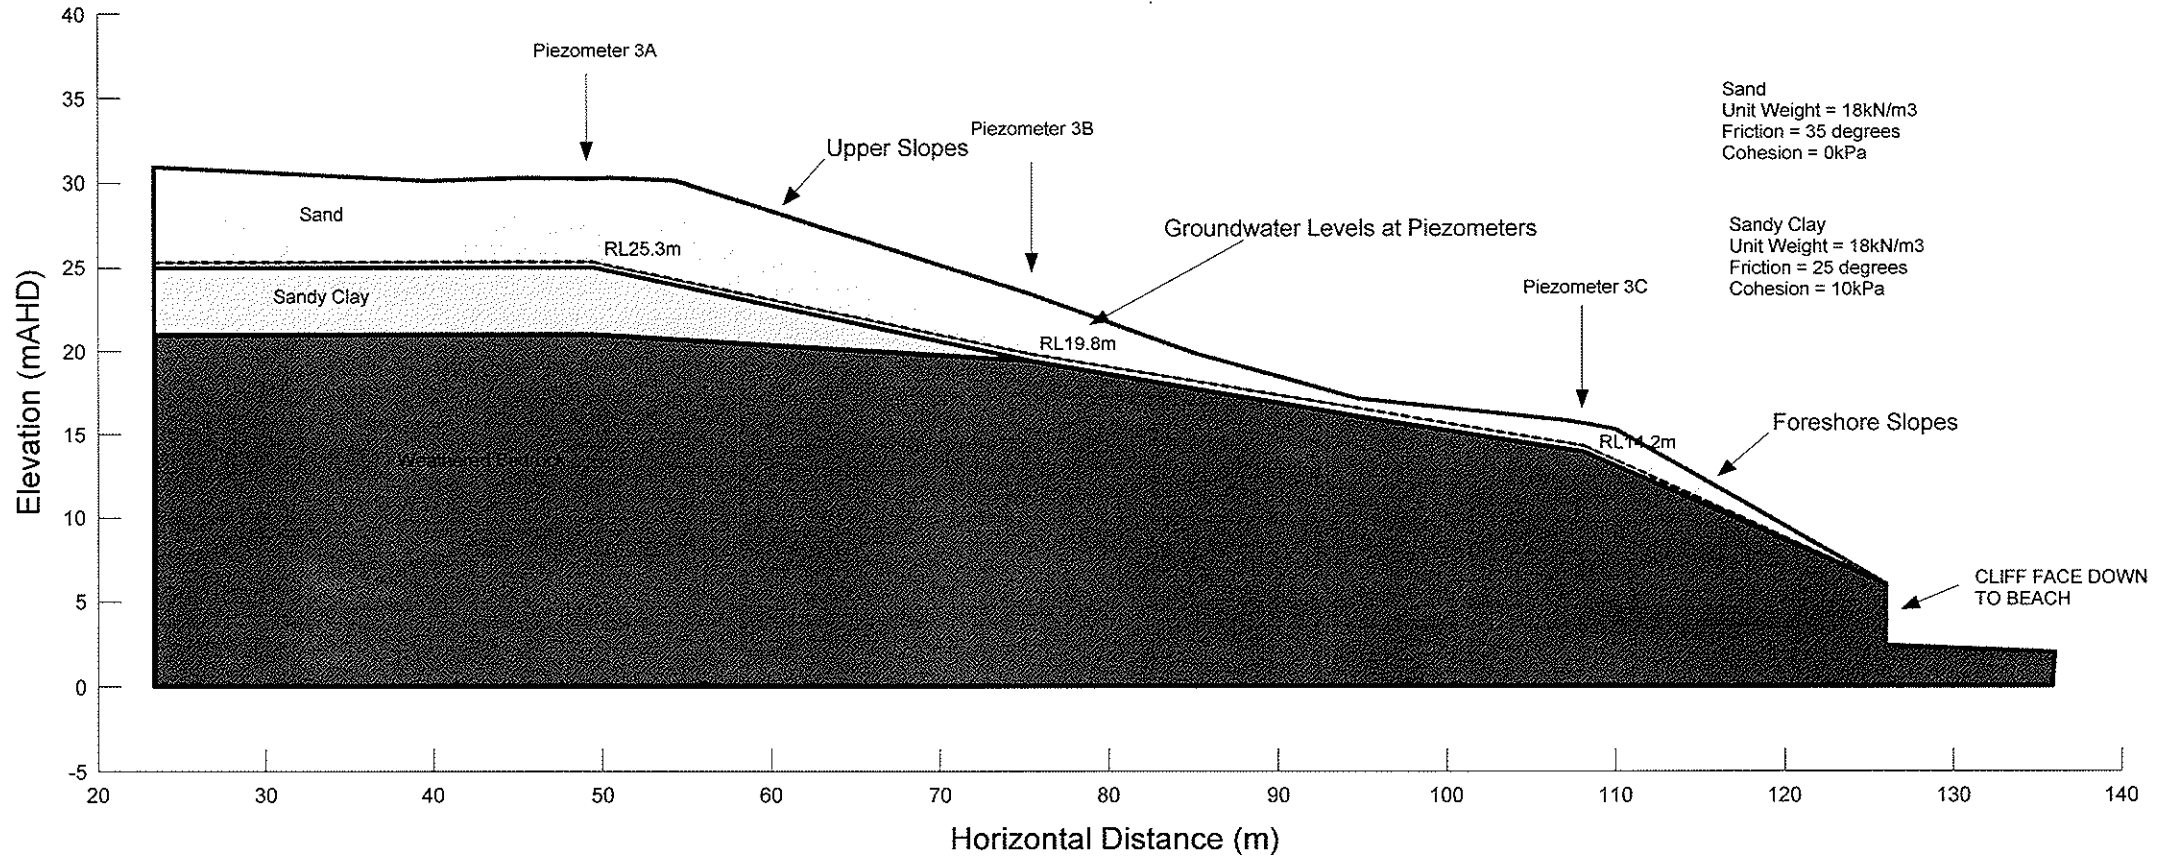
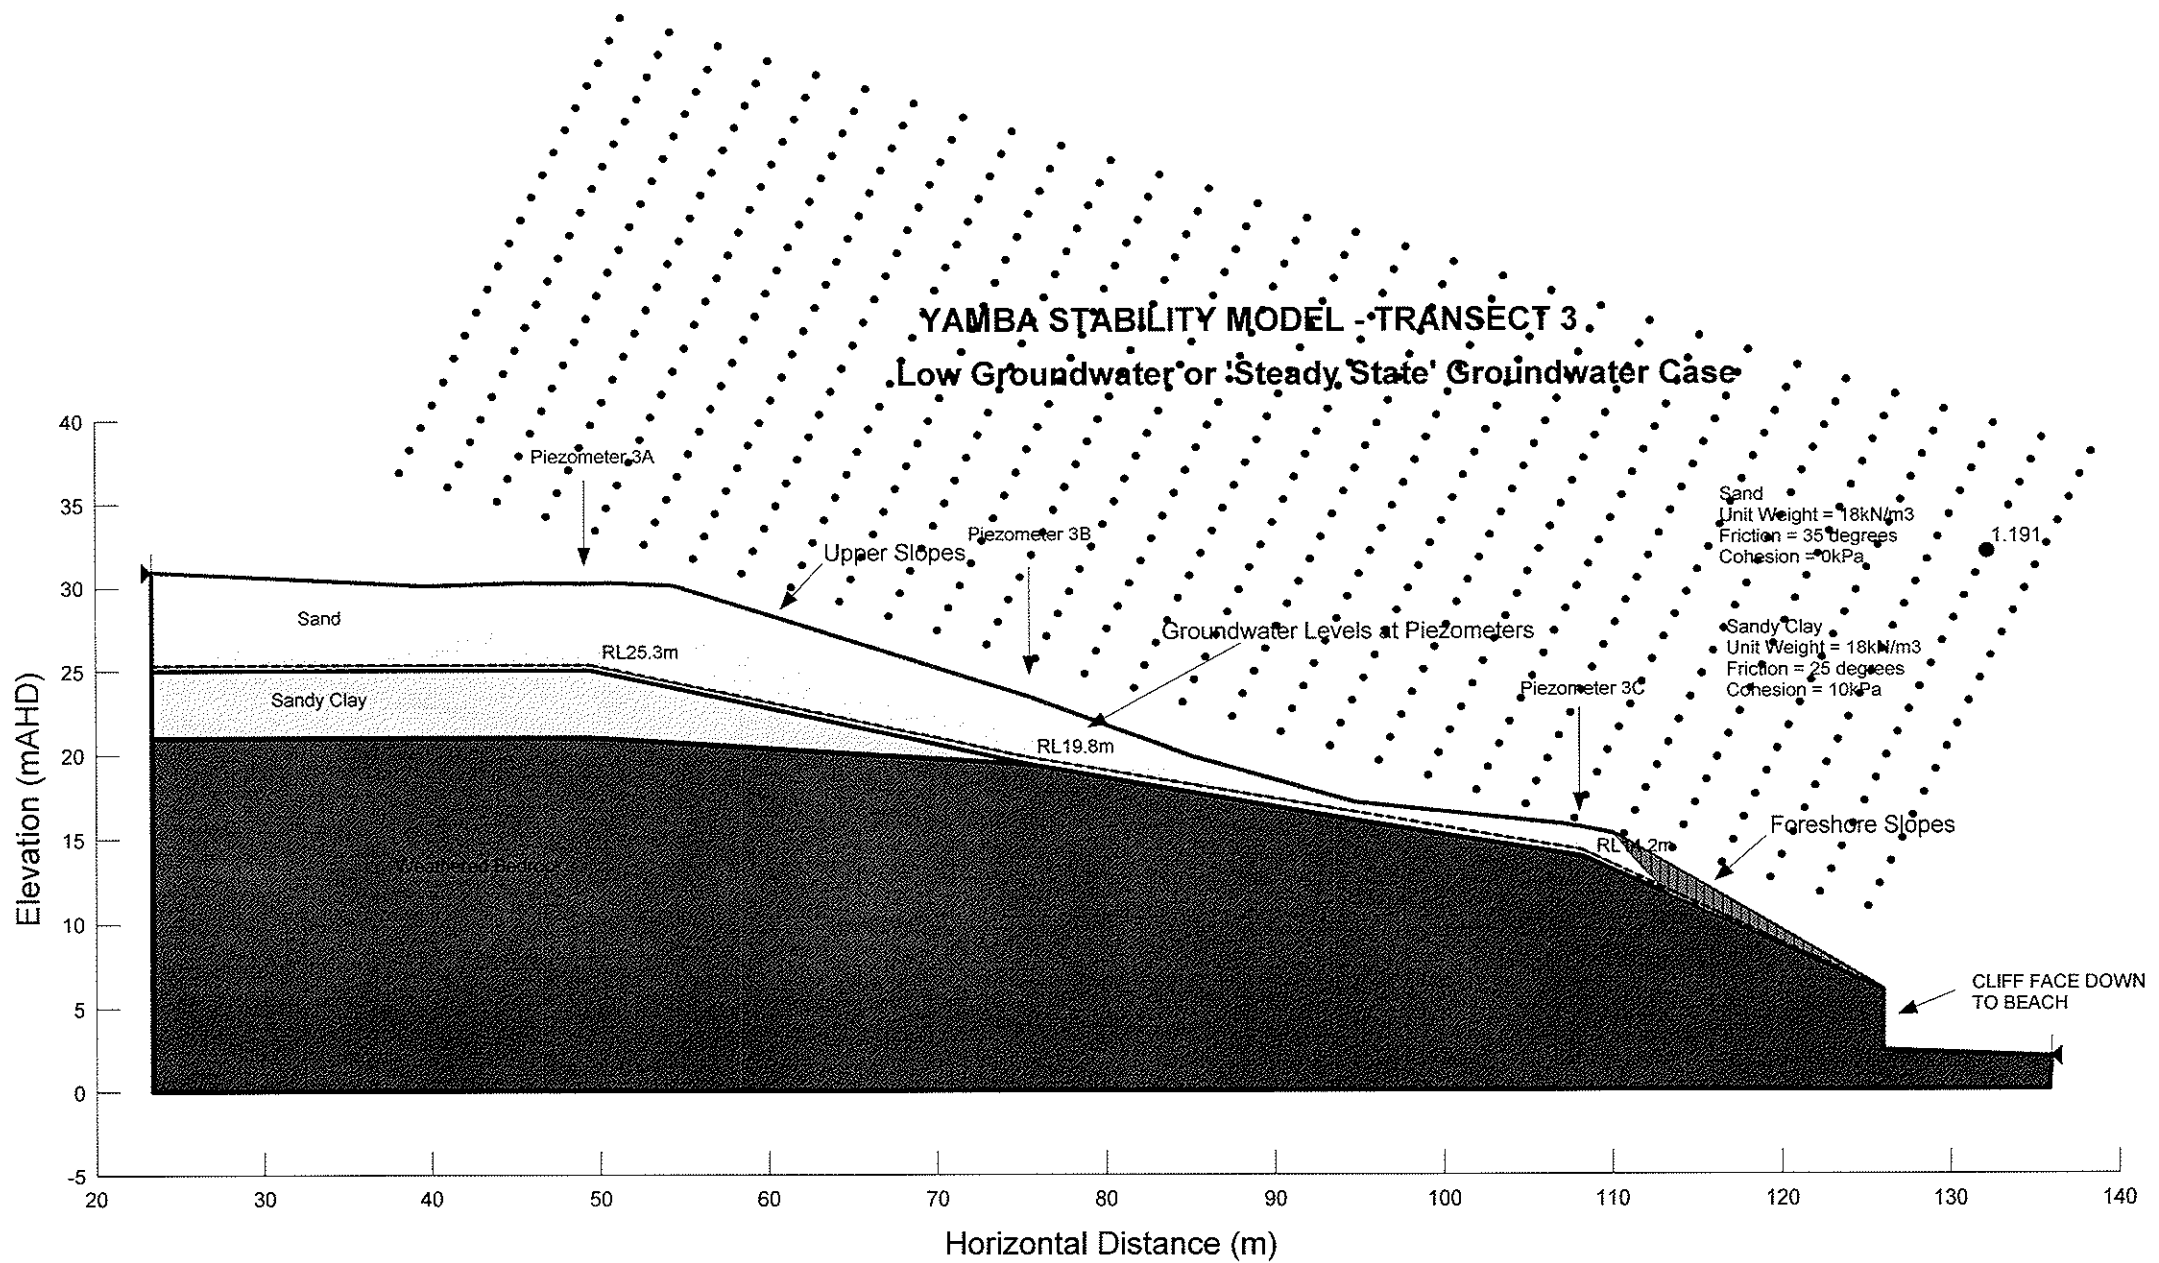
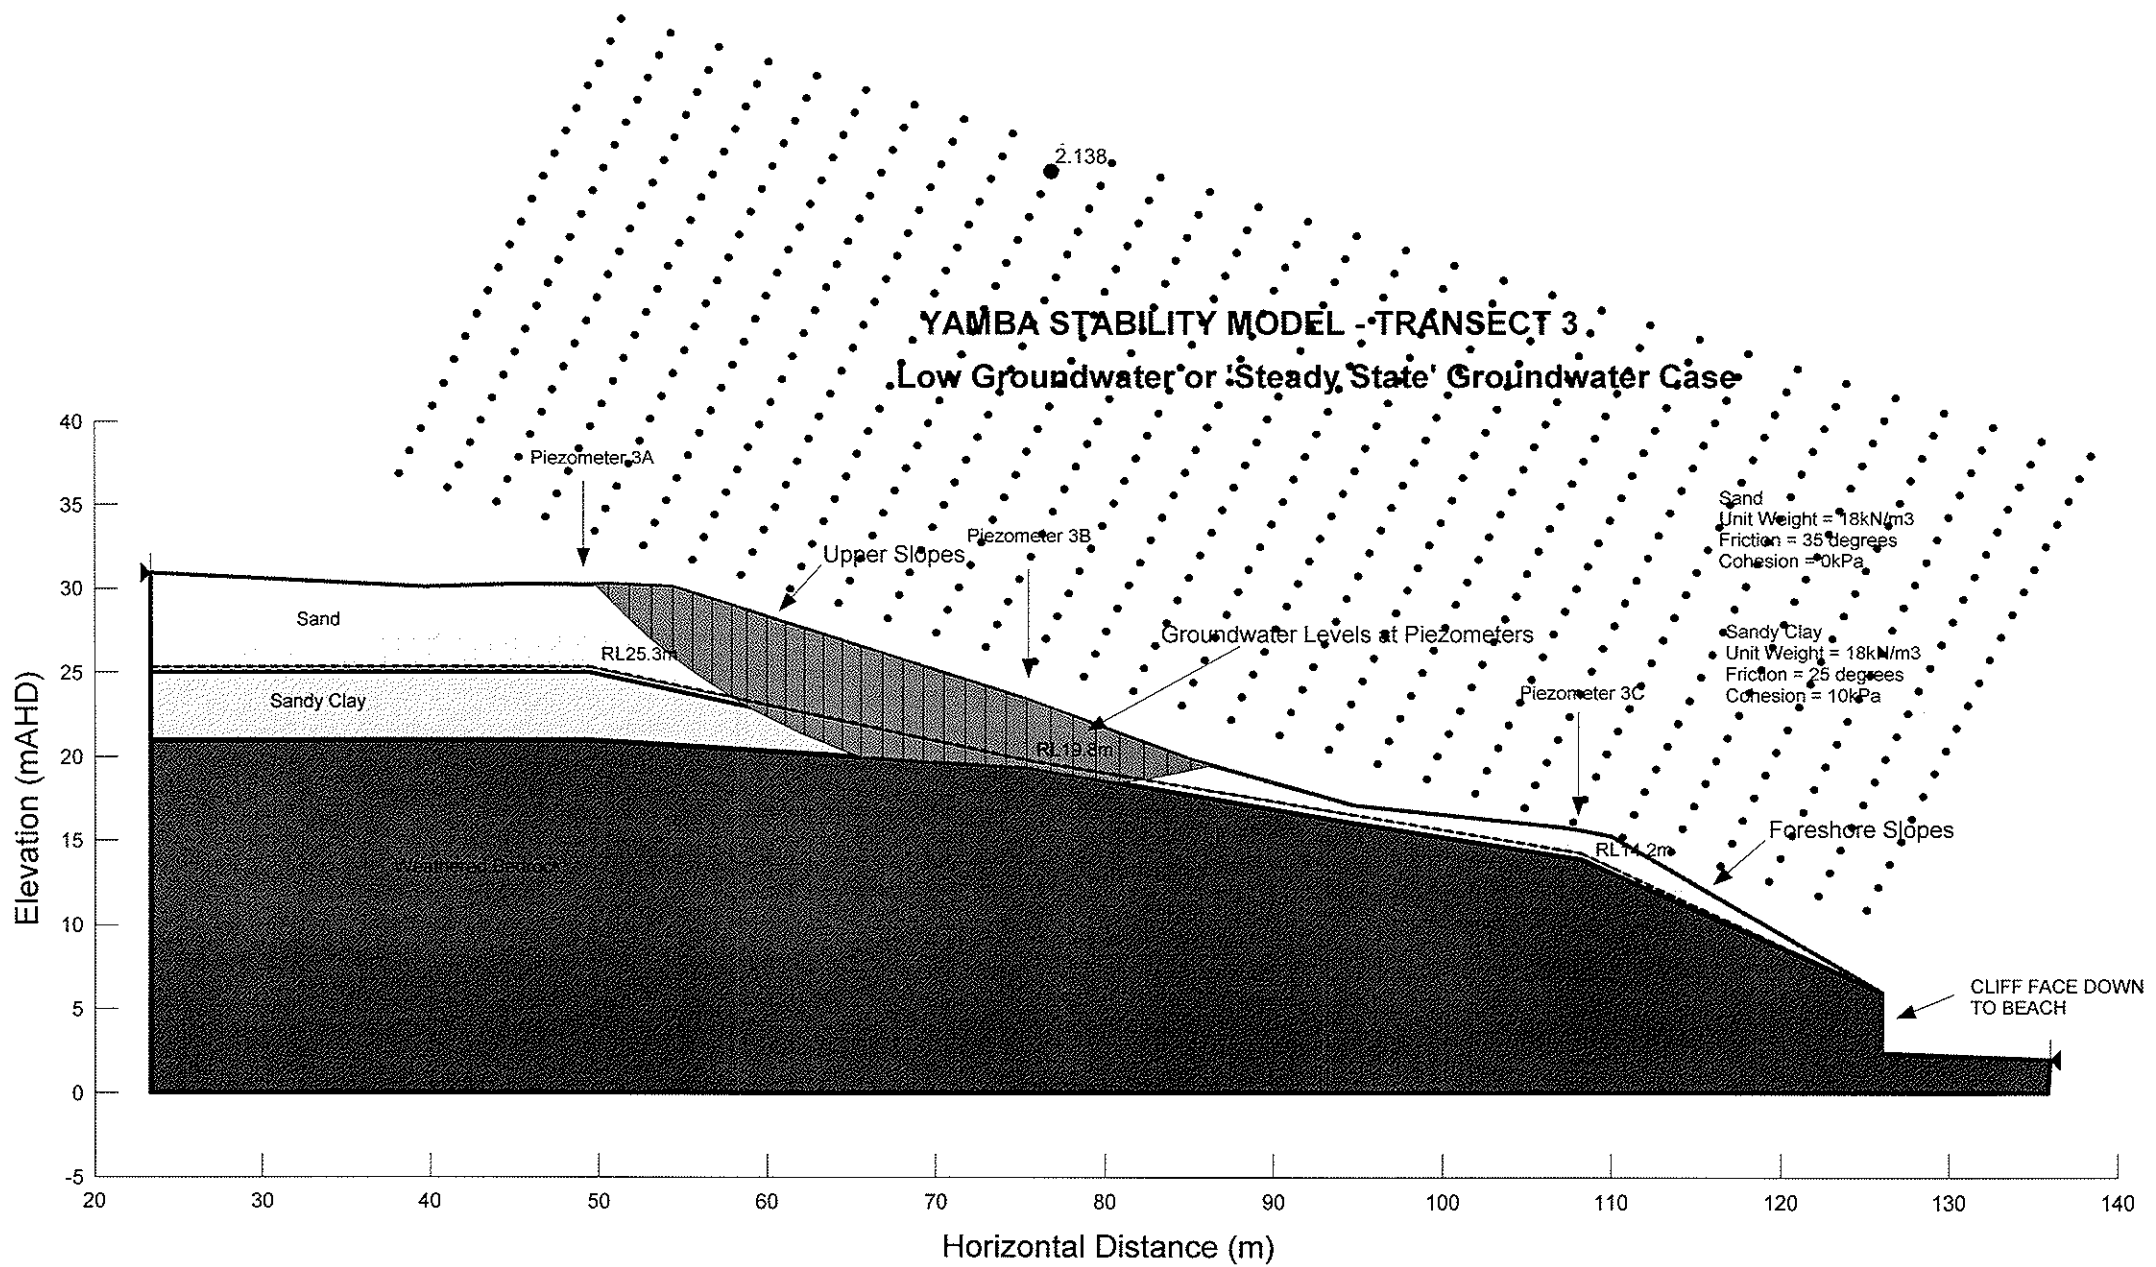
YAMBA STABILITY MODEL - TRANSECT 3 **Low Groundwater or 'Steady State' Groundwater Case**

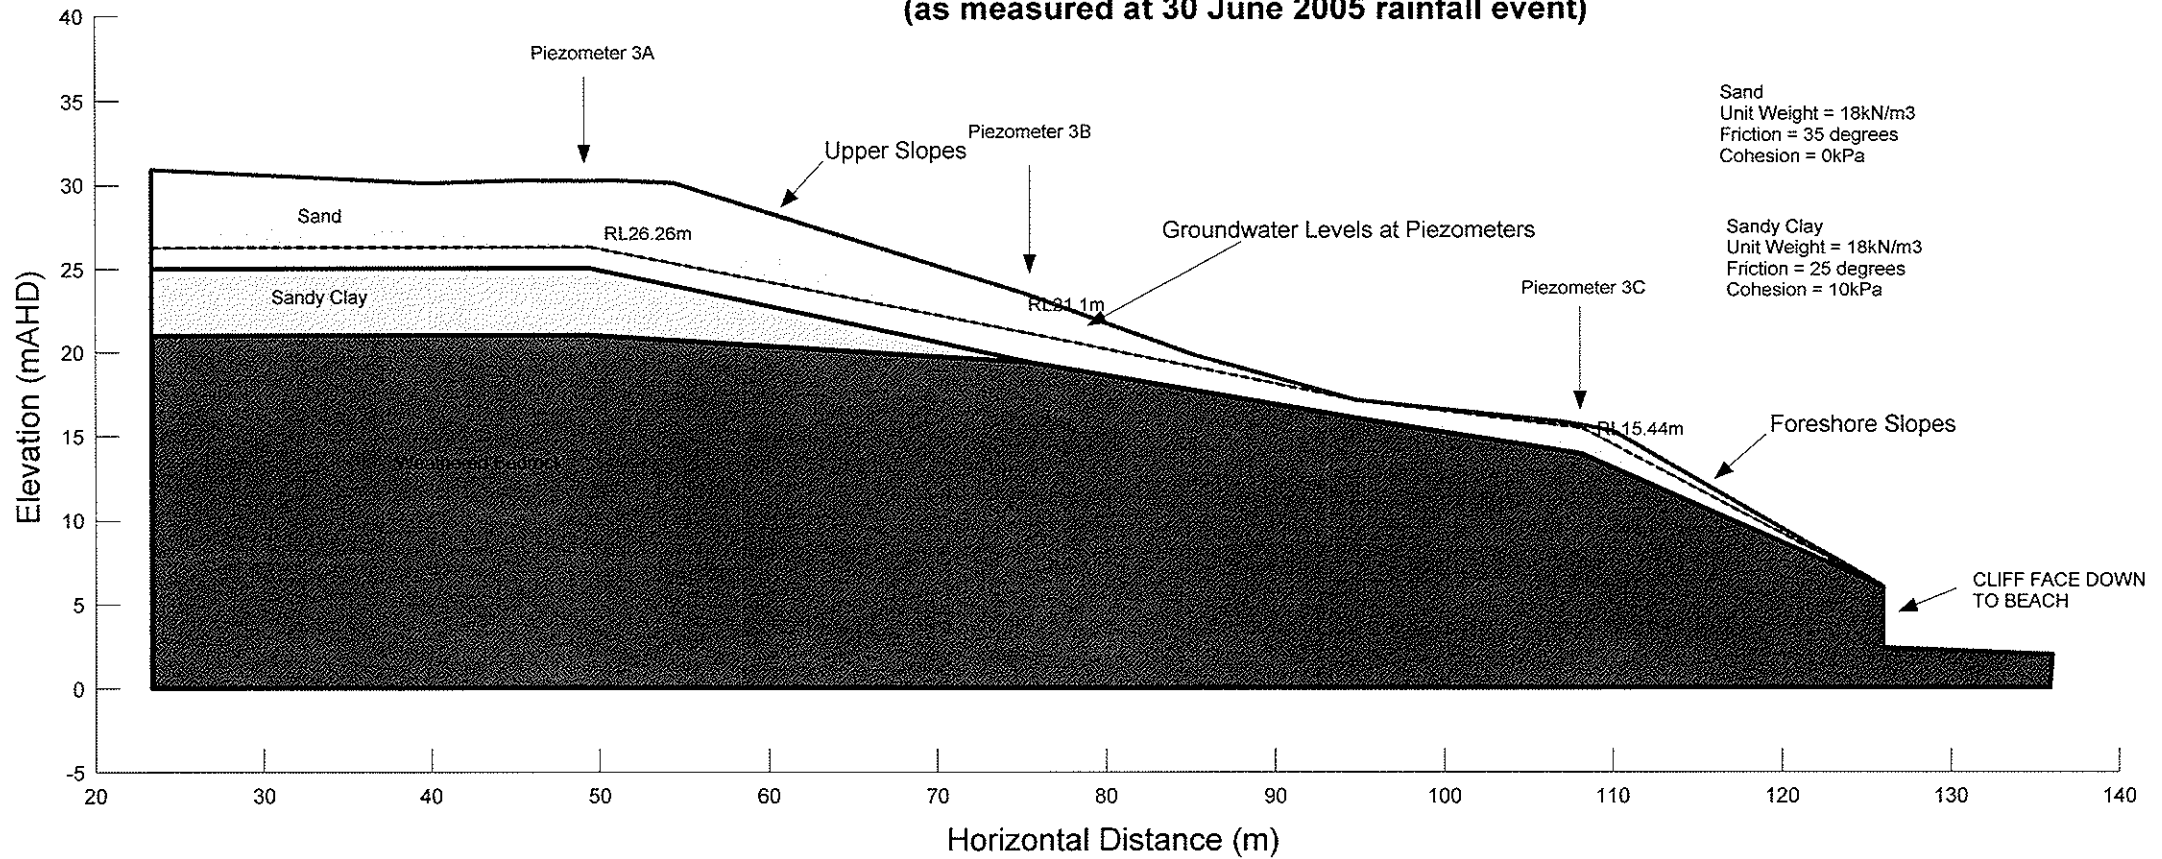
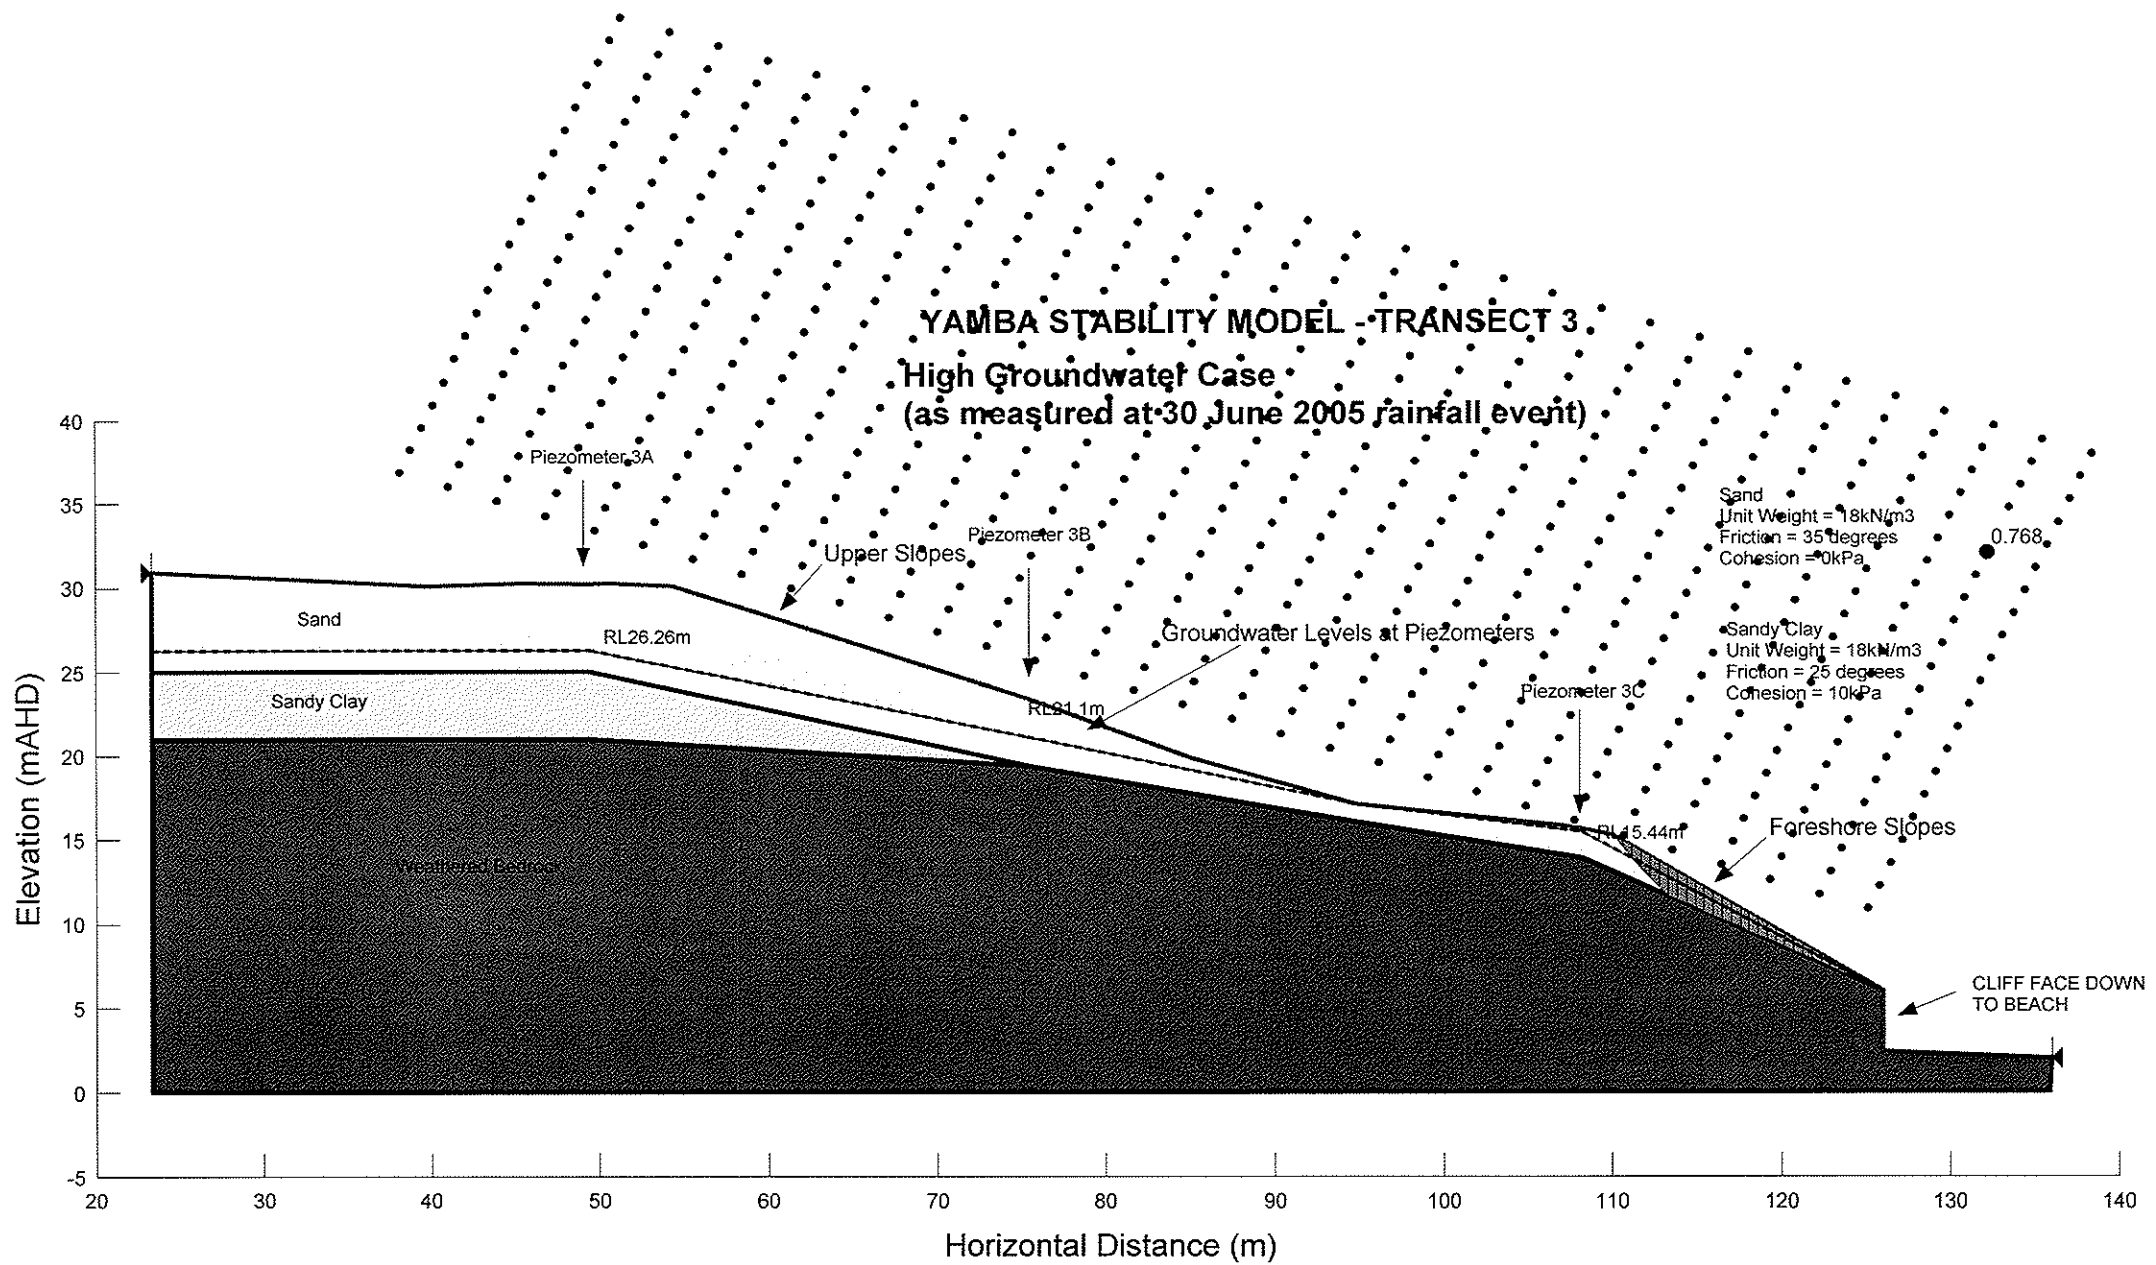
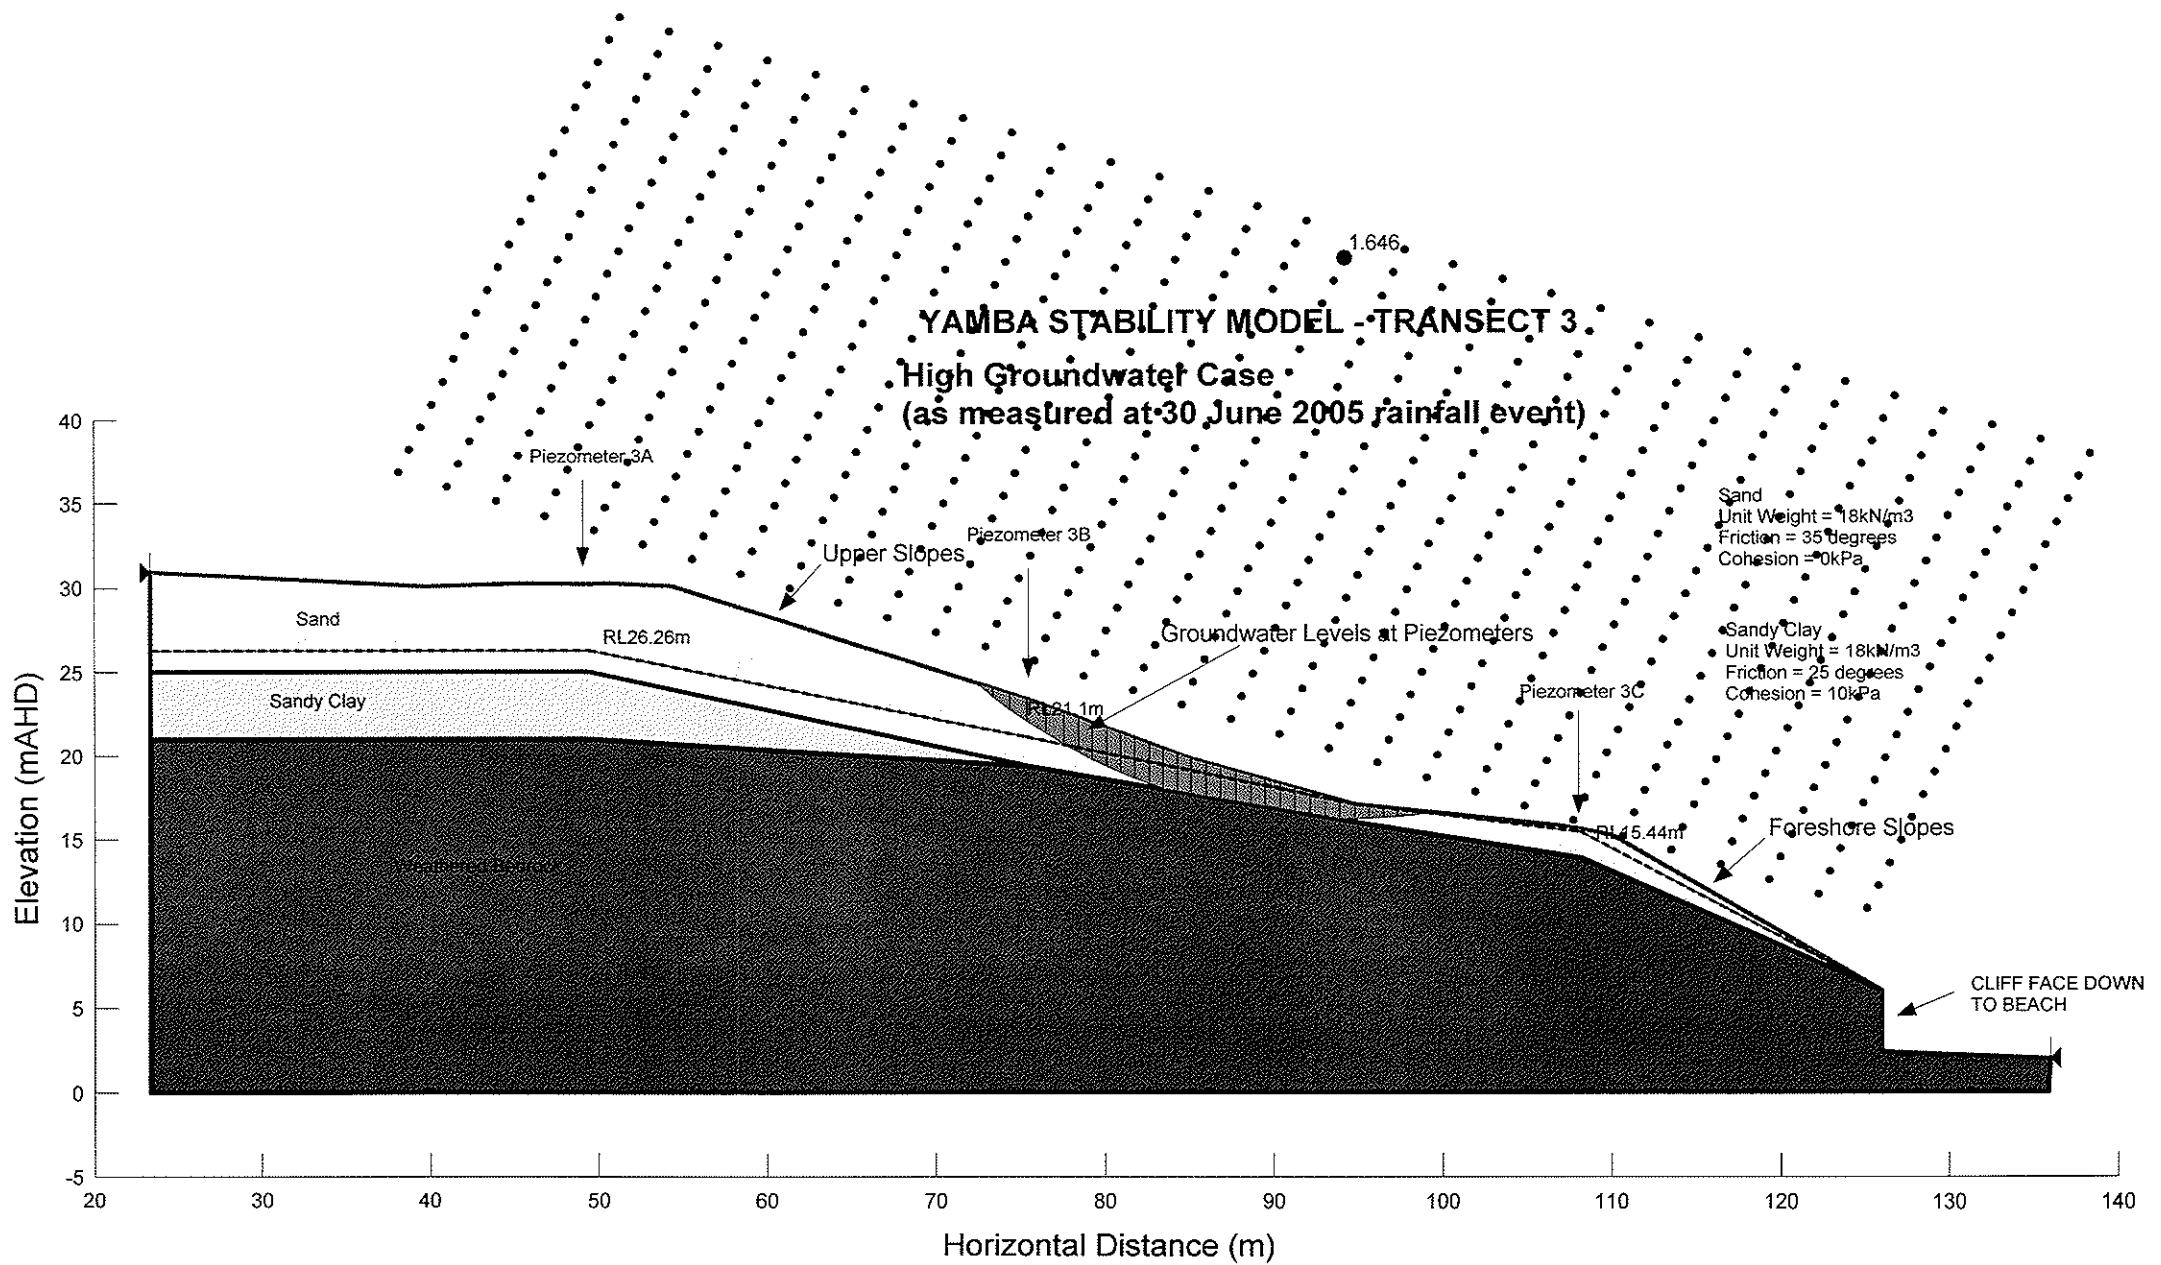
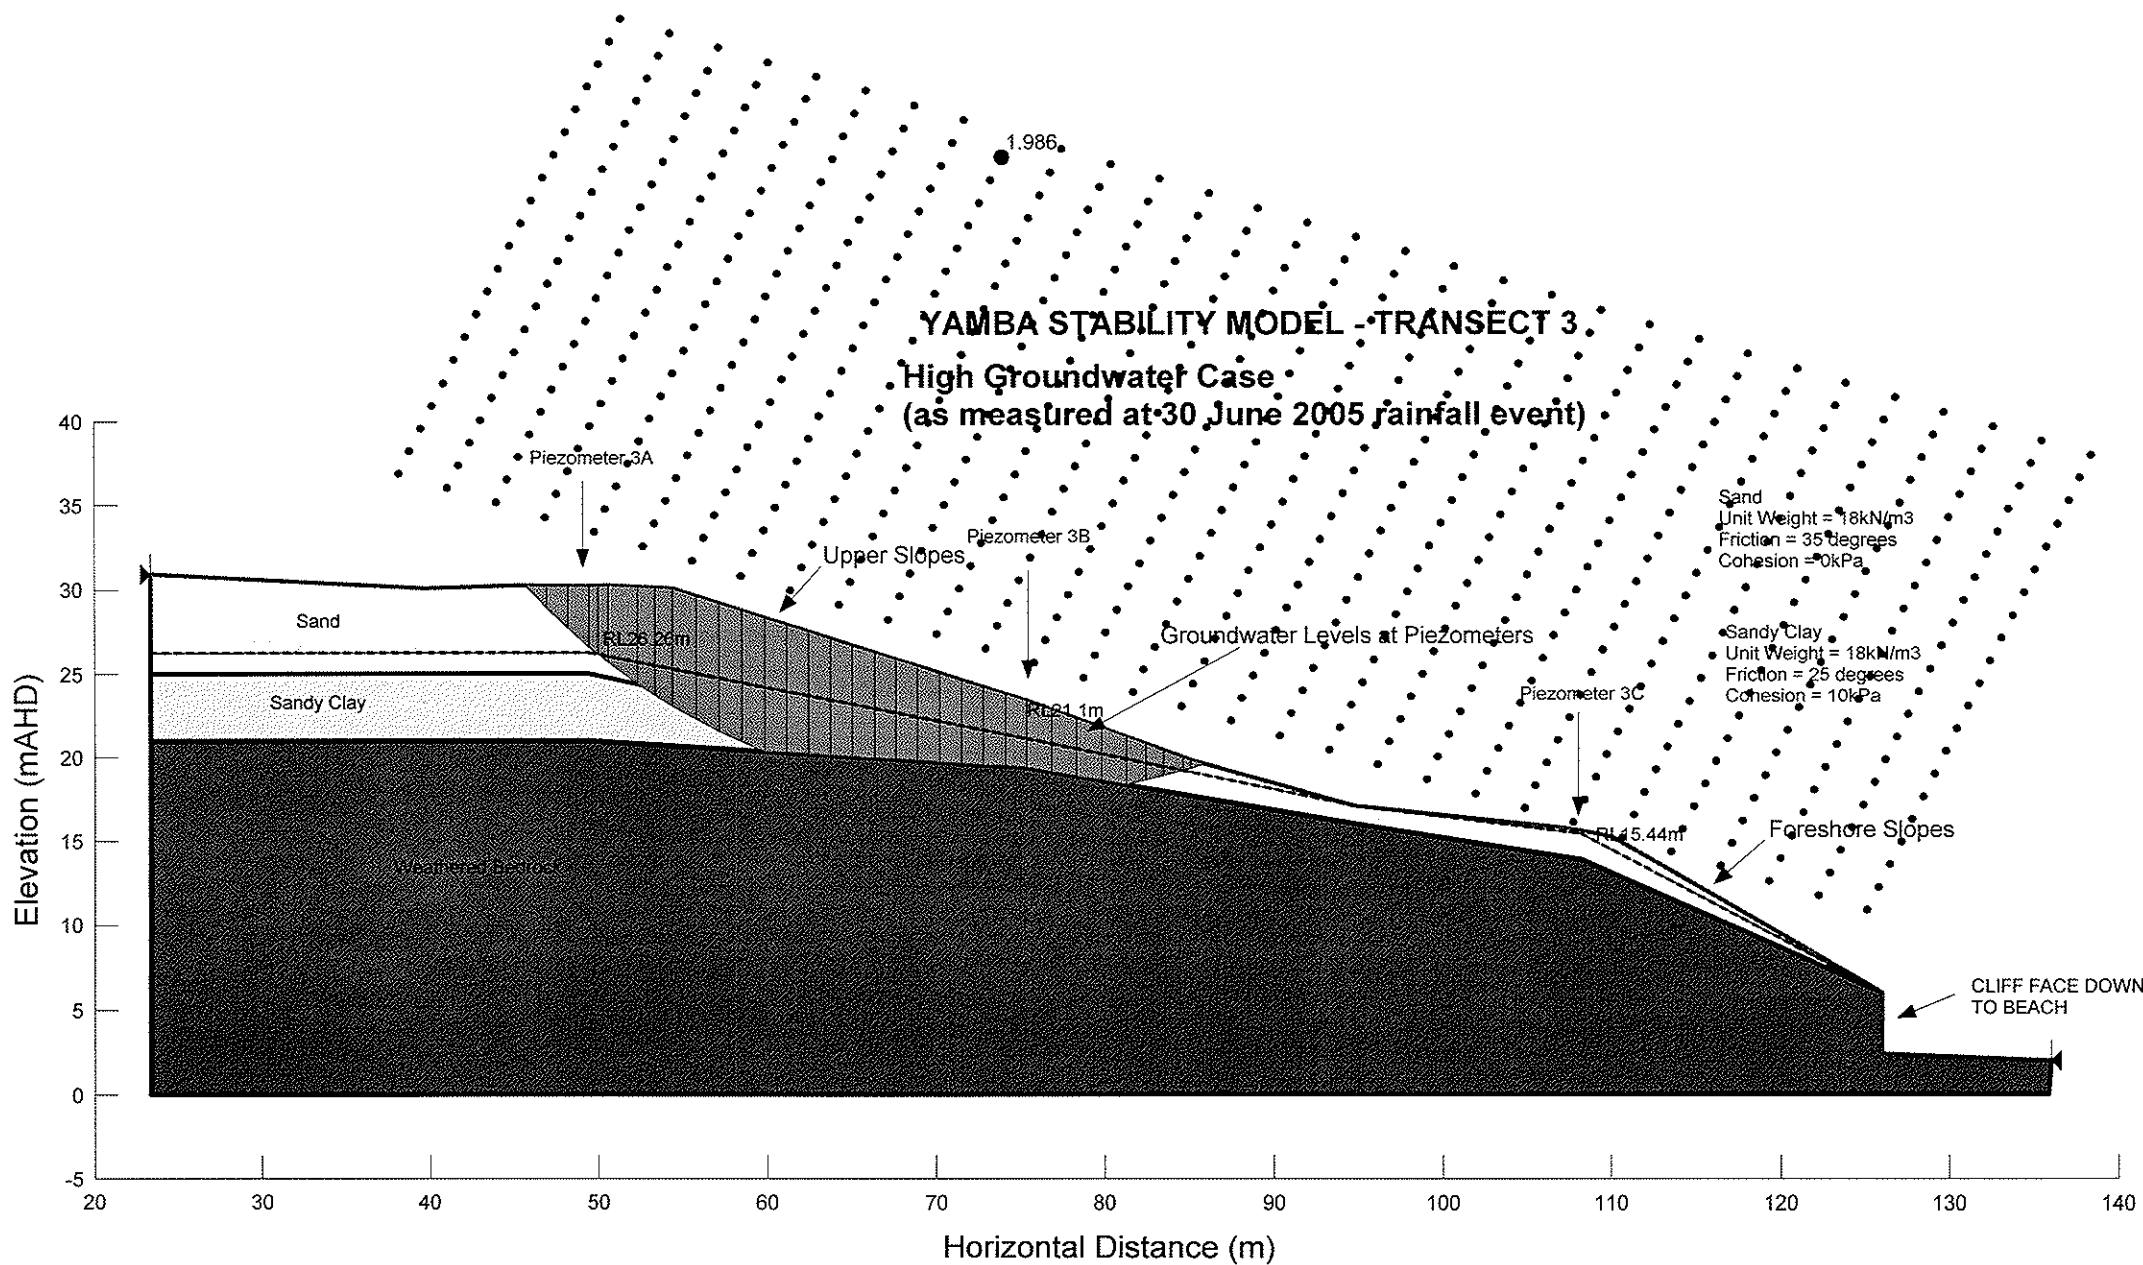
High Groundwater Case
(as measured at 30 June 2005 rainfall event)

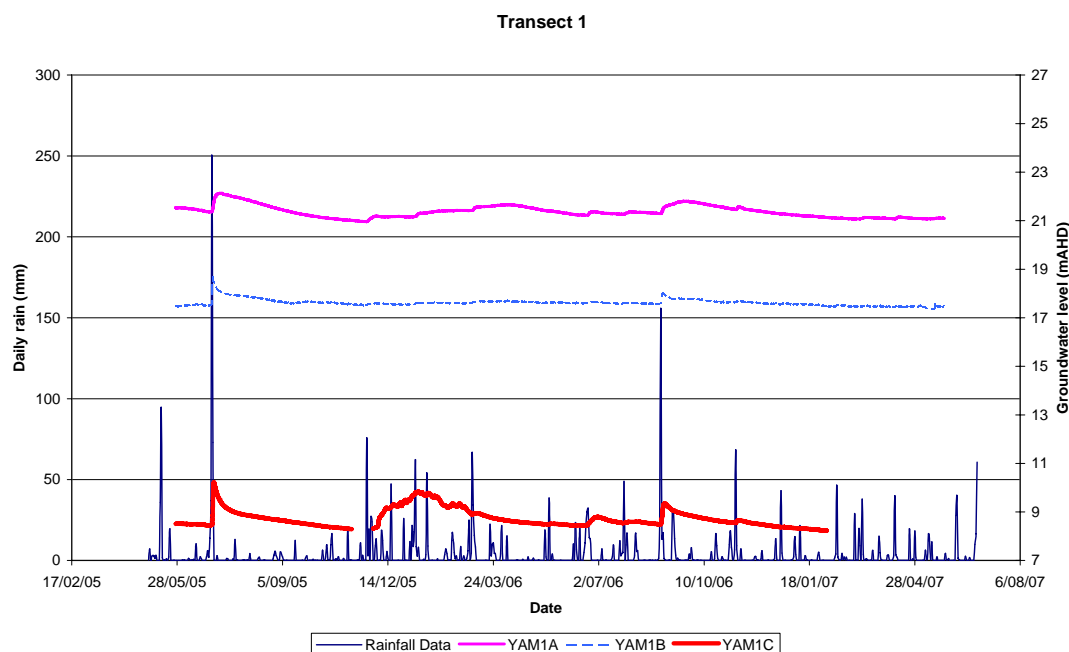
The lower piezometers across the study area (ie. sites B and C) showed greater response to this June, 2005 event than the upper piezometers (Table 2, Figure 3). Sites 1A to 3A showed 0.6 to 0.95 m rise in level over a period of approximately 3 to 7 days. Sites 1B, 1C, 2C, 3B and 3C displayed rises of 1.12 to 1.74 metres over a period of between 12 and 24 hours. However, it is noted that the initial rise rate of piezometer 3A was fast but delayed. The lower piezometers all began to respond to the event before the upper piezometers.

This data reflects the fact that there is a limited catchment area upslope of the study area. As a result, piezometers located at near the base of the slope are characterised by a larger response to rainfall infiltration over a larger, upslope area.

Fig 3 Groundwater levels for Transect 1 (May 2005- May 2007)

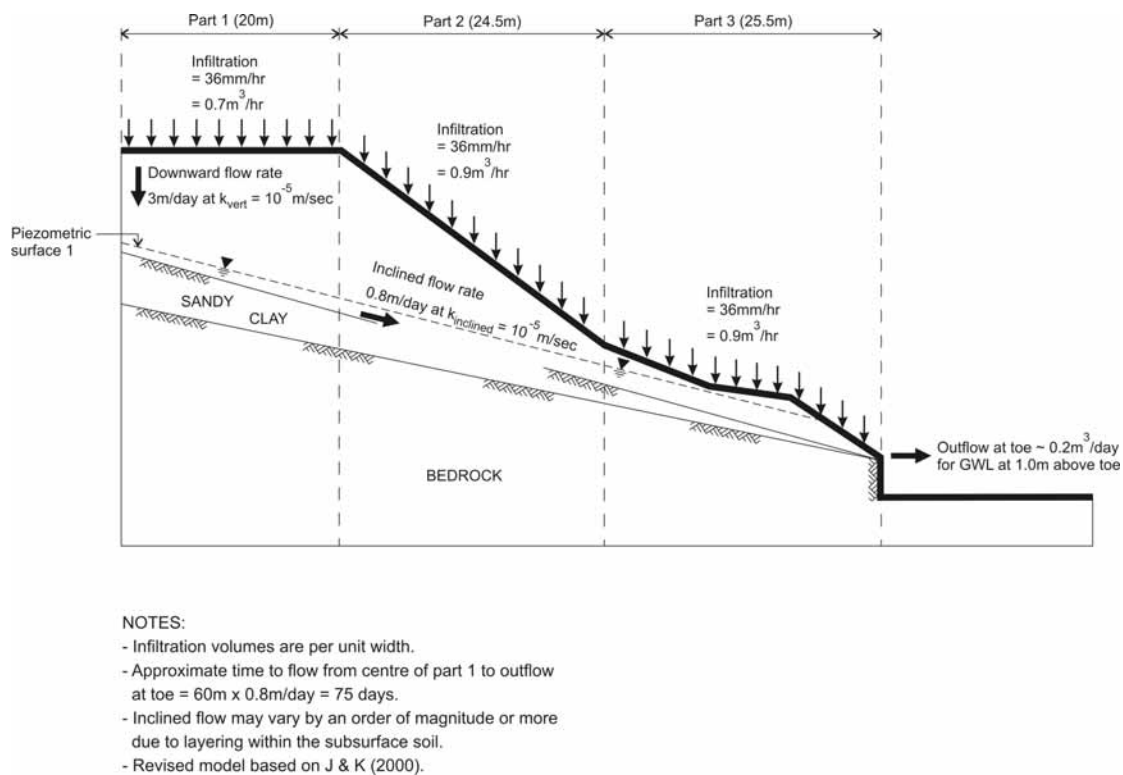
Lateral groundwater flow rates for Transect 1 were calculated to be 0.18 m³/day similar to the 0.2 m³/day projected by the initial groundwater model (Figure 4). These flow rates assumed a saturated hydraulic conductivity value of 10⁻⁵ m/s or 36 mm/hr (Douglas Partners, 1996). These values are considered to be realistic for silty sand, and are unlikely to be improved by site specific testing.

Limited drainage rates mean that groundwater levels below the crest of the dune remain high for 2 to 3 months after a major rainfall event. Therefore, antecedent rainfall will be the most critical element in producing groundwater levels which may cause instability of the slope.

Fig 4 Revised hydrogeological conceptual model (modified from J&K, 2000).

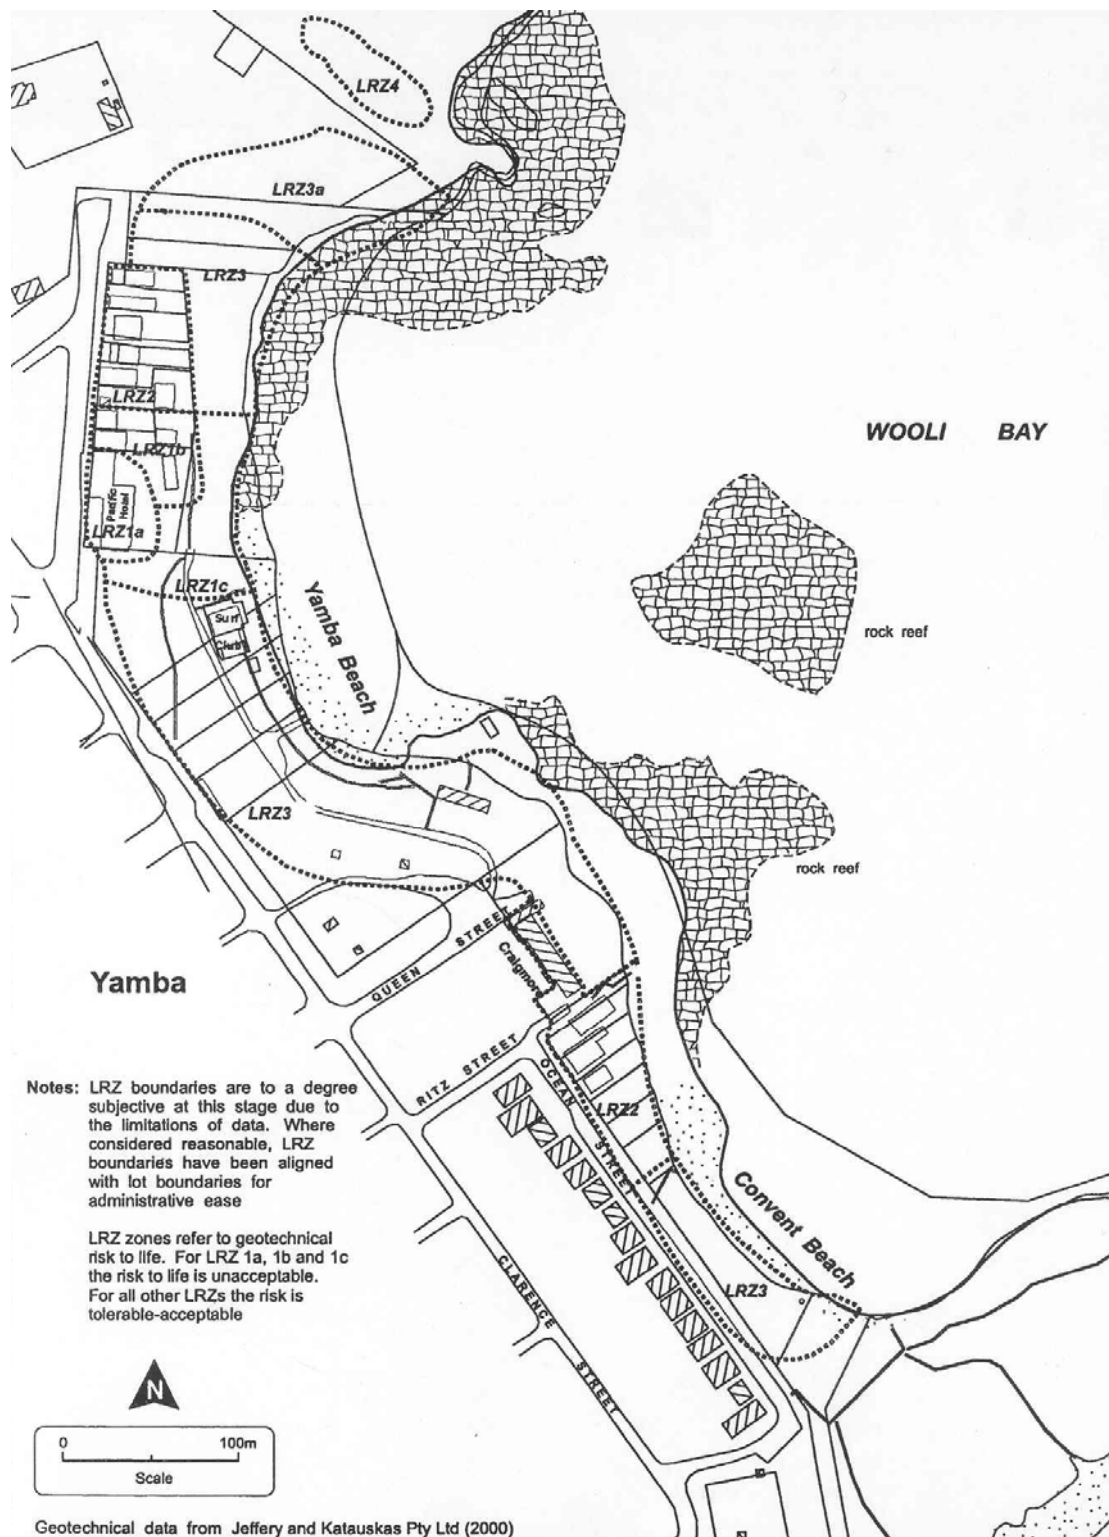
The data obtained from investigations and monitoring during this project do not allow any adjustment to the LRZs.

Fig 5 Landslide risk zones (After J&K 2000 and MHL 2003).

Various slope treatment and stabilisation options should be investigated in more detail for implementation as a matter of priority. In the meantime, monitoring of groundwater levels and inclinometers should continue. WRL and Jeffery and Katauskas Pty Ltd have recommended that council should continue with the emergency levels and management strategies until more permanent stabilisation measures are adopted.
