GPS interference detected in Sydney-Australia

Proceedings of IGNSS Symposium 2007

GPS Interference detected in Sydney-Australia

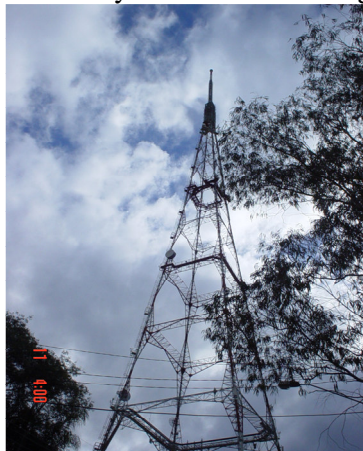
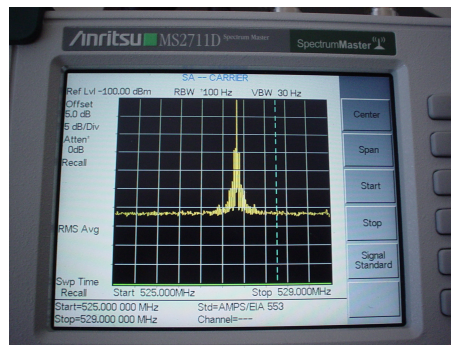
The TV transmitter power and the detection of the TV channel 28 transmission by means of the spectrum analyser are shown in Figure 2.

Figure 2 TV Tower in Hampden Road - Artarmon (left hand side) and the detection of the TV transmission (at 527.25 MHz) by means of the spectrum analyzer (right hand side)

The interferer is an analogue TV channel (Phase Alternation Line - PAL), which means that it is characterized by a vestigial sideband 8 MHz wide. The lower band edge is at -1.75 MHz from the carrier frequency and the upper band edge is at +6 MHz.

The transmitter we considered has the carrier frequency at $f_c = 527.25$ MHz. This means that its 3rd harmonic is at 1581.80 MHz. Consequently the lower frequency of the 3rd harmonic is at 3×1.75 MHz = 5.25 MHz from 1581.80 MHz. Its distance from L1 central frequency is only 1 MHz from L1 GPS central frequency ($1581.80 - 5.25 = 1576.55$ MHz), which means that it falls within the front-end filter bandwidth of the receiver used in this test: the 3 dB bandwidth of the NordNav filter is 3.78 MHz.

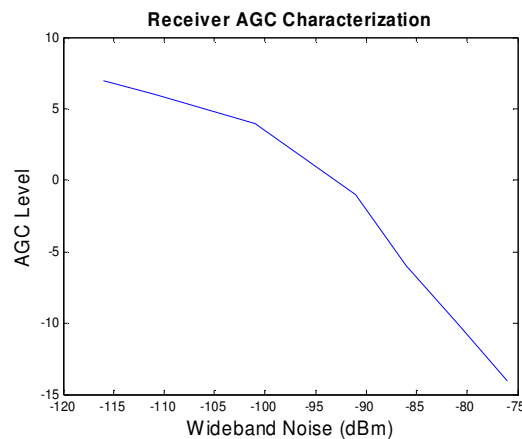
Figure 8 Characterization of the behavior of AGC level w.r.t the received in-band power in the NordNav software receiver

This experiment is performed in a few steps where the input noise power changes by adjusting the programmable attenuator. Figure 8, shows the level of the AGC versus the input power. The figure shows that the AGC decreases the gain once the input power is high.

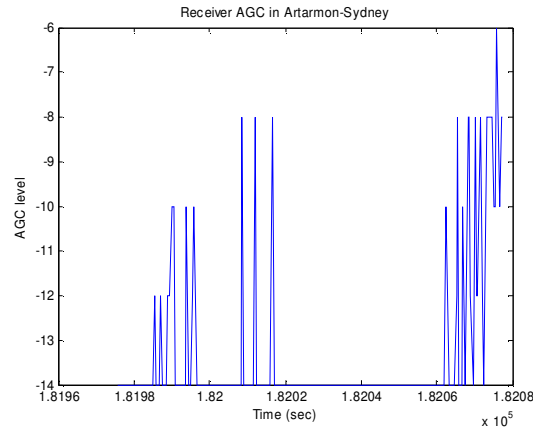
Figure 11 AGC level in the strongly interfered area versus time

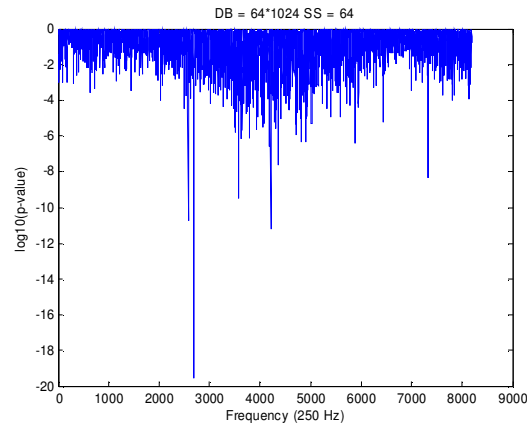
figure. In fact interference in those moments is not strong enough to be detected by a 62.5ms window size. Figure 15 shows that by using a 256 ms window size this interference is recognizable. With a longer window size we can have both more SS (sample size) and DB (data block) size.

Figure 15 P-value across the L1 bandwidth for time 23 sec
