**ANALYSIS OF SHORELINE VARIABILITY AND
EROSION/ACCRETION TRENDS:
DECEMBER 2006 - MAY 2007**

**REPORT 6
PALM BEACH COASTAL IMAGING SYSTEM**

Technical Report 2007/21

Client Name Gold Coast City Council

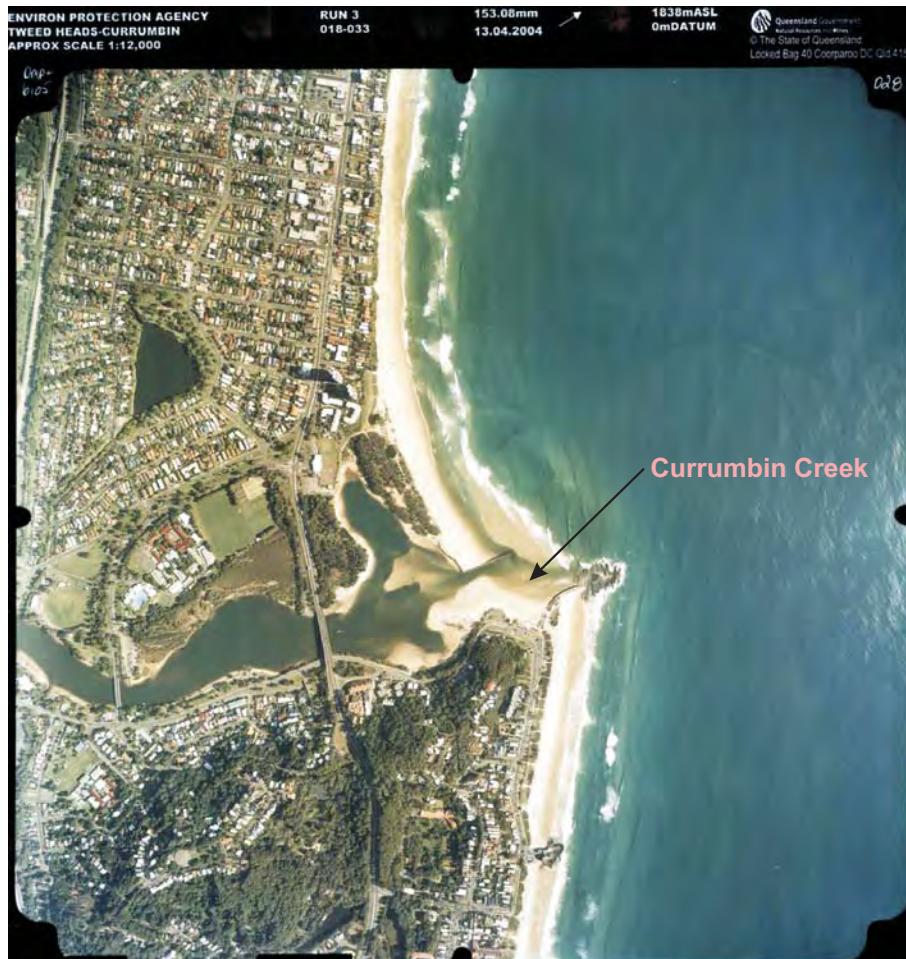
Palm Beach Embayment,
Southern Portion

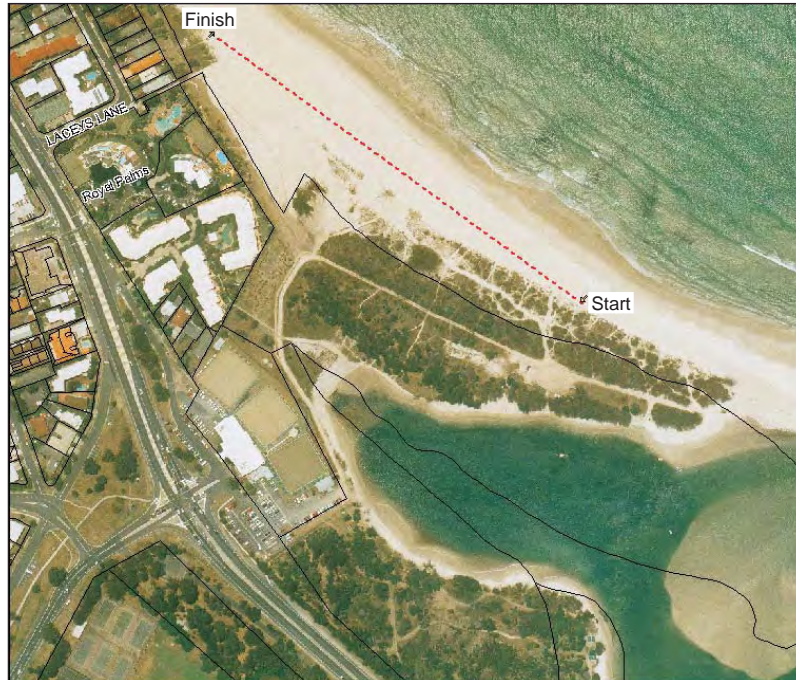
SAND PLACEMENT - 2004

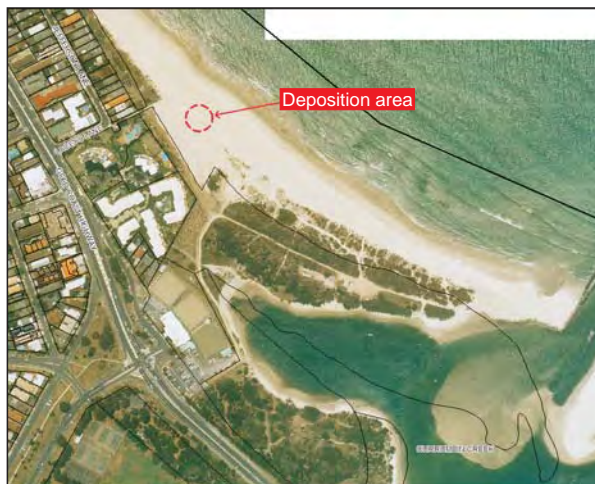
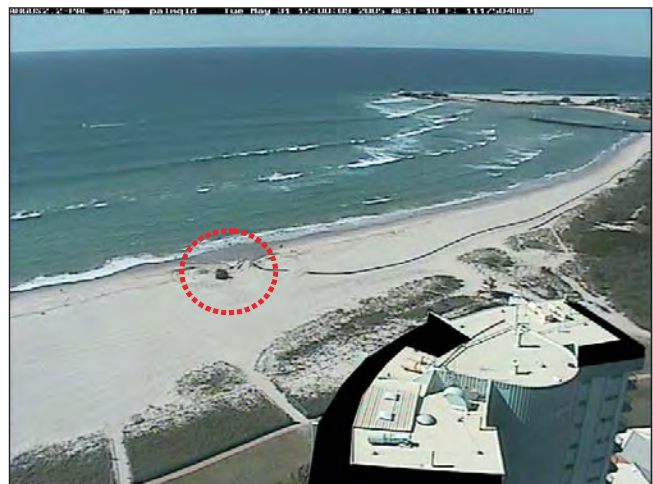
SAND PLACEMENT - 2005

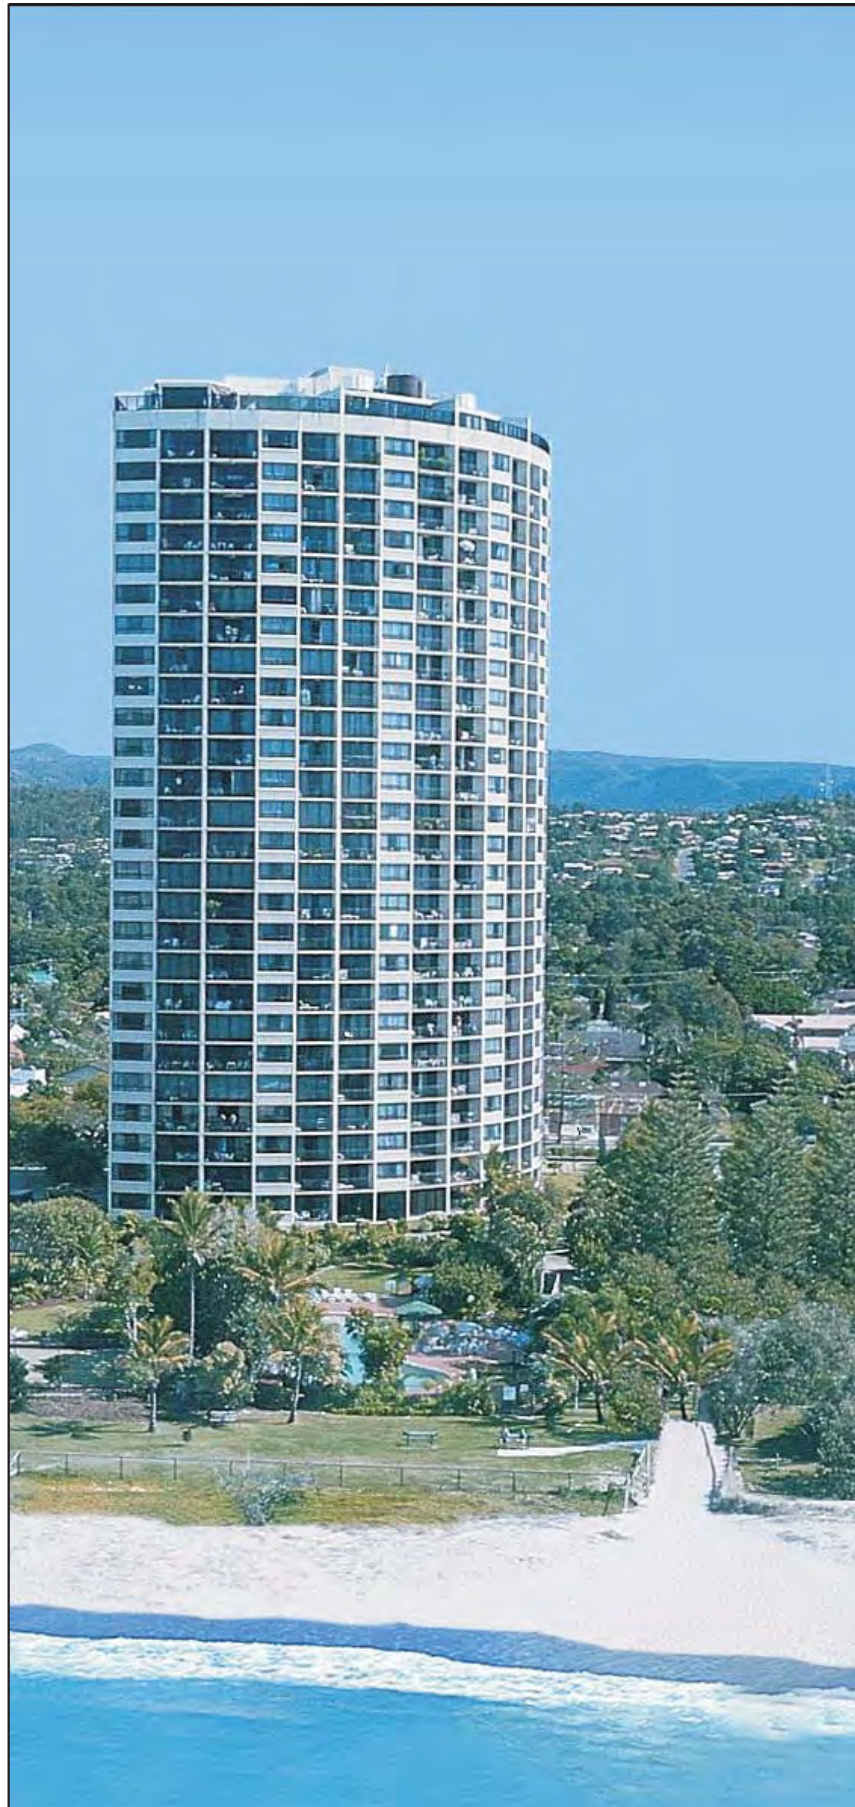
Figure
3.2

The ARGUS coastal imaging system was installed at Palm Beach in late May 2004. The system is located at an elevation of approximately 80m above mean sea level, within the roof services area of the Royal Palm building ([Figure 3.2](#)). The Royal Palm is located approximately 50m - 100m landward of the frontal dune, approximately 500m to the north of the Currumbin Creek entrance.

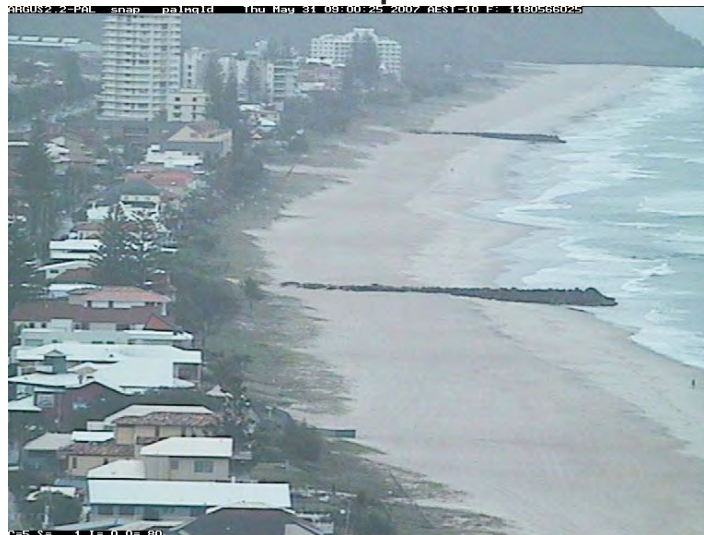
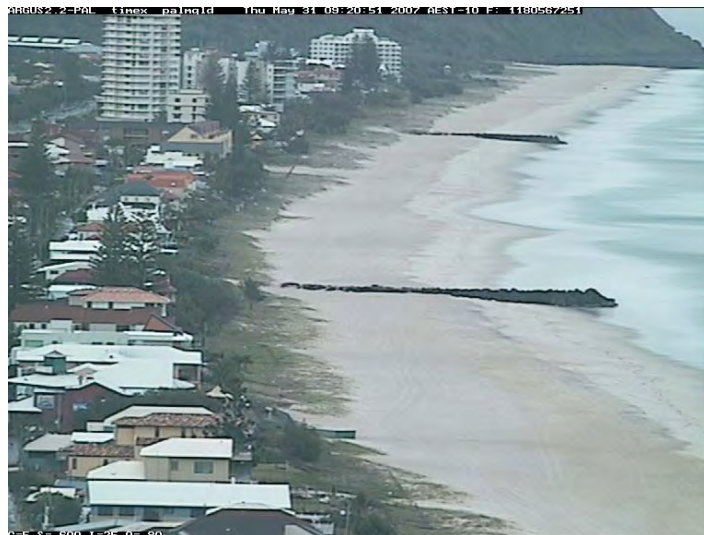
02114-3-3.cdr

snap

timex

var

Variance images can assist to identify regions which are changing in time, from those which may be bright, but unchanging. For example, a white sandy beach will appear bright on both snap-shot and time-exposure images, but dark in variance images. Because of this, other researchers have found that variance images are useful at some specific coastal sites for analysis techniques such as the identification of the shoreline, as the (bright) changing water surface is readily identifiable against the (dark) beach. An example of a var image is shown in [Figure 3.4](#) (lower panel).

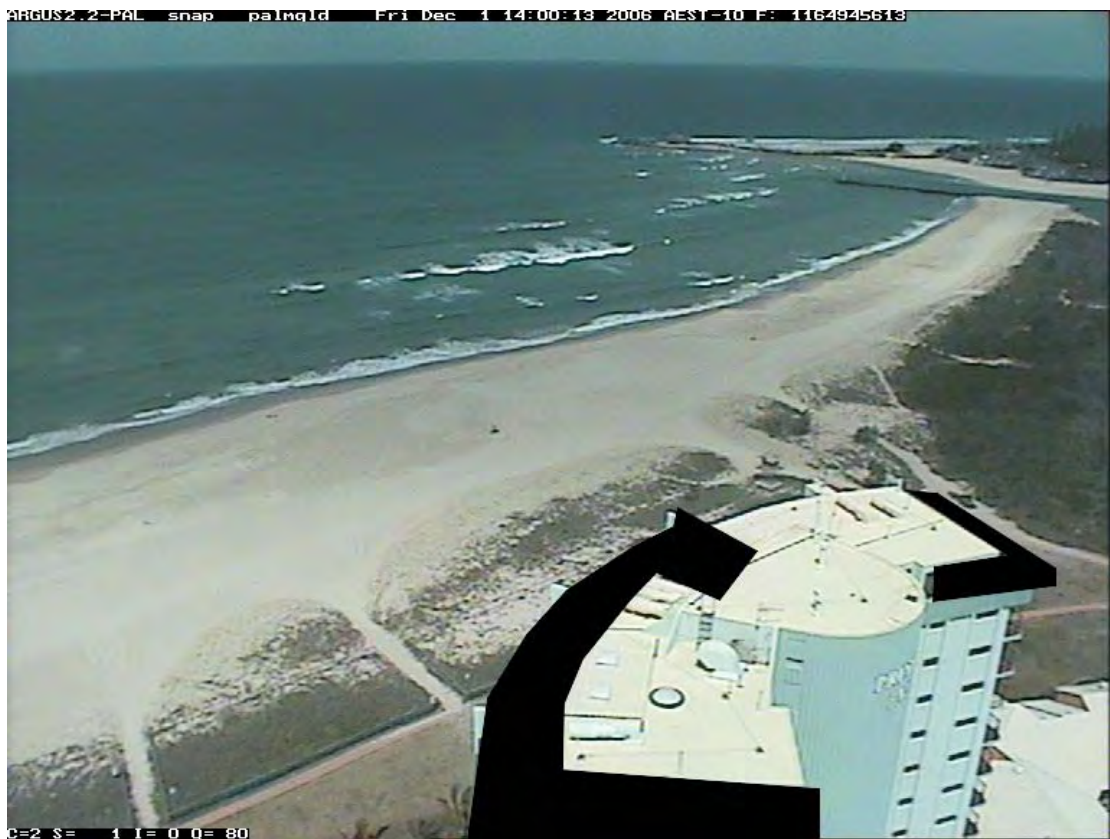
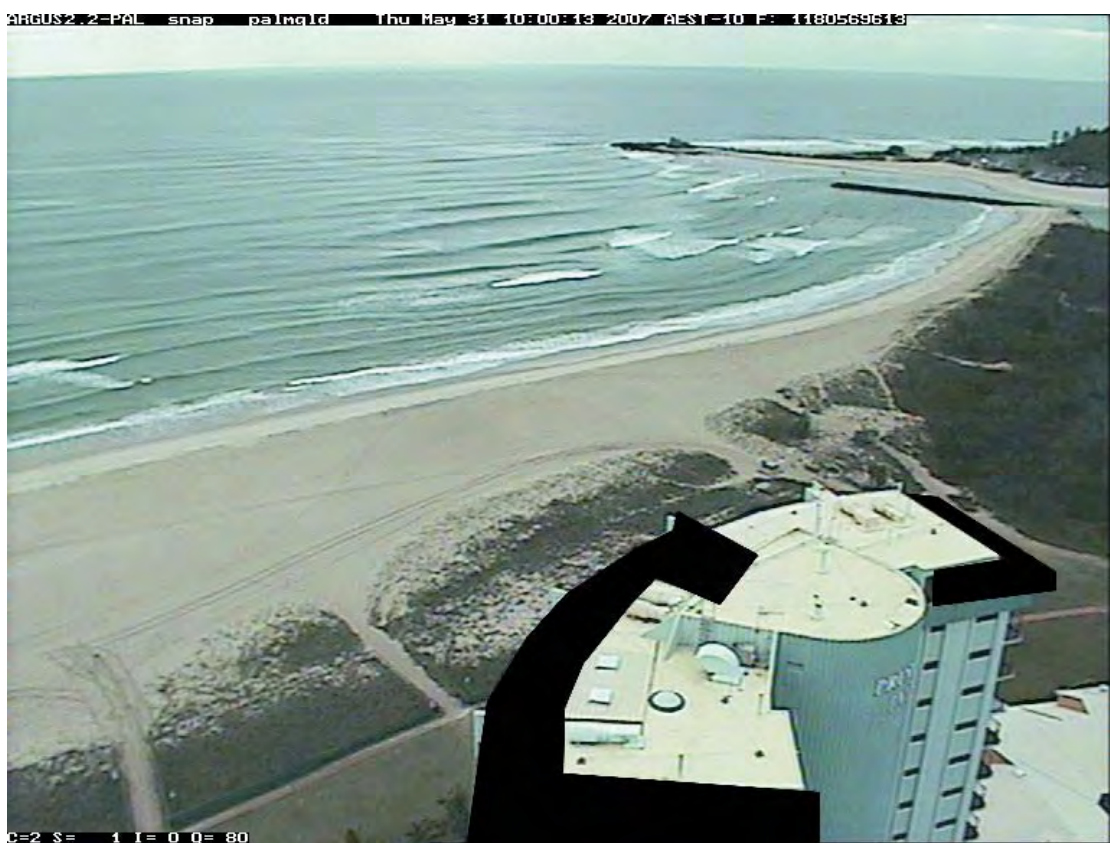
Figure 5.2 shows the snap images obtained at mid-tide from Camera 2 (south) in December 2006 and May 2007 respectively. The corresponding snap images of the northern sections of beach obtained from Camera 5, are shown in Figure 5.3. Along the southern section of beach (Figure 5.2) in the region of the Currumbin Spit, significant narrowing of the beach has occurred. The amount of beach narrowing steadily decreases in a northward direction, but is still relatively apparent even as far north as the immediate vicinity of the Royal Palm building.
