# Analysis of shoreline variability, seasonality and erosion/ accretion trends Dec 05 - May 06 report 4 Palm Beach coastal imaging system

**ANALYSIS OF SHORELINE VARIABILITY AND  
EROSION/ACCRETION TRENDS:  
DECEMBER 2005 - MAY 2006**

**REPORT 4  
PALM BEACH COASTAL IMAGING SYSTEM**

WRL Technical Report 2006/14

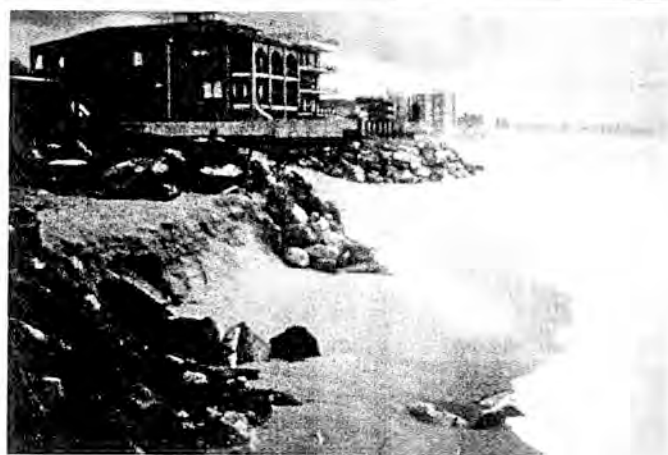
Figure 12. Present condition of the nonengineered revetment that is in place to protect beachfront property at the site of the newly installed ARGUS station at Narrabeen Beach, NSW (Source: Warringah Council).
