North Wonboyn NSW Foreshore Protection Study

WRL Technical Report 2013/29
May 2015

By M J Blacka, A Mariani and J T Carley

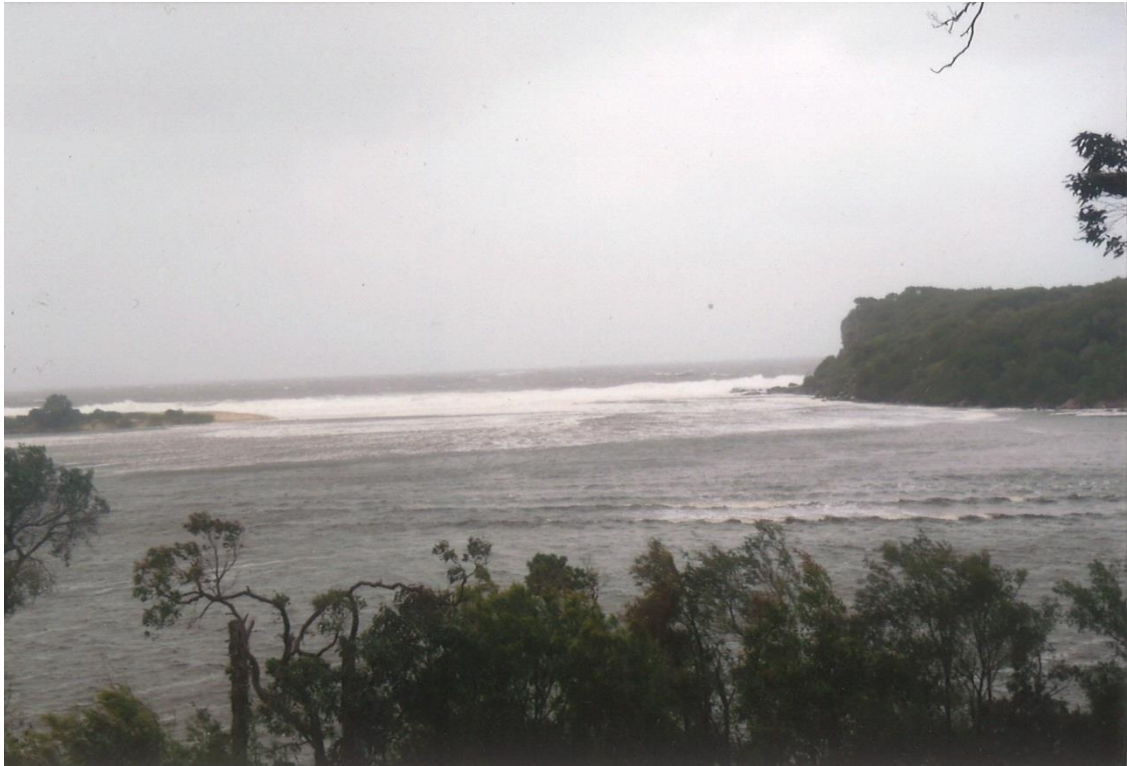
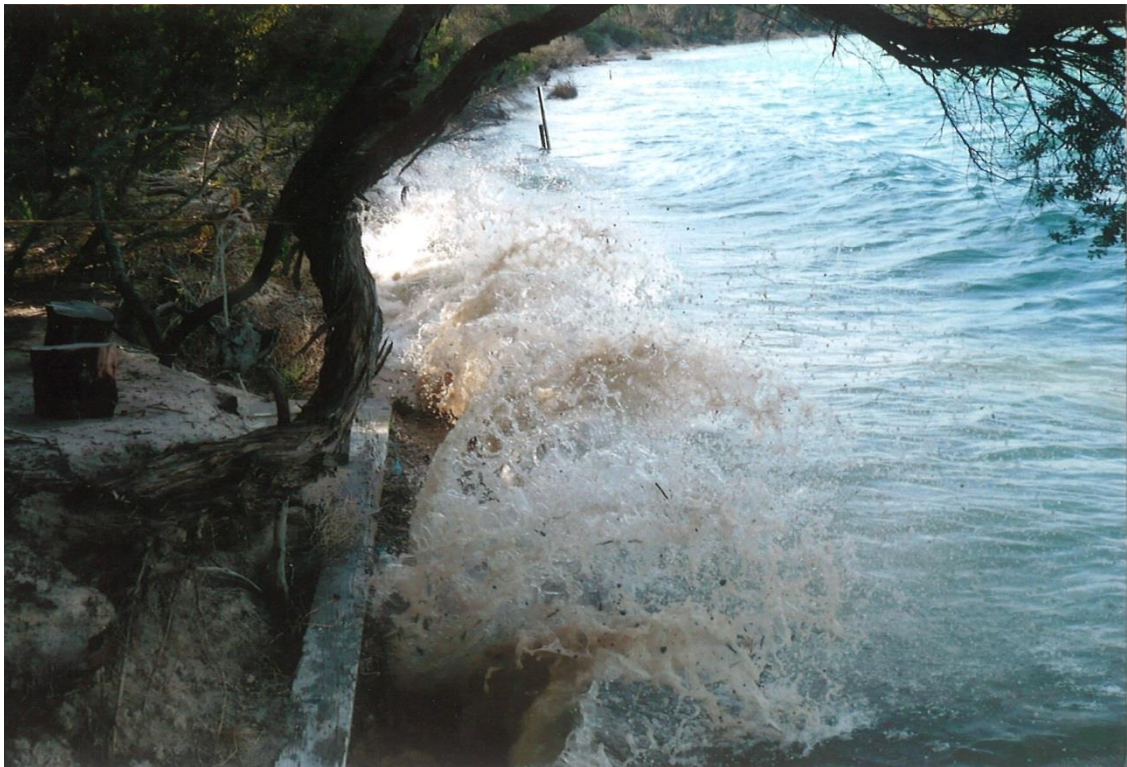
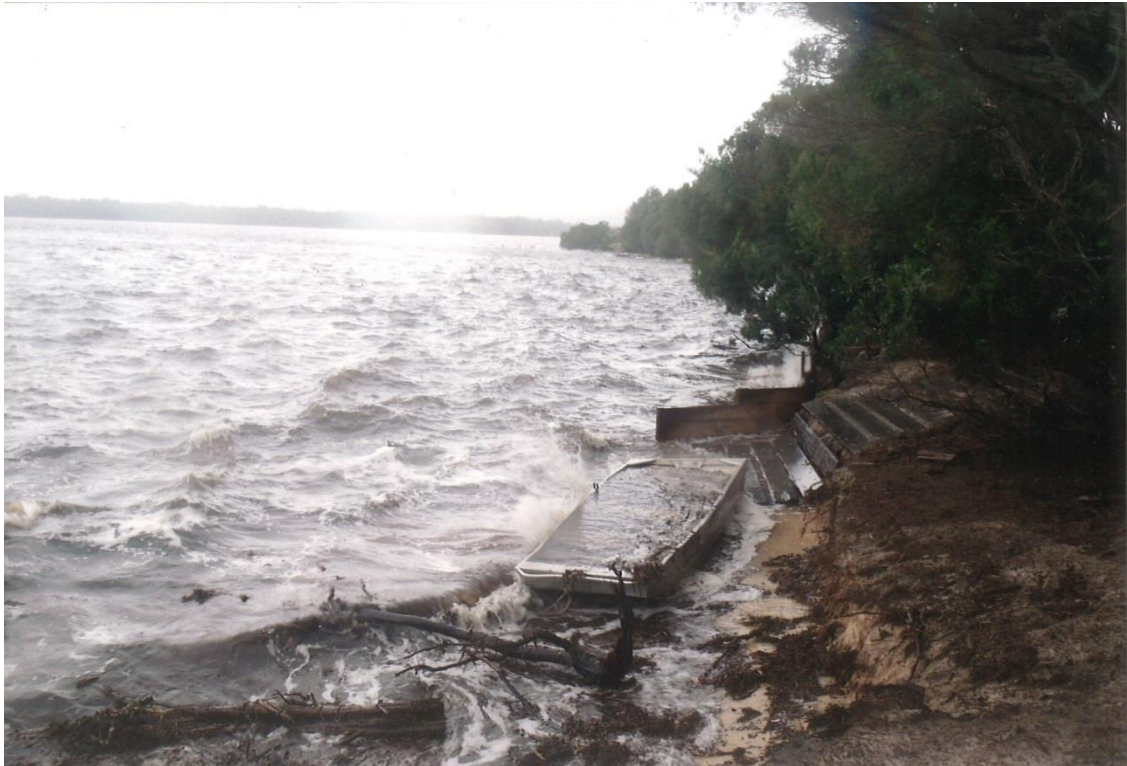
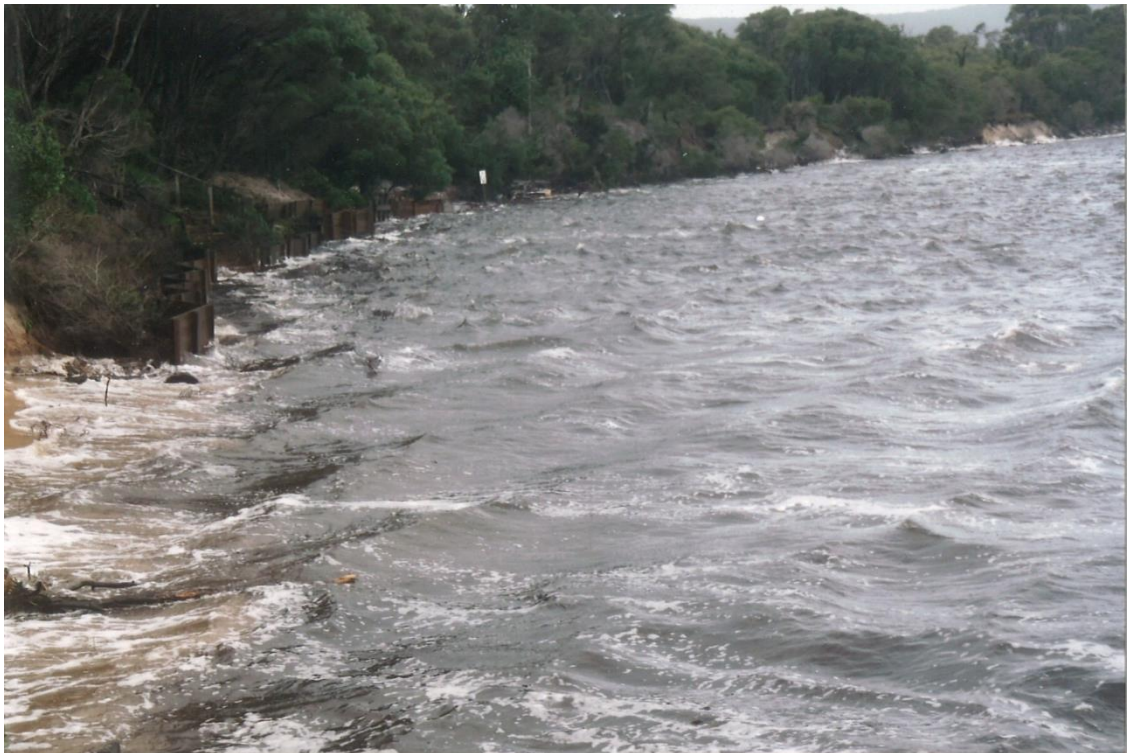
**Figure 2.2: Images of Recent Storm at North Wonboyn
(Source: Robert Smith)**

**Figure 2.2 Cont'd: Images of Recent Storm at North Wonboyn
(Source: Robert Smith)**

Figure 2.2 shows the North Wonboyn foreshore during a recent storm event.

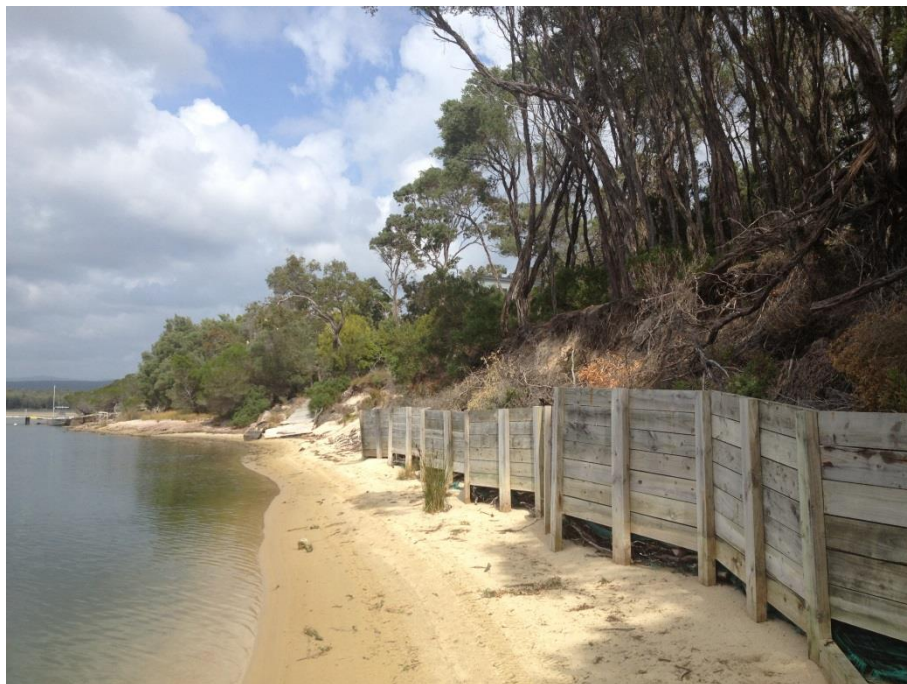
Figure 3.4: Existing Treated Pine Sleeper Seawall (Looking West)

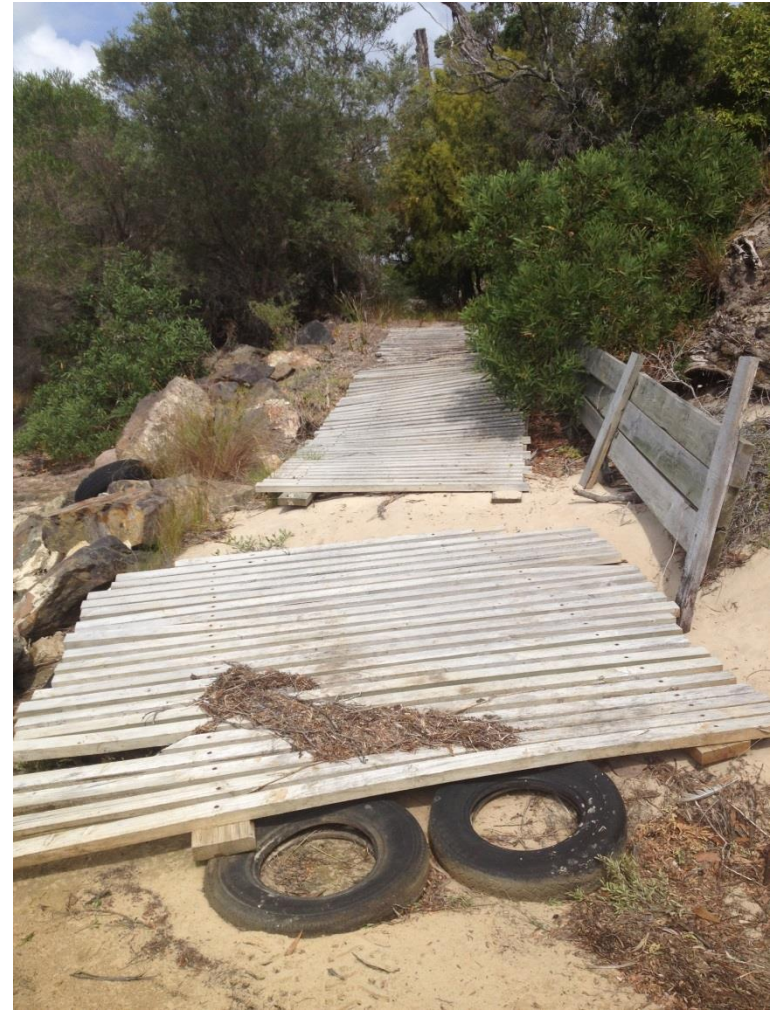
Figure 3.6: Damaged Timber Slatted Boat Ramp

The foreshore along this stretch of the estuary is predominantly used for recreational purposes by the local residents of North Wonboyn, with several small private boats moored on the beach. Access to the beach for people is via timber stairs that form a part of the seawall (Figure 3.5) and for vehicles/boats is via timber slatted boat ramps (Figure 3.6).

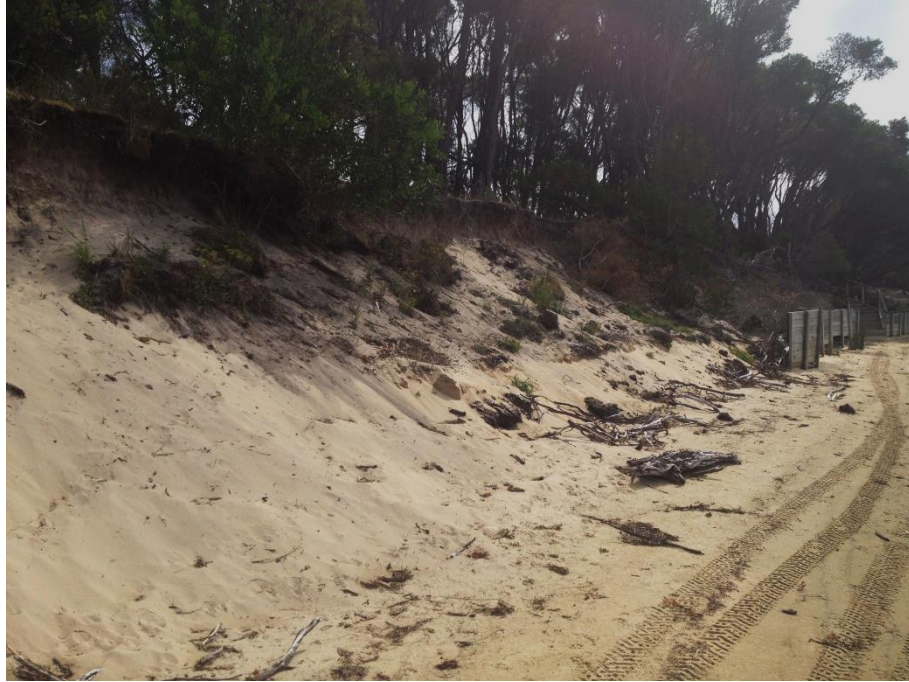
Figure 3.7: Eroded Foreshore at Western End of Seawall

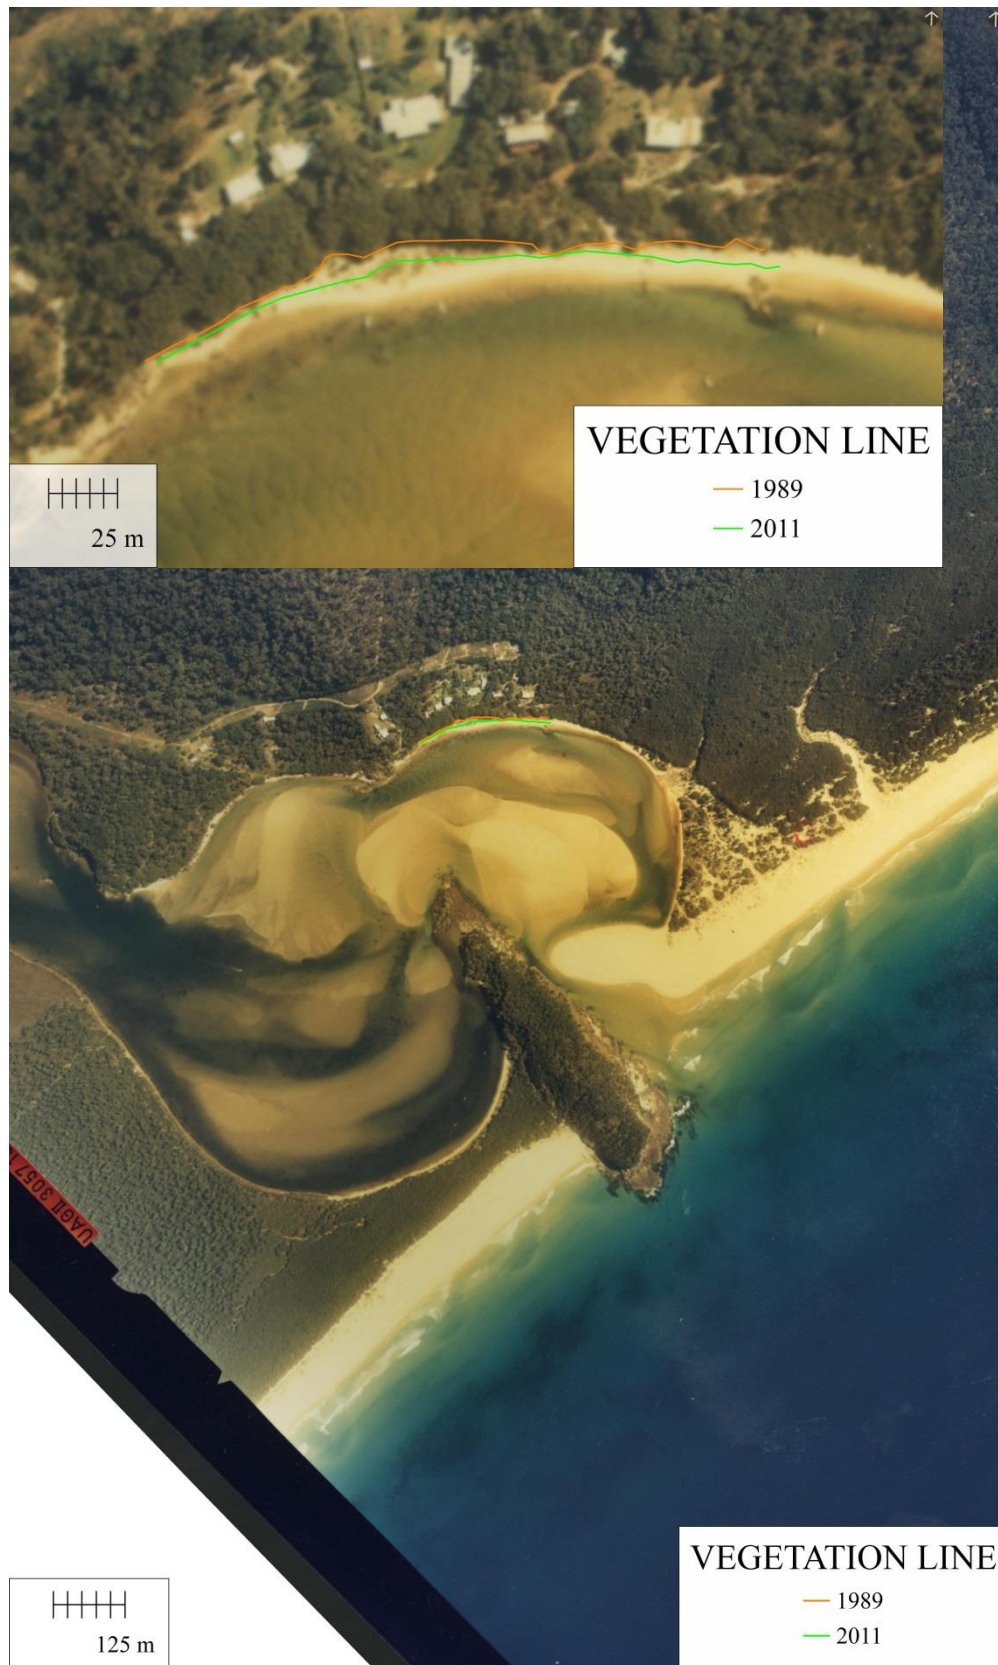
Figure 4.1: Aerial Photo 28/02/1989 and 1989 and 2011 Vegetation Line Mapping

The aerial photographs used in the analysis are reproduced in Appendix A. The images were geo-referenced and rectified and a study foreshore section at North Wonboyn of approximately 200 m fronting six (6) dwellings and Crown Reserve was analysed. The vegetation line over the various years was identified, superimposed and compared. Figure 4.1 shows the 1989 and 2011 vegetation lines superimposed on the geo-referenced 1989 aerial photo.

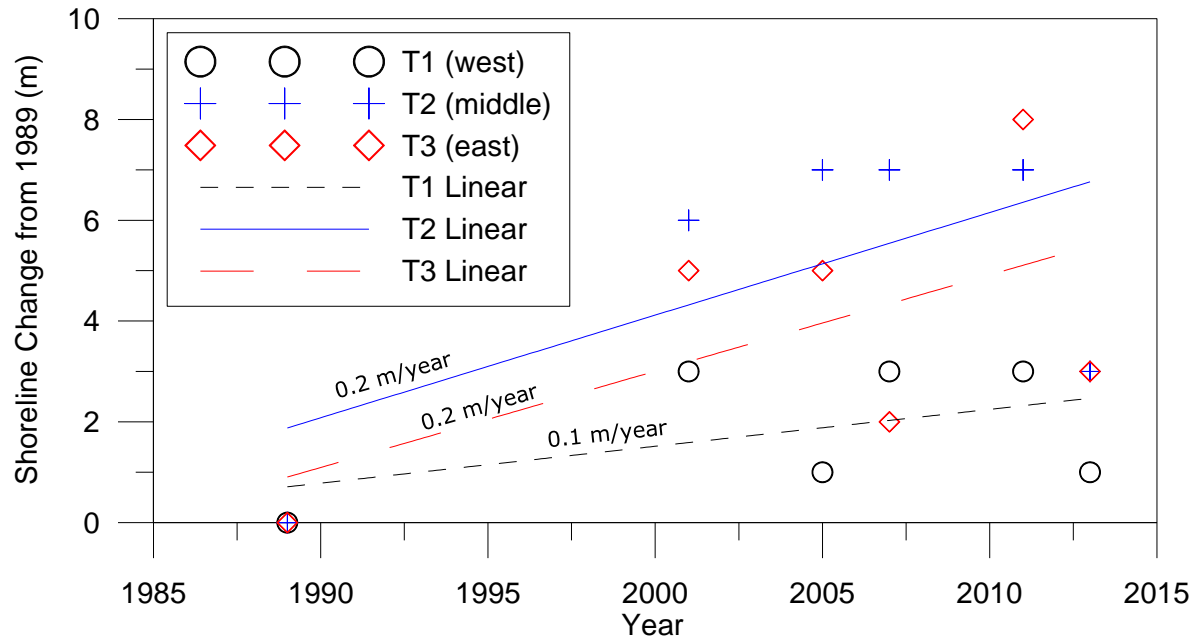
Figure 4.4: Shoreline Changes from 1989 Position

Three transects were analysed in terms of changes of vegetation line position over the years. The location of the transects is shown in Figure 4.3. Plots of changes in vegetation line position relative to the 1989 and 2001 positions are shown in Figure 4.4 and Figure 4.5 respectively.

The analysis of the transects showed there were no clear long term trends. Nevertheless, fitting an average linear trend showed that on average the shoreline accreted at the three transect locations from 1989 to 2013, at average rates of 0.1 to 0.2 m/year. However from 2001 to 2013, the shoreline receded at locations T1 and T2, i.e. the western and middle section of the study area, with recession rates of -0.1 to -0.2 m/year. The eastern section of the study area (transect T3) did not show a trend of either accretion or recession. However, the most significant factor in the latest (2013) shoreline position is the erosional change since the 2011 aerial photo.

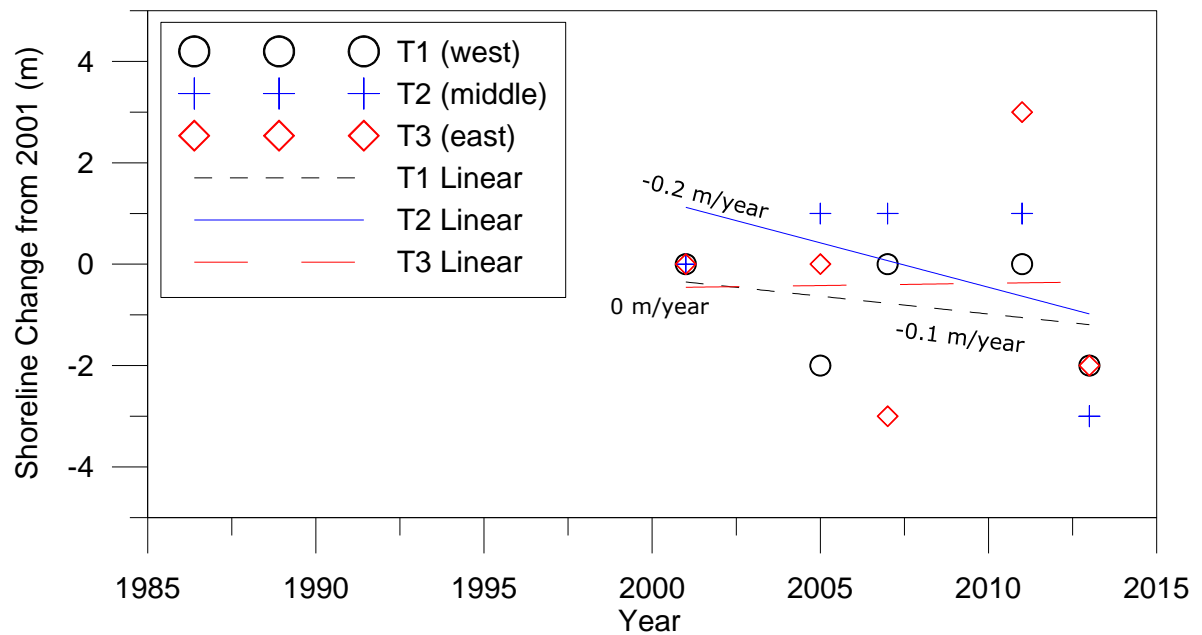
Figure 4.5: Shoreline Changes from 2001 Position

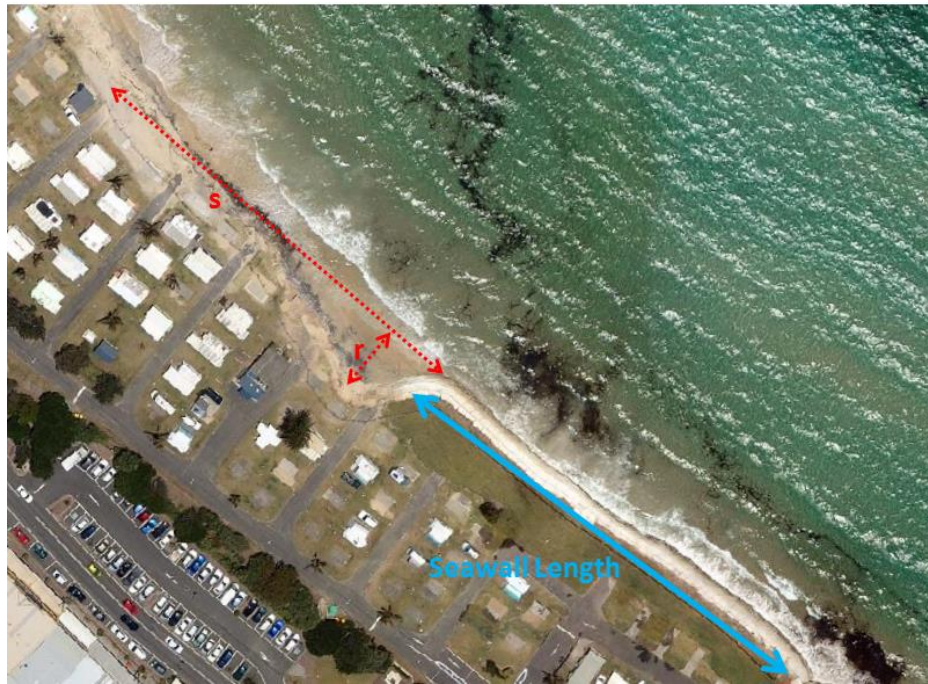
Figure 5.1: Kingscliff NSW Example of Excess Seawall End Erosion Depth, r and Length, s

While a substantial amount of research has been undertaken investigating the structure-beach interaction and documenting cases of beach response (summarised in Kraus, 1988; Kraus and McDougal, 1996), due to the complexity of the processes, robust and widely-accepted methods for predicting the magnitude and extent of beach response to seawalls are not available. Figure 5.1 shows an example of seawall end effects at Kingscliff, NSW. Differences in erosion “end effects” between different seawall types are not currently known.

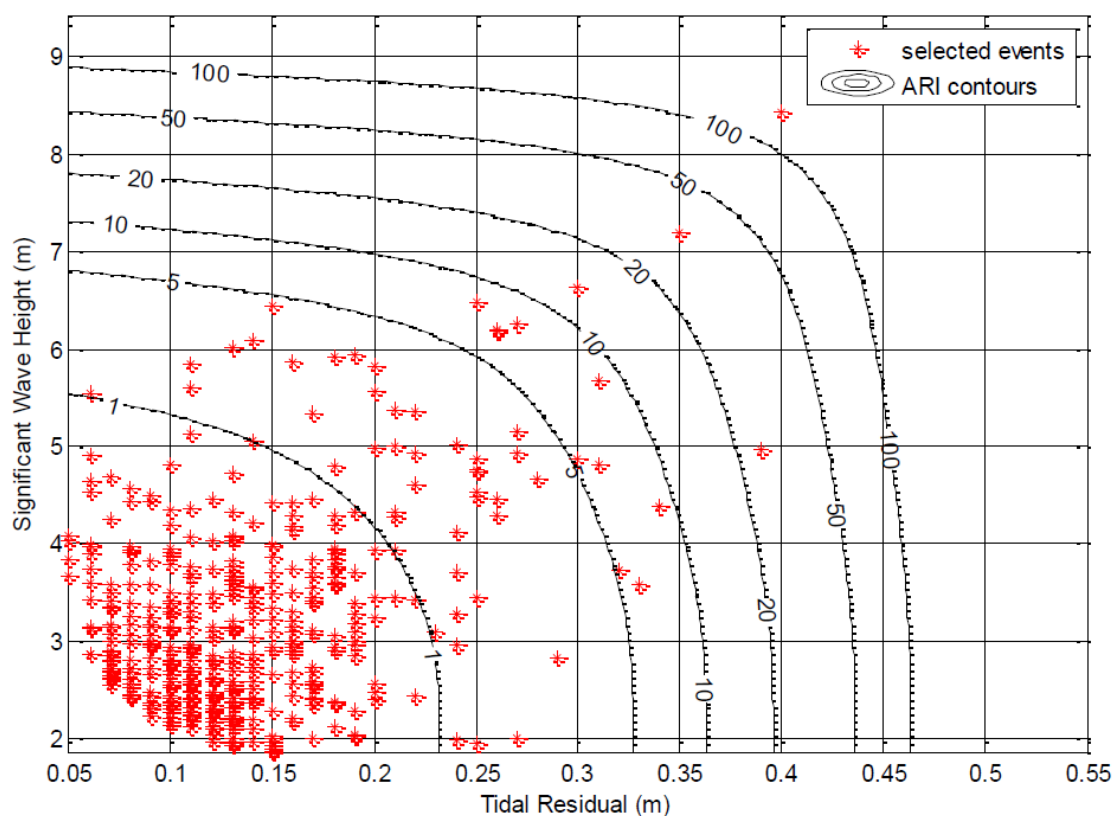
Figure 7.1: Joint Probability of Waves and Tidal Residuals for Sydney (Source: Shand *et al.*, 2012)

Therefore, as a conservative estimate, it has been assumed that for the ARI considered, the same ARI be applied to each component. That is, it has been assumed that the 100 year ARI (1 hour duration) wave height and water level coincide, together with the 100 year ARI beach erosion level. This is acknowledged to be conservative, however, well accepted (less conservative) alternative methodologies are not available.

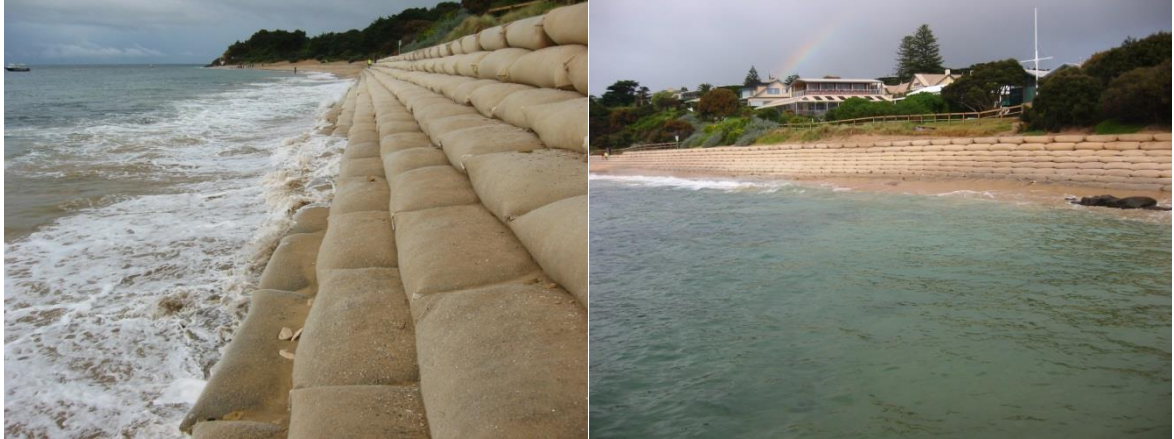
Figure 8.1: Typical Engineered Geotextile Container Revetment, Portsea, Victoria

Sand-filled geotextile container revetments generally have a recommended slope of 1V:1.5H. Figure 20 shows a typical engineered geotextile container seawall acting as a revetment at Portsea, Victoria.
