# Stress corrosion cracking of rock bolts: an examination of the metallurgical and environmental factors behind preliminary rock bolt failure

*STRESS CORROSION CRACKING OF ROCK BOLTS: AN  
EXAMINATION OF THE METALLURGICAL AND  
ENVIRONMENTAL FACTORS BEHIND PRELIMINARY ROCK  
BOLT FAILURE*

Thesis submitted as a requirement for the degree  
PhD. of Engineering (Failure Analysis)

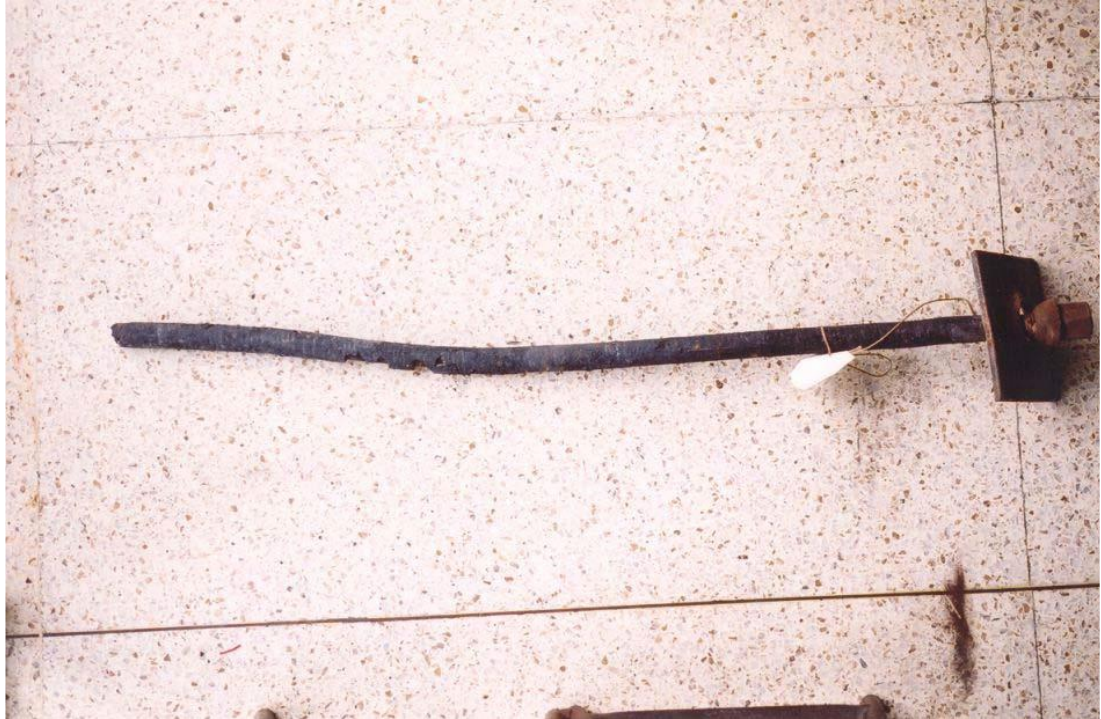
**Figure 2-34: Bolt broken in grouted region. The bolt contains a bend (arrowed) about one third of the way between the fracture and the protruding end<sup>[107]</sup>.**

and the protruding end, Figure 2-34. Cracking and spalling of the grout can be seen in this region, Figure 2-34 and Figure 2-36, confirming Shutter et al.'s<sup>[103]</sup> proposal that cracking of the grout occurs exposing the underlying metal when the rock bolts are bent as result of strata shear. Cracking and spalling of the grout is also evident in the vicinity of the fracture in this bolt, Figure 2-35.

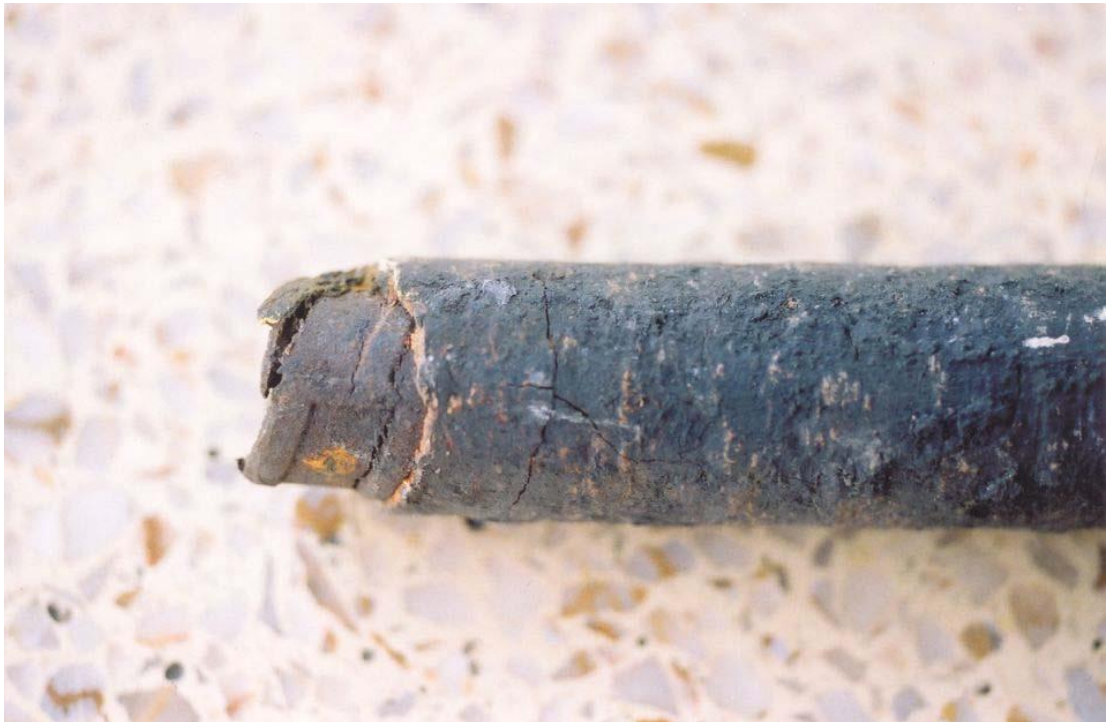
**Figure 2-35: Close up view of fracture in bolt shown in Figure 2-34<sup>[107]</sup>.**

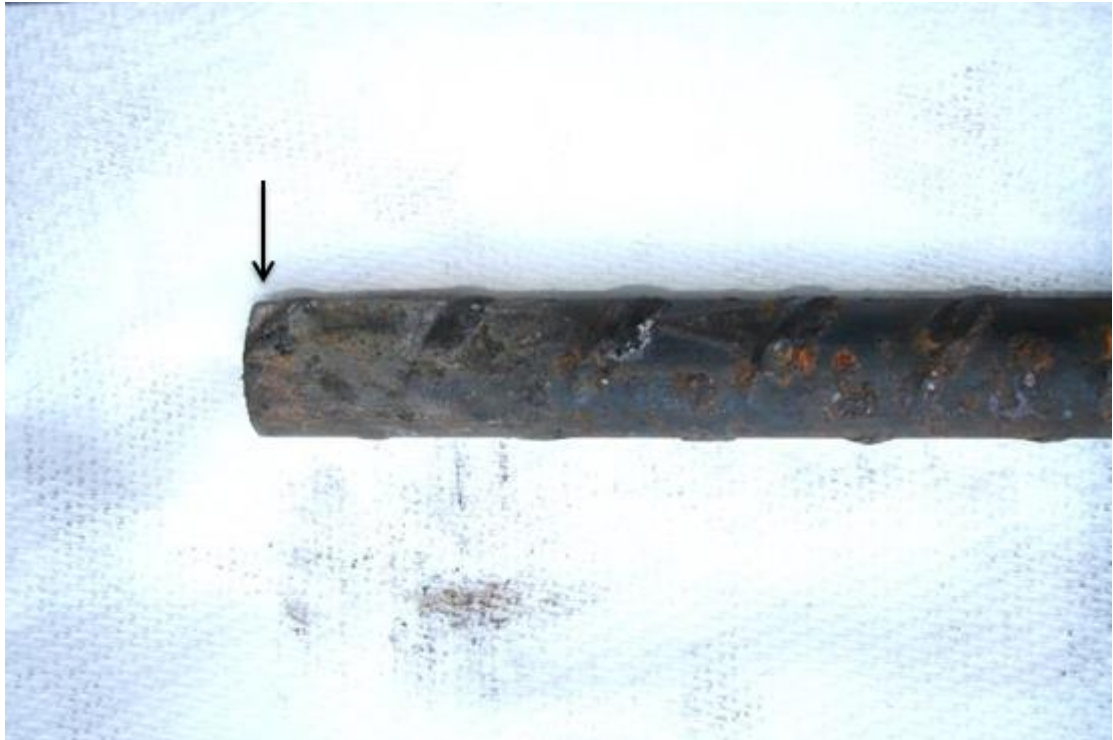
**Figure 4-1: Failed rock bolt recovered from mine site. A slight bend can be seen (arrowed) adjacent to the position of the fracture.**

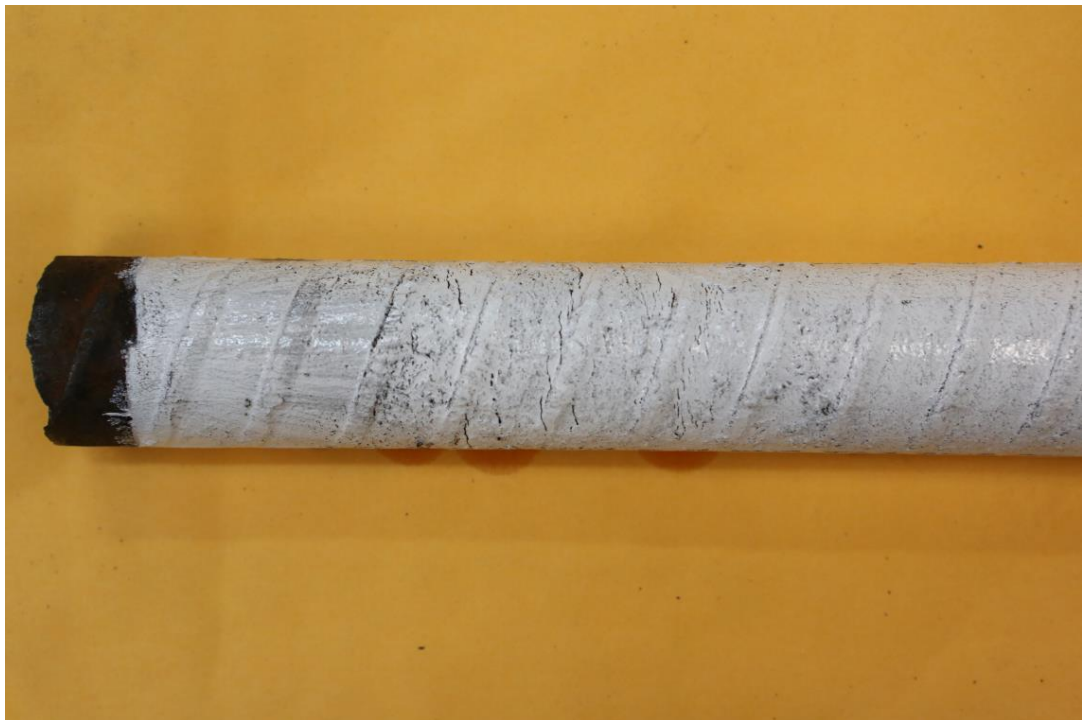
**Figure 4-2: Subcritical cracks revealed in Rock bolt 2 by magnetic particle inspection**

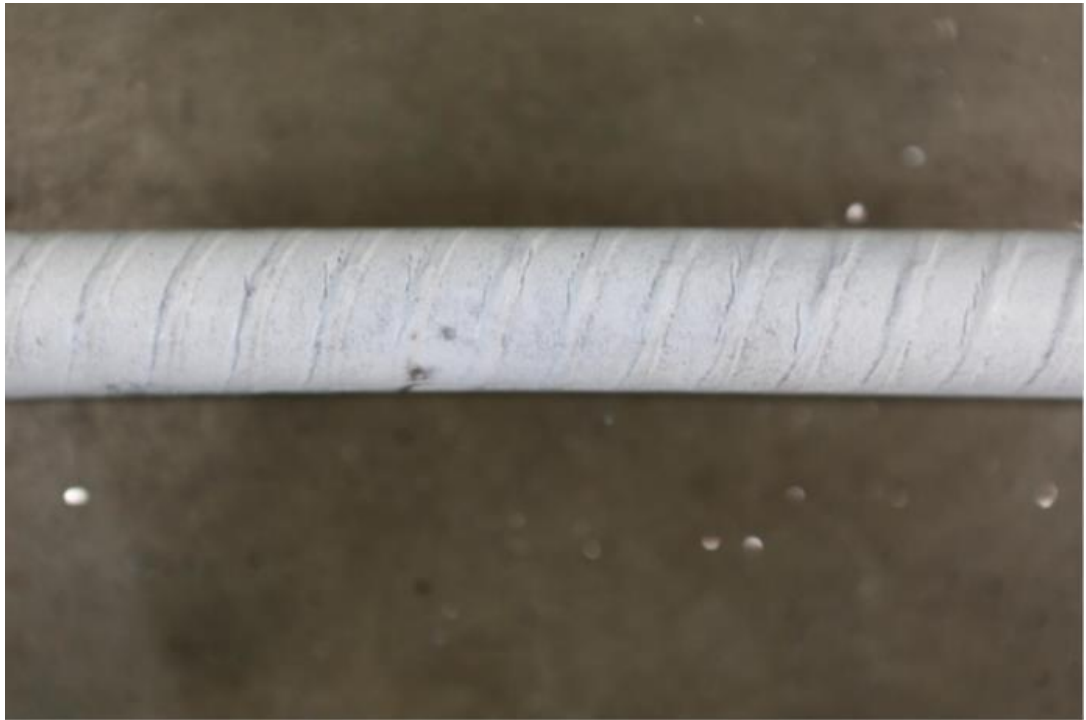
**Figure 4-3: Subcritical cracks revealed in Rock bolt 7 by magnetic particle inspection.**

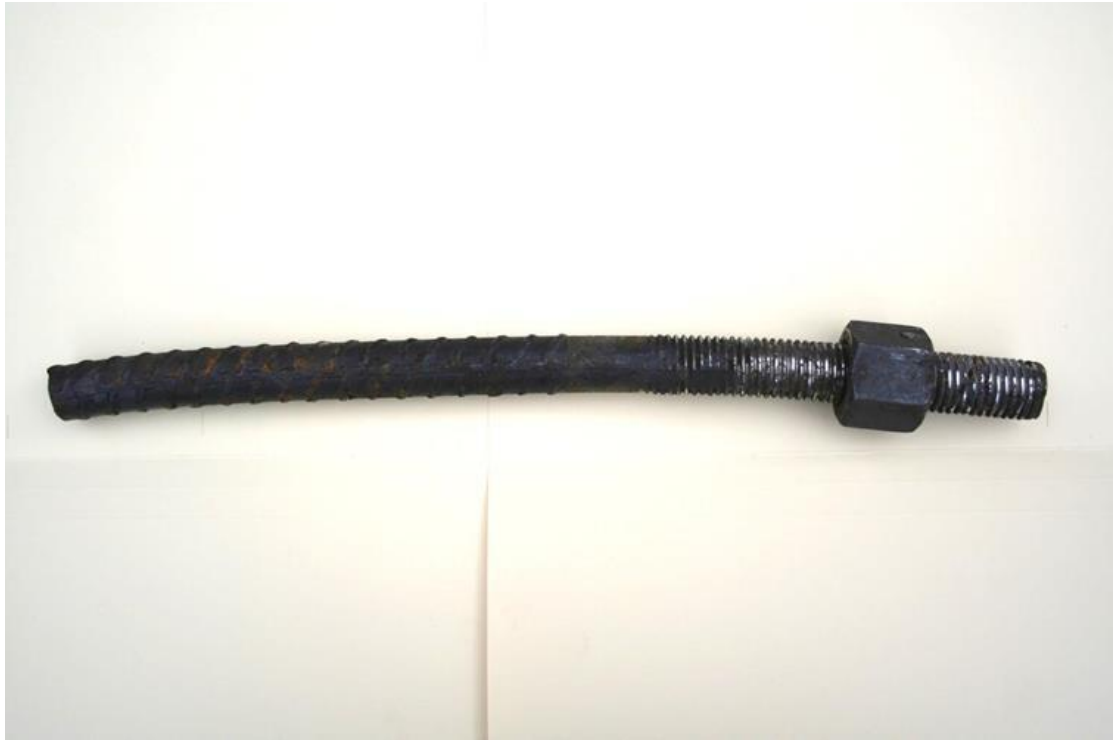
**Figure 4-28: Rock bolt 1 profile.**

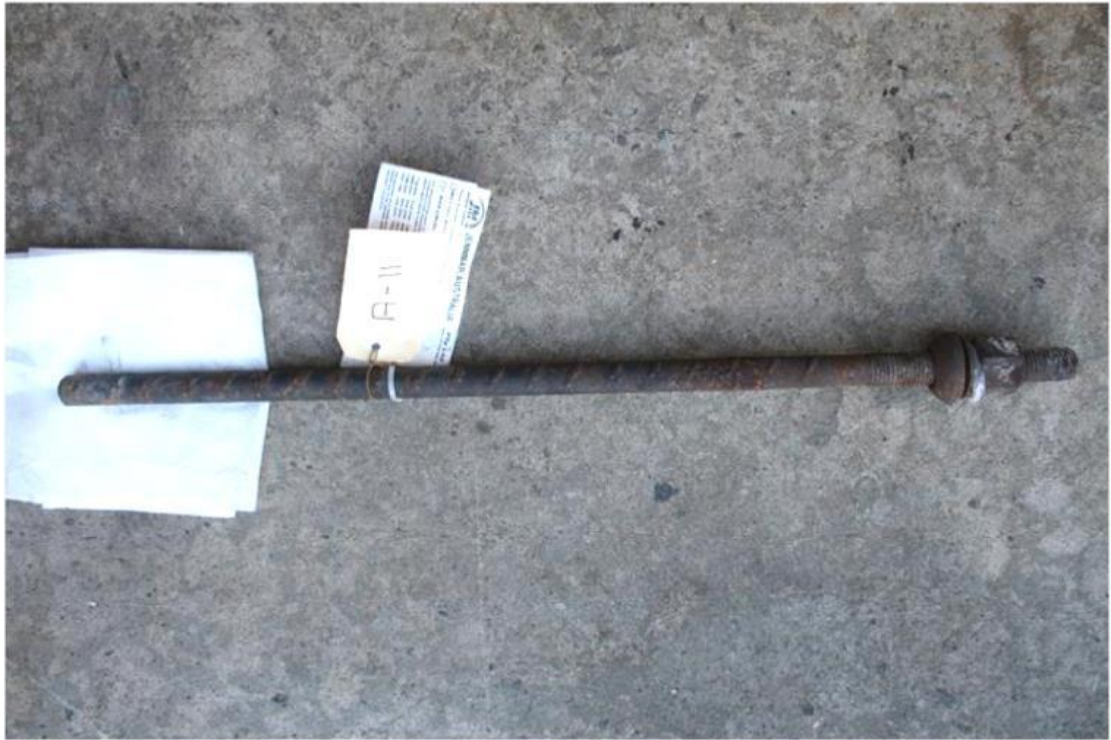
**Figure 4-34: Rock bolt 12 profile.**

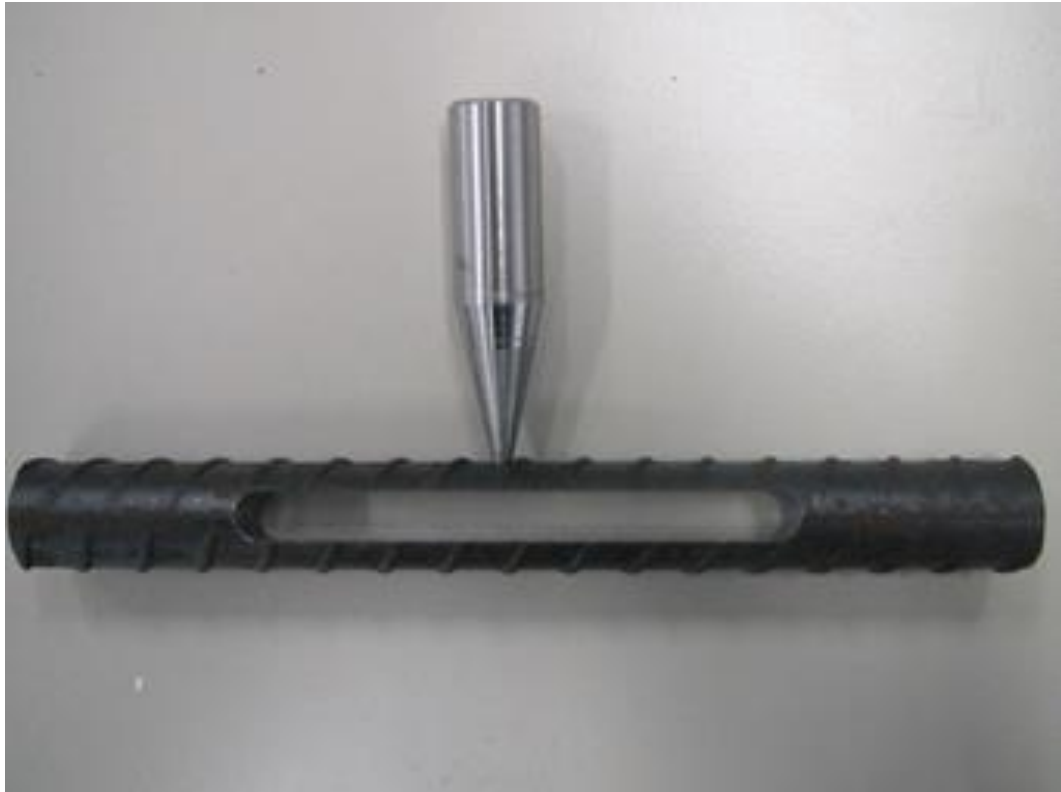
**Figure 5-8: Slotted specimen with loading pin.**

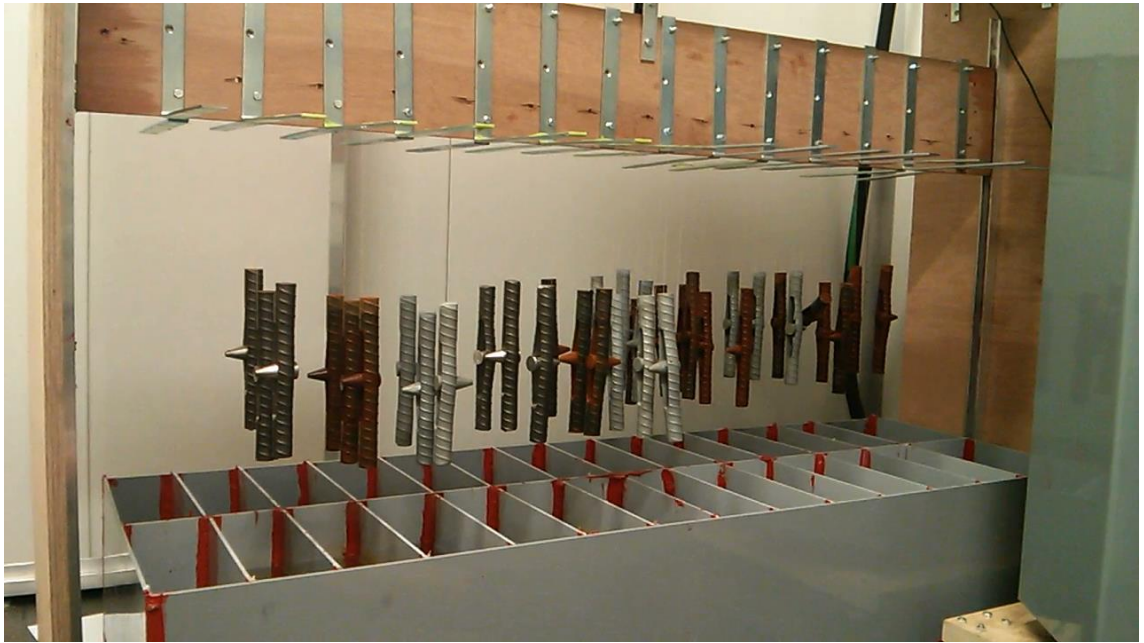
**Figure 5-10: Test rig used for cycling test specimens through alternating wetting and drying cycles.**

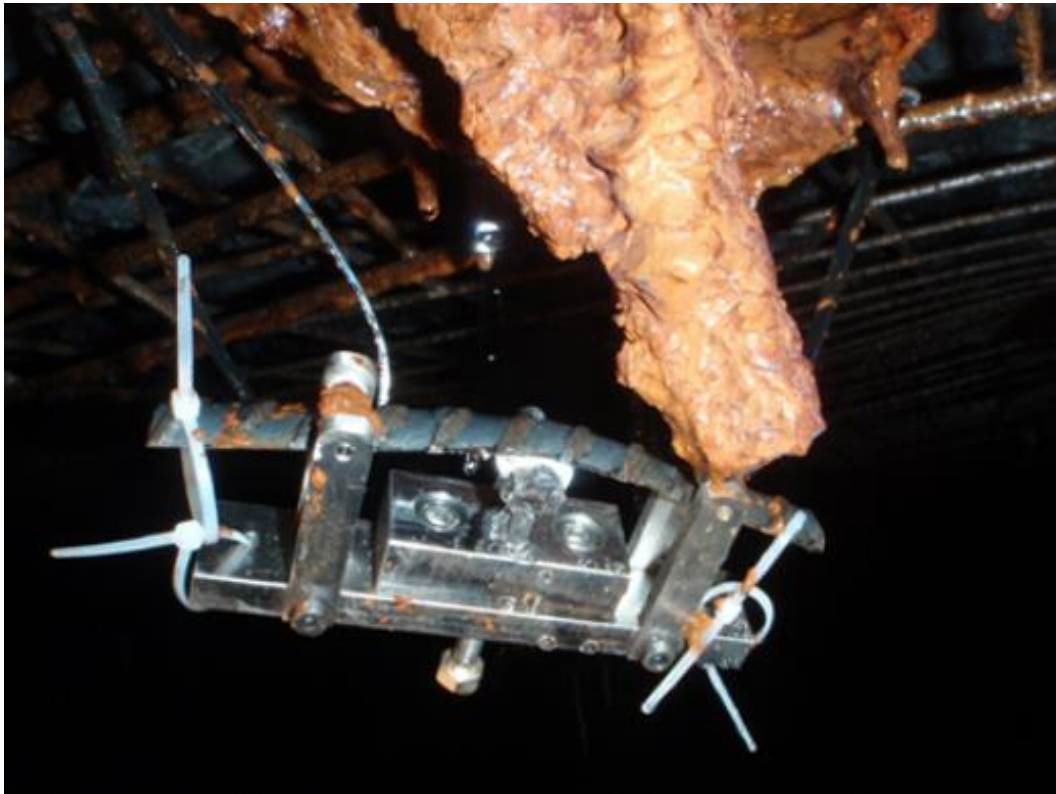
**Figure 5-11: Three-point bend test specimen in place in Mine B.**

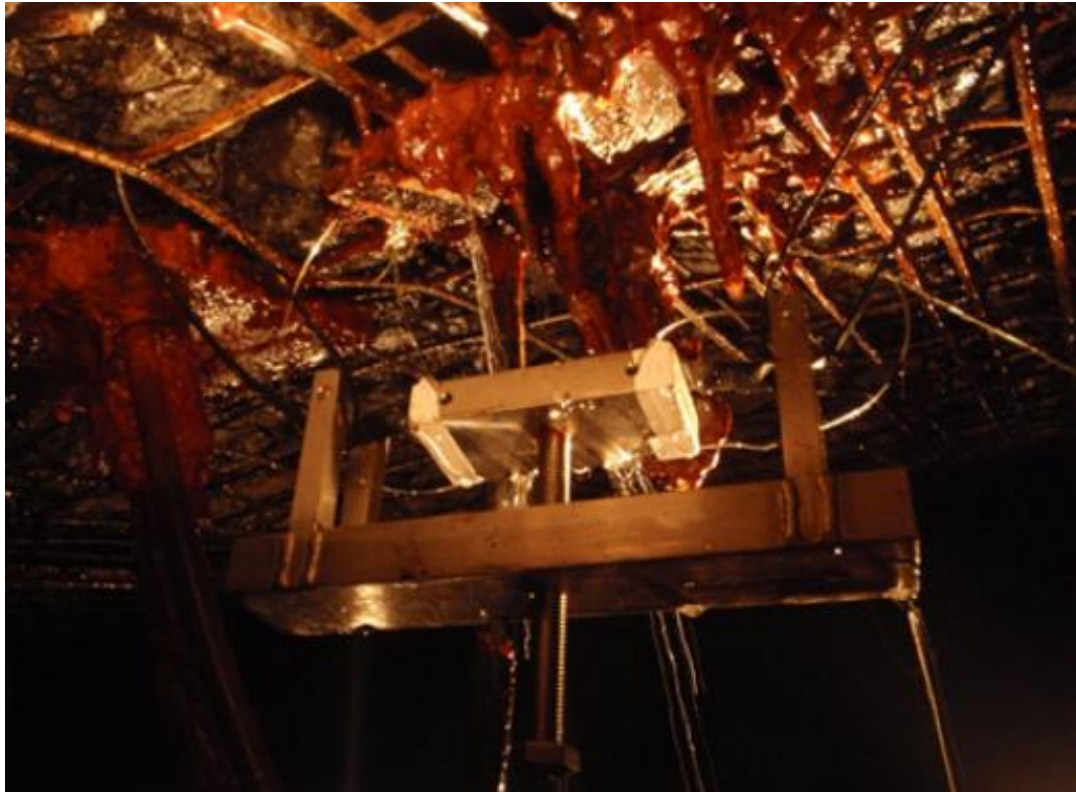
**Figure 5-12: Four-point bend test specimen in place in Mine B.**

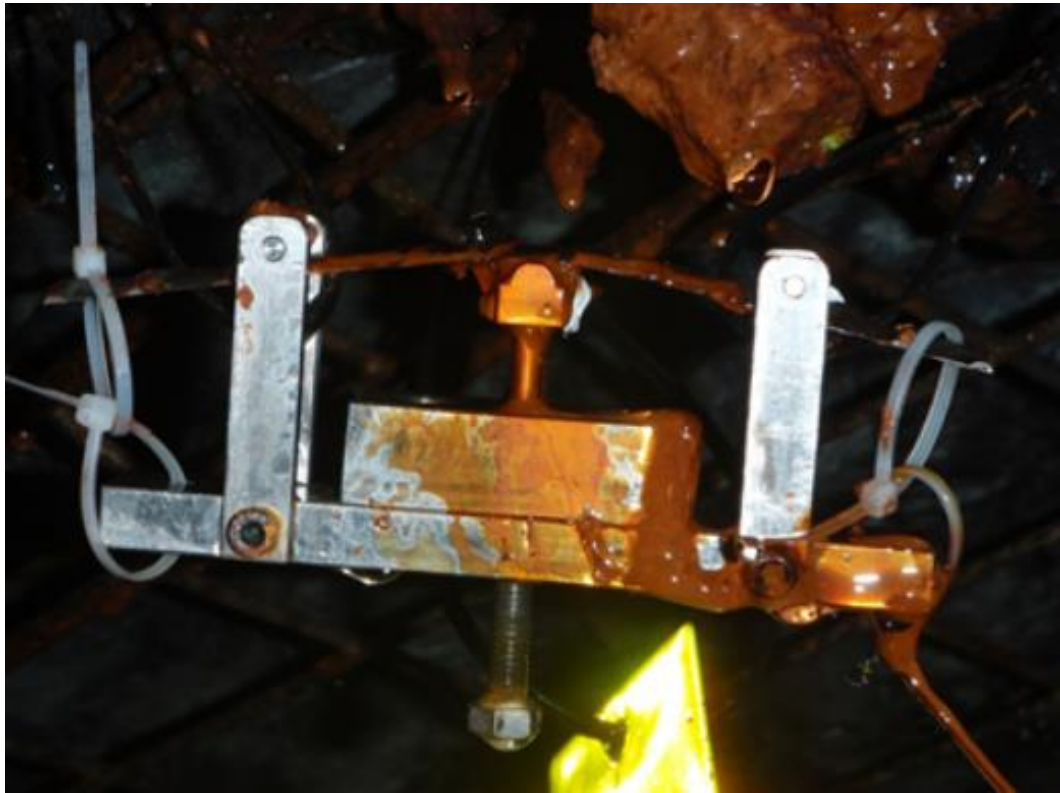
**Figure 5-13: Three-point bend specimen after 1 week in Mine B.**

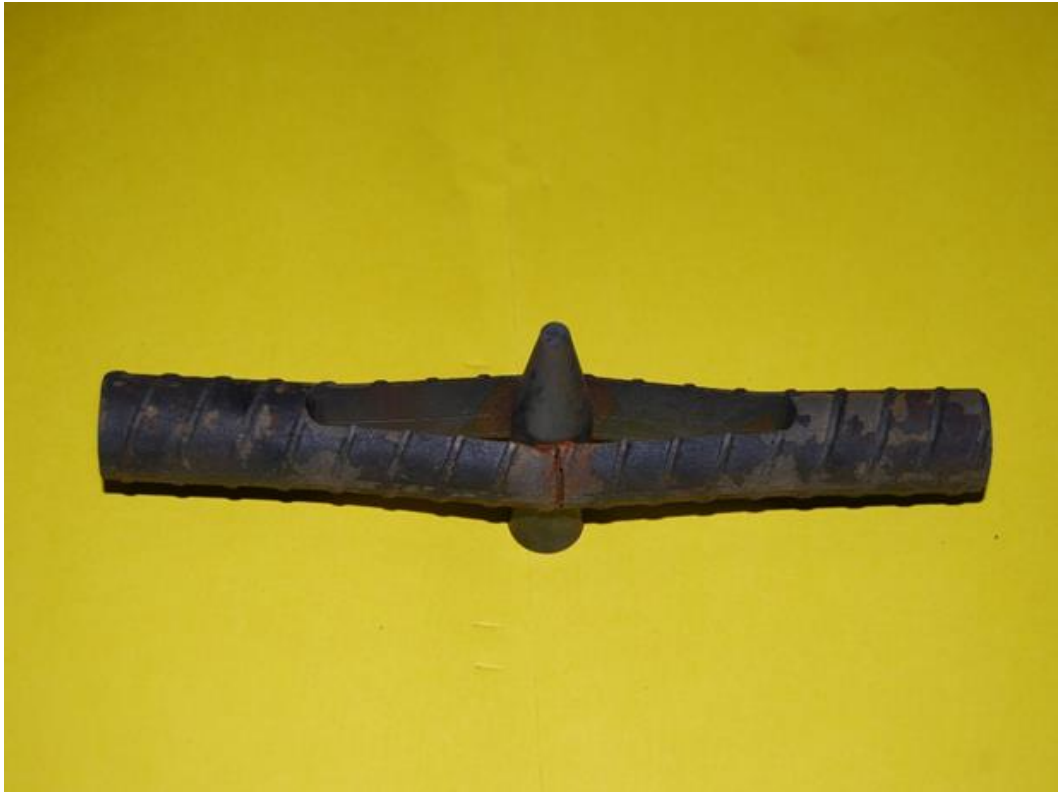
**Figure 5-15: AISI 1355 pin-loaded specimen after failure.**

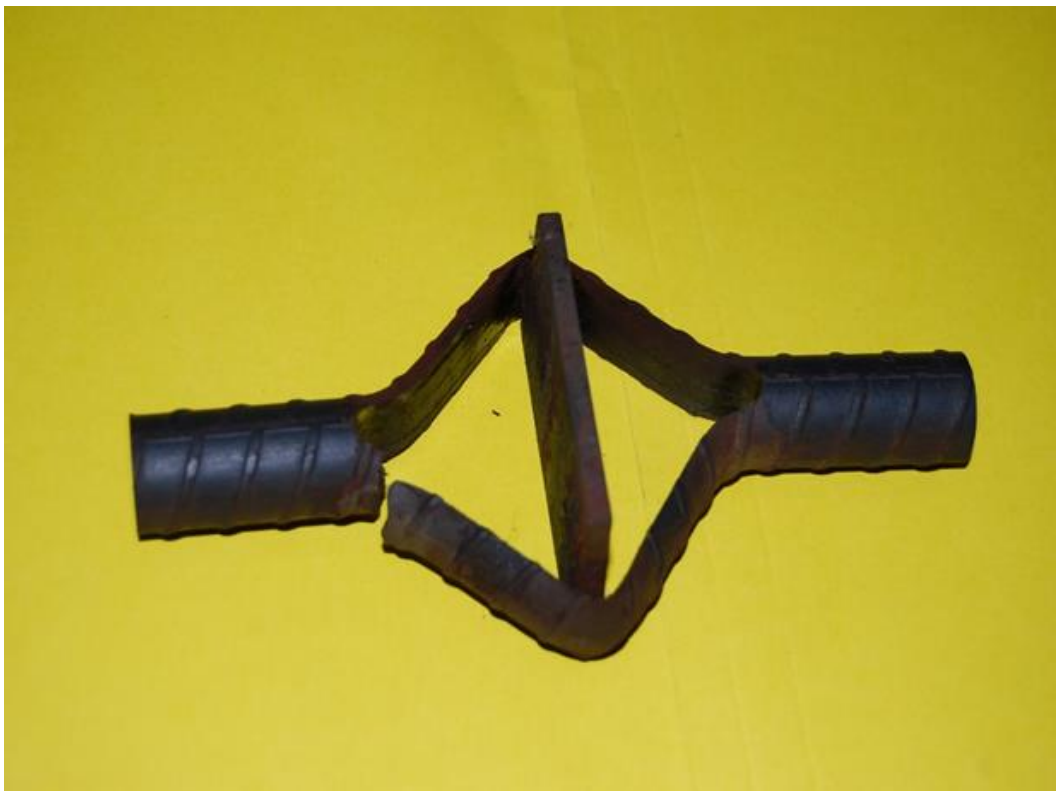
**Figure 5-16: AISI 1355 bar loaded specimen after failure.**
