THE UNIVERSITY OF NEW SOUTH WALES
WATER RESEARCH LABORATORY

REPORT No. 56

Seepage Control with Plastic Membranes

Part 5 - Physical Properties of
Australian Plastic Films Suitable
for Dam Lining

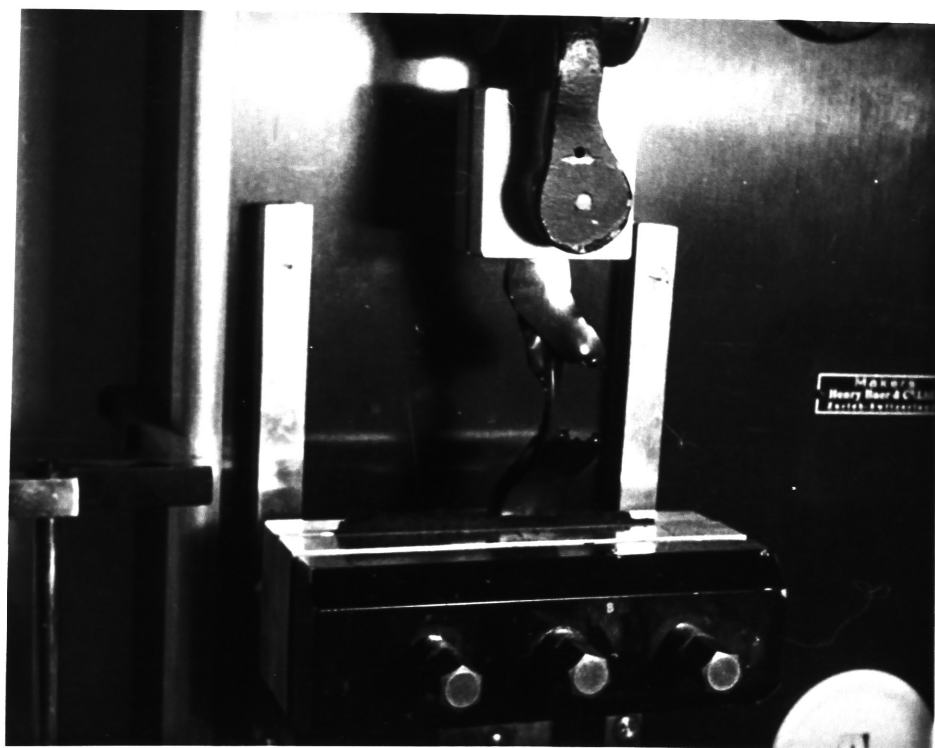
Fig.2. B.S. tear test on Polythene.

The "Baer" textile testing machine used for tensile testing above was also used for tear strength tests. The loading rate was 11" per minute. A sample of polythene under test is shown in Fig. 2.

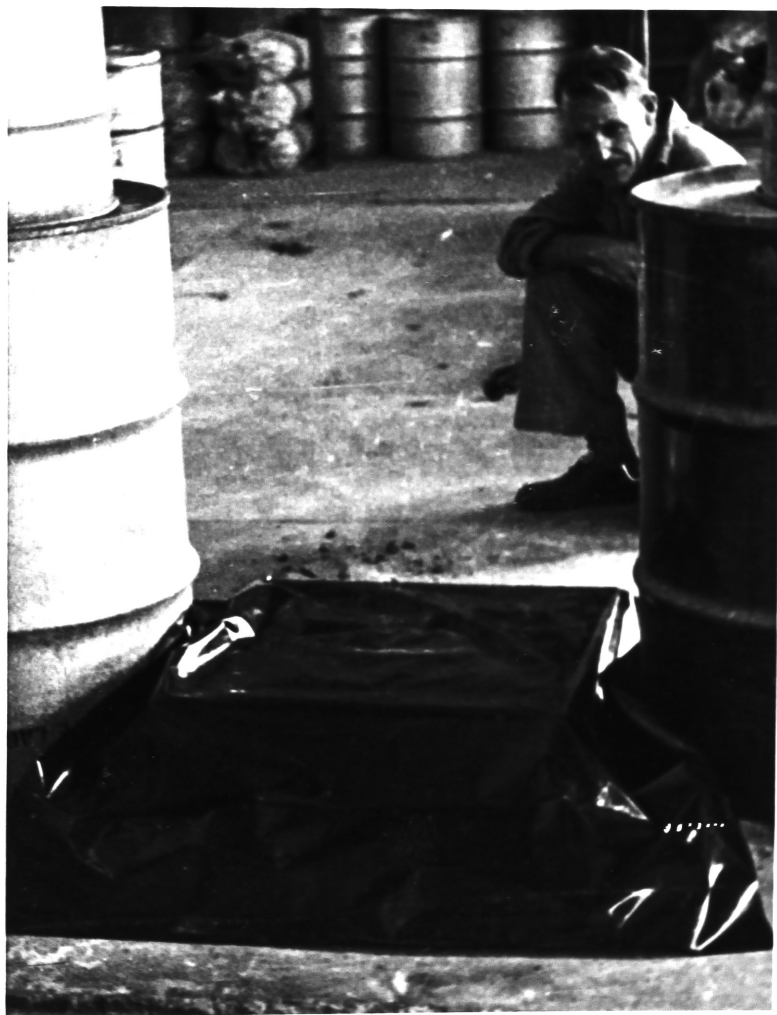
Fig.10. Drop box apparatus used for soil covering test.

- 2.8 Test to Simulate Covering of Films with Soil in the Field:- This test was carried out using the apparatus shown in Fig. (10) where one cubic foot of soil consisting of 75% of river sand and 25% of $\frac{3}{4}$ " crushed basalt was dropped from a height of 4 ft. onto a sample of plastic membrane resting on 3" of sand. A pinhole test according to B.S. 1763: 1956 (Ref.1) was then carried out to detect any puncturing.
- 2.9 Microscopic Examination:- Several specimens were examined under a low power (6x) microscope using both reflected and transmitted light.

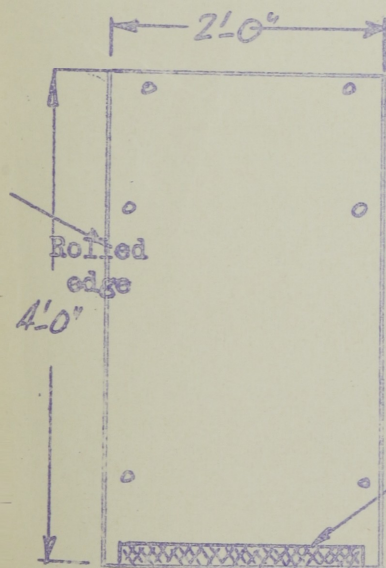
ISOMETRIC VIEW.

Note:- All surfaces to be painted with 1 coat of "Silverglow" aluminium base paint before erection.

EXPOSURE RACK FOR BURIED WEATHERING TESTS
ON THIN PLASTIC MEMBRANES.

PLAN OF TRAY.

A suggested design for exposure racks is shown in figs. (15) and (16). Control samples would also have to be stored at standard conditions and tested simultaneously with the exposed samples.
