Applying and validating the PTVA-3 Model at the Aeolian Islands, Italy: assessment of the vulnerability of buildings to tsunamis

Natural Hazards and Earth System Sciences
v. 10
pp. 1547-1562
1561-8633 (ISSN)

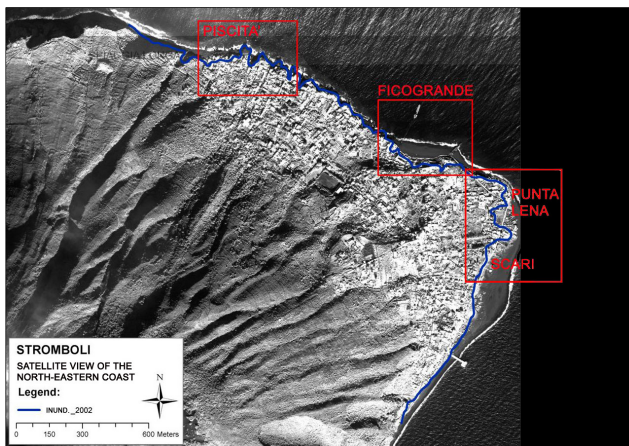
Fig. 2. A “Worldview” satellite image of the north-eastern coast of Stromboli Island. Main administrative divisions are highlighted with red frames. The blue line marks the limit of maximum inundation caused by the 2002 tsunami.

The first wave arrived about 3 min after the landslide as the sea water flooded Ficogrande beach (Fig. 2), and one minute later Punta Lena and Scari were inundated and severely damaged. A sea surface withdrawal was observed on the island of Panarea (Fig. 1) at 13:20 LT, about 5 min after the initial tsunami generation. Afterwards, two or three strong sea swells inundated a part of San Pietro harbour. In less than 20 min all the Aeolian Islands had been struck by the tsunami and anomalous sea movements were later observed in Milazzo, on the northern Sicilian coast, about 60 km south of Stromboli (Tinti et al., 2006a; Maramai et al., 2005b).

The north-eastern coast of Stromboli was the most severely affected by the tsunami, with run-up ranging from 3 to 11 m. Severe effects were observed at Ficogrande, Piscit  and Punta Lena (Fig. 2) where buildings fronting the sea were heavily damaged.

At Scari (Fig. 2), the tsunami effects were less severe and only few buildings on the beach were damaged, although the maximum inland inundation (135 m) was recorded here, most probably because of the low beach slope.

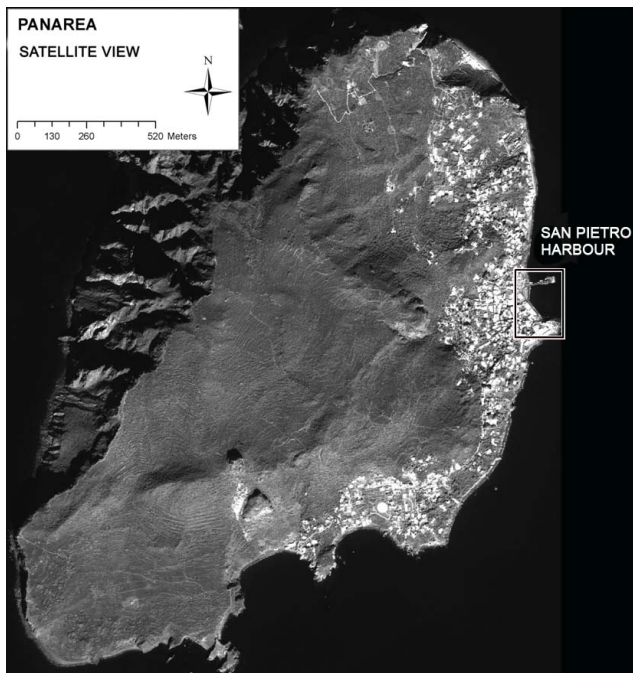
Fig. 3. A “Worldview” satellite image of Panarea Island. The frame indicates the harbour of San Pietro, where five buildings were inundated during the 2002 tsunami. Given the small flooded area, the inundation line was not recorded on Panarea Island.

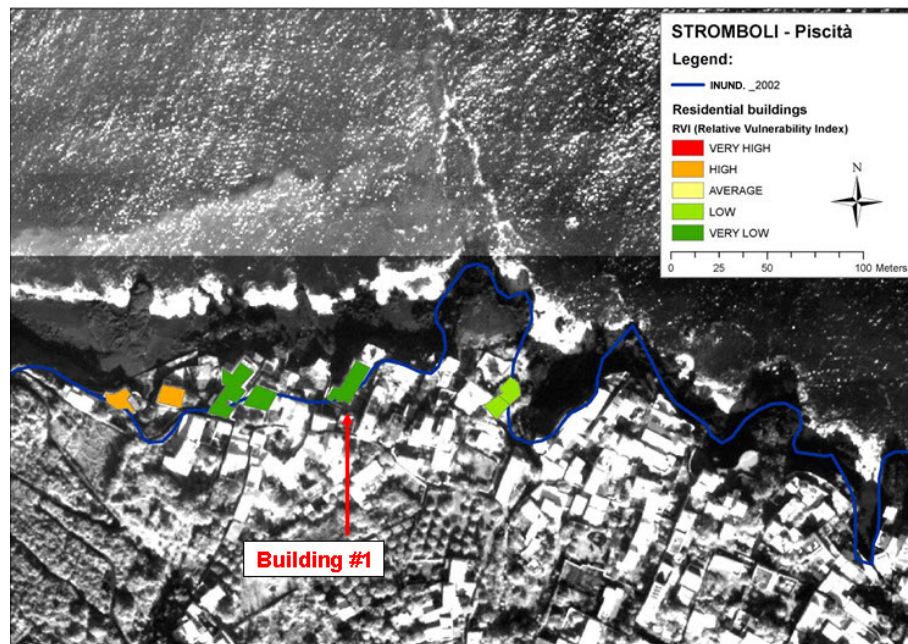
Fig. 4. Vulnerability map of Piscità (Stromboli Island). The map layout corresponds to the red frame in Fig. 2. The blue line marks the limit of maximum inundation caused by the 2002 tsunami. Building #1 has been used to validate PTVA-3 Model results. A picture of damage suffered by building #1 during the 2002 tsunami is shown in Fig. 8.

Whilst the original version of the PTVA Model has been validated during post-tsunami field surveys on the Maldives (Dominey-Howes and Papathoma, 2007), we undertook a further validation to confirm the accuracy of PTVA-3, the recently improved, next-generation of the model. For six buildings on Stromboli we could compare results forecast by the model with the damage suffered by the same buildings during the 2002 tsunami. The comparison has been carried out on a visual base, using pictures taken by the INGV and the University of Bologna during the post-tsunami field surveys in early January 2003 for reference. Buildings used for the validation of the model have been numbered from #1 to #6 and marked with red symbols on the vulnerability maps of Stromboli island (Figs. 4–6).

Figure 8 shows the façade of building #1 after the 2002 tsunami. The footprint of the same building is highlighted in the vulnerability map of Piscità (Fig. 4). Although the picture provides only a partial view, no relevant damage can be seen, except from an unhinged window on the first floor. Building #1 is located on the coastal cliff and intersects the line of maximum horizontal water inundation. Accordingly, the water depth impacting the building was minimal and did not even flood the whole ground-floor. Damage to the interior and to parts vulnerable to water contact was negligible. The RVI score calculated by the PTVA-3 Model for that building is “very low” and result are thus consistent with the observed damage.

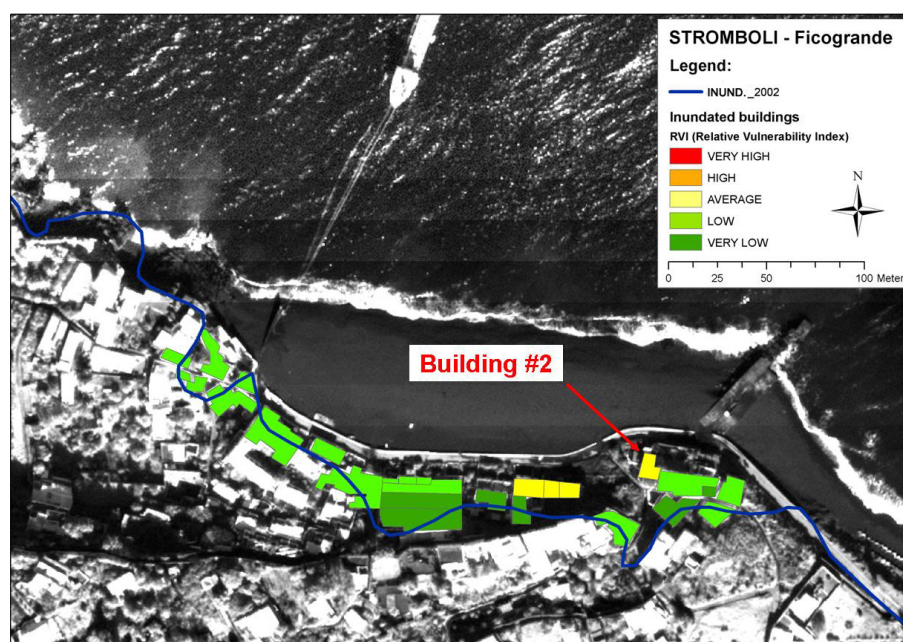
Fig. 5. Vulnerability map of Ficogrande (Stromboli Island). The map layout corresponds to the red frame in Fig. 2. The blue line marks the limit of maximum inundation caused by the 2002 tsunami. Building #2 has been used to validate PTVA-3 Model results. Two pictures of damage suffered by building #2 during the 2002 tsunami are shown in Fig. 9.

Damage to building #2, at Ficogrande (Fig. 5), is shown in Fig. 9. The flow broke through a door in the front wall, penetrated indoors, destroyed the interior and one partition wall and travelled through the backdoor of the house (Tinti et al., 2006a). The overall damage level is clearly heavier than the one observed in building #1 at Piscità. The PTVA-3 Model classified building #2 as having an “average” RVI. Although such an RVI score may appear to be an underestimate, Fig. 9 shows that no damage occurred to the weight-bearing walls of the building. Apart from an internal partition wall, which is not designed to withstand any kind of pressure, damage involved only doors, windows, furniture (which is not considered by the PTVA-3 Model) and the interior, especially parts vulnerable to water (electric appliances, fixtures, paving tiles, etc.).

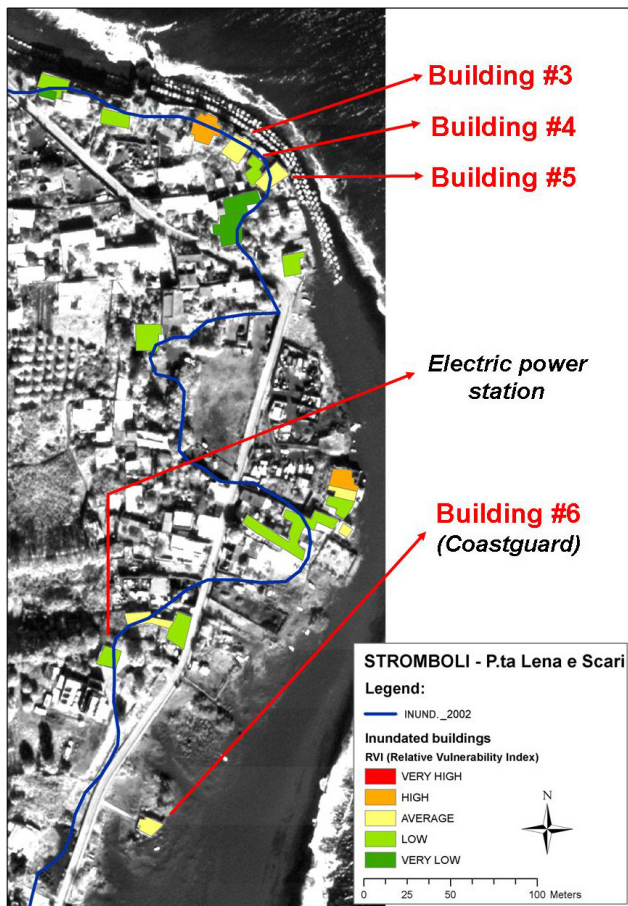
Fig. 6. Vulnerability map of Punta Lena (north) and Scari (south), Stromboli Island. The map layout corresponds to the red frame in Fig. 2. The blue line marks the limit of maximum inundation caused by the 2002 tsunami. Buildings from #3 to #6 have been used to validate the PTVA-3 Model results. Damage suffered by these buildings during the 2002 tsunami are shown in Figs. 10–13.

In Punta Lena and Scari, we could check the accuracy of the PTVA-3 Model results for four buildings (buildings #3 to #6) (Fig. 6). Three of them (buildings #3 to #5) are residential houses located a few m from the sea at Punta Lena. Building #6, in Scari, is the Coastguard station.

Building #6, the Coastguard station, is situated on Scari beach (Fig. 6). It has one storey, a brick-made structure and a ground-floor almost completely closed, with no openings on the seaward wall. There is no protection from the sea apart from a coastal dune that rests against the seaward side of the building. The RVI score of building #6 is “average”. Figure 13 shows a picture of the building taken few days after the 2002 tsunami. Whilst the picture does not provide a detailed view of the structure, it appears that the general damage level is lighter than that observed in buildings #2, #3 and #5, although they have the same RVI score. This is due to the relative position of the building and the coastal dune. The shielding effect provided by the dune was higher than predicted by the model, which is designed to consider the protection from natural defences but does not include such particular cases. However, whilst building #6 was well protected against the first impact of the tsunami, it has been inundated by more than 1 m of water. As a consequence, some damage to the interior must have occurred, although this was not recorded and cannot be seen in the photograph (Fig. 13).

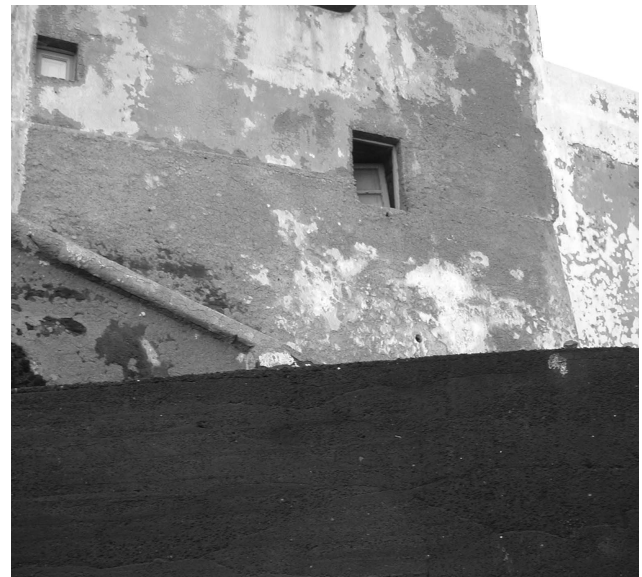
Fig. 8. View from north-west of building #1, at Piscità (Stromboli – Fig. 4). The picture was taken few days after the 2002 tsunami. The only visible damage is an unhinged window on first floor. The PTVA-3 Model classified building #1 as having a “very low” RVI score which correlates well with the actual damage sustained by this building.

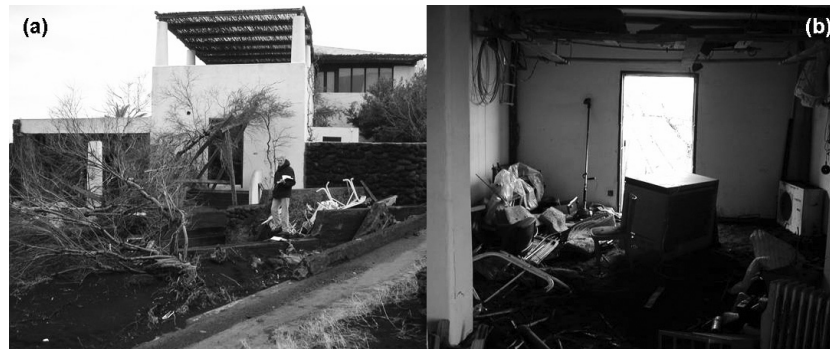
Fig. 9. Pictures of building #2, at the eastern end of Ficogrande (Stromboli – Fig. 5), taken after the 2002 tsunami. **(a)** A view of the building from north-west. **(b)** Damage to the interior. The PTVA-3 Model classified building #2 as having an “average” RVI score.

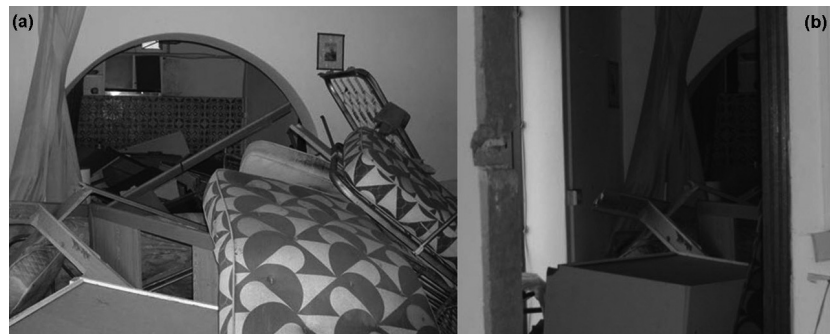
Fig. 10. Two pictures of building #3 (Punta Lena, Stromboli – Fig. 6) taken after the 2002 tsunami. **(a)** Damage to the interior. **(b)** A view of the main entrance of the building, where the door have been ripped off the wall. The PTVA-3 Model assigned to building #3 an “average” RVI score.

Damage to building #3 (RVI = “average”) is shown in Fig. 10. The flow broke through doors and windows and caused total destruction to the interior. However, there is no evidence of damage to the load-bearing walls. The overall damage level is thus comparable to building #2 at Ficogrande.

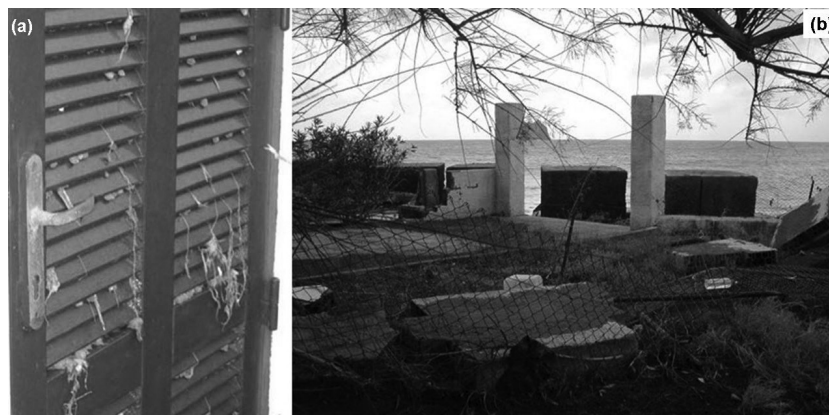
Fig. 11. Two pictures of building #4 (Punta Lena, Stromboli – Fig. 6), taken after the 2002 tsunami. (a) A door on the seaward wall of the building. The inundation did not break it down, but penetrated through the shutter openings and flooded the ground-floor. The building was protected by the vegetation in the front garden (b), some concrete works (a small wall and a table) and by the coastal defences along the shoreline (concrete cubic rocks). The PTVA-3 Model classified this building as having a “low” RVI.

Damage to building #4 (RVI = “low”) is partially shown in Fig. 11. The front door has not been broken-down and suffered only minor damage. However, the water penetrated indoors through the shutter openings and flooded the ground-floor, causing damage to the interior. The overall impact on the structure was lighter than for neighbouring buildings. This was due to shallow inundation depth and to the protection provided by the front-garden vegetation and some artificial structures between the building and the sea (a brick wall, a large concrete table in the garden and the coastal defences along the shoreline) (Fig. 11b). As forecast by the PTVA-3 Model, such protection slowed down the flow and prevented some of the floating debris from impacting the building structure.

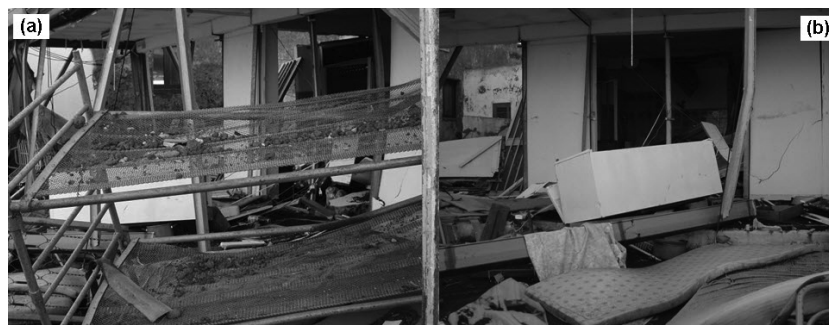
Fig. 12. Two pictures of building #5 (Punta Lena, Stromboli – Fig. 6) taken after the 2002 tsunami. The flow broke doors and windows, penetrated indoors and dragged the building contents outside (a). A large crack can be observed in the front side wall (b). However, that wall does not appear to be part of the load-bearing structure of the building, as does the undamaged column at its right. The PTVA-3 Model classified building #5 as having an “average” RVI score.

Figure 12 shows damage to building #5 (RVI = “average”). Like building #2 and 3, window and door frames have been ripped off the wall. The building interior has been completely destroyed and the contents widely dispersed. The im-

pact caused a crack in the front-wall, but left load-bearing column to its right undamaged (Fig. 12b). The front-porch has been almost completely destroyed. However, the load-bearing structure of the building is largely untouched.

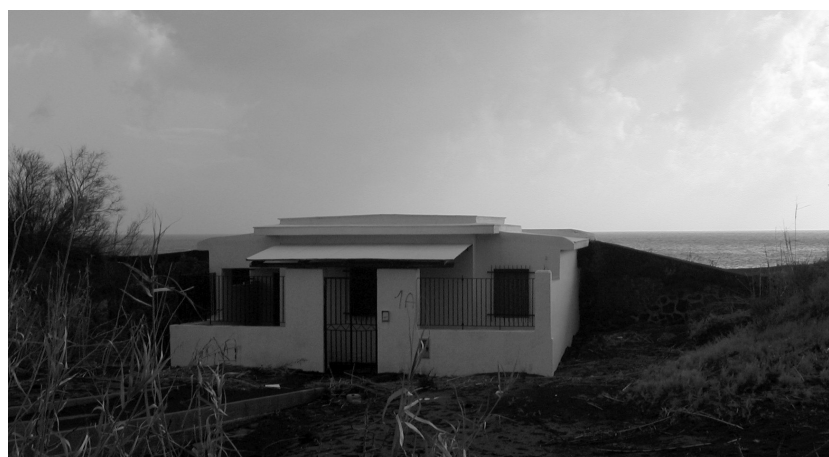
Fig. 13. View of the western side of building #6. The picture was taken a few days after the 2002 tsunami. Building #6 is a Coastguard station on the beach of Scari (Stromboli – Fig. 6). As clearly shown by the picture, the seaward side of the building is totally “covered” by a coastal dune. The PTVA-3 Model attributed to building #6 an “average” RVI score.
