water research laboratory

Report No. 95

RESISTANCE OF LOW COST SURFACES FOR FARM DAM SPILLWAYS

April, 1967

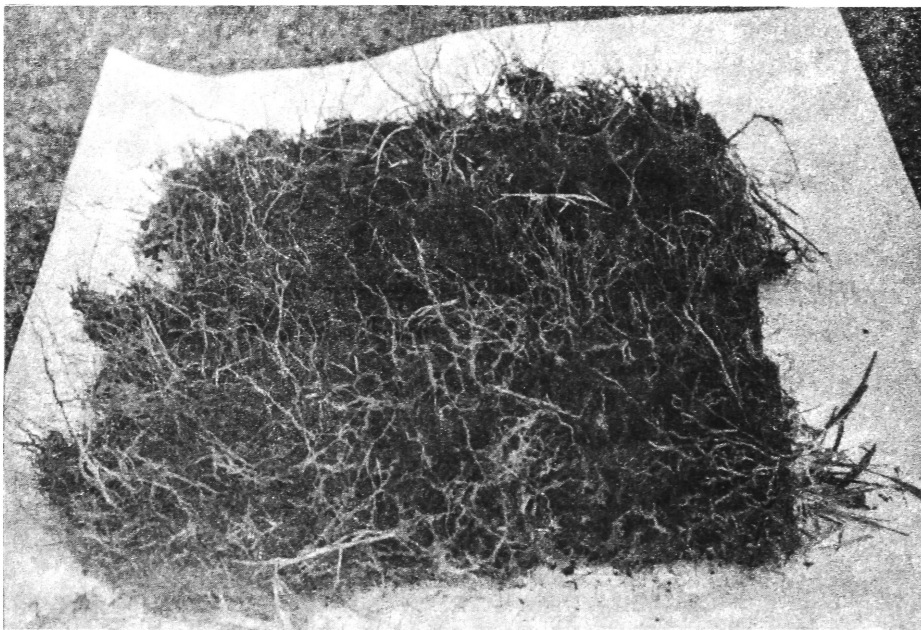
Humphries (1955) describes Rhodes grass as a "tufted perennial with a fibrous, deep and tenacious rooting habit whose roots may extend in deep loamy soils 10 to 12 feet below the surface. On account of its deep rooting habit, it is regarded as excellent for drought tolerance. It has a strong crown which bears many aerial leafy shoots growing 3 to 5 feet high with slender stems. Prostrate runners or stolons which root at the nodes or joints giving good ground cover and soil protection are also formed. Fresh plants also grow from them and provide for continual renewal of the stand under conditions which may be adverse for regeneration of seed. This type of habit is regarded as most desirable for soil conservation purposes since the productive and competitive advantages of a tall species are combined with the soil binding character of a sod-forming species. Rhodes grass grows predominantly in the summer making the bulk of its growth between October and May in N. S. W. It is thus best adapted to areas with hot, humid wet summers and mild winters. It is grown under annual rainfall conditions of 22-50 inches, but for the lower values predominantly summer incidence is required". Rhodes grass as grown for these tests and its root system are shown in Fig. 8.

(a) Rhodes grass

(b) Root system

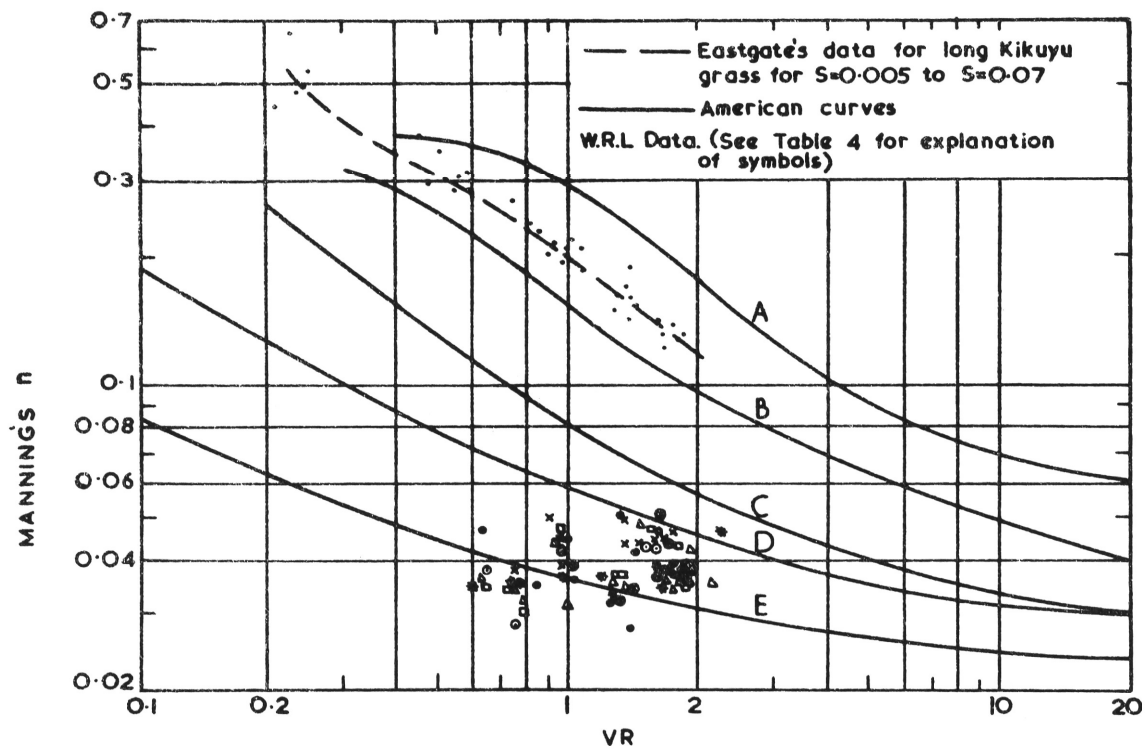
FIGURE 14: RETARDANCE COEFFICIENTS FOR KIKUYU GRASS
CE-E-7007

with slope, tested, nor with velocity or depth of flow. Although an appreciable scatter is evident in the points plotted, this can be ascribed only to the limitations in accuracy imposed by the difficulties of measuring supercritical channel flows and does not correlate with any of the other variables. The retardance of the grasses can be specified independent of length over the range of the parameters tested and over any range likely to be found in a field installation as Couch 0.035, Rhodes and Kikuyu 0.04.

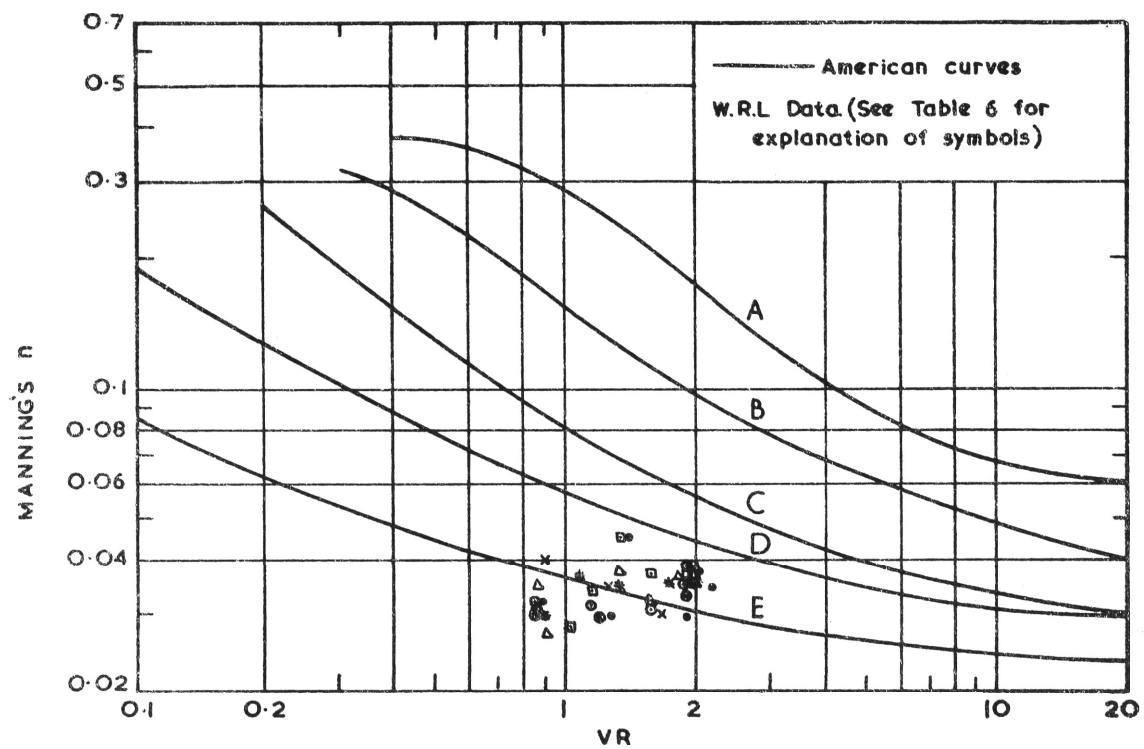
FIGURE 16: RETARDANCE COEFFICIENTS FOR COUCH GRASS
CE-E-7009

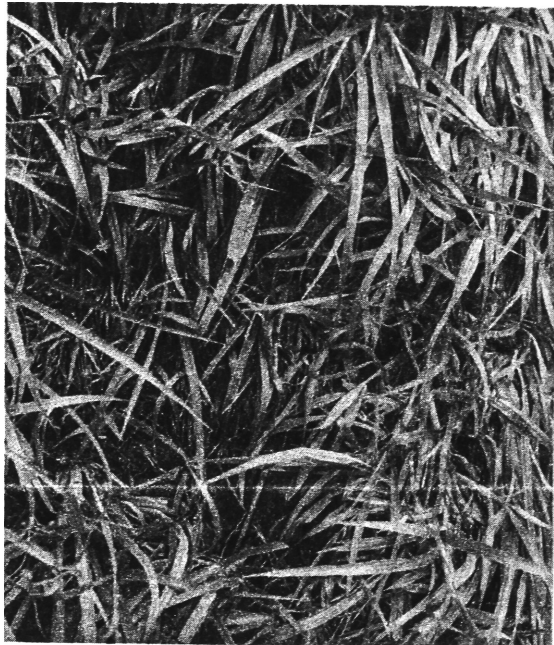
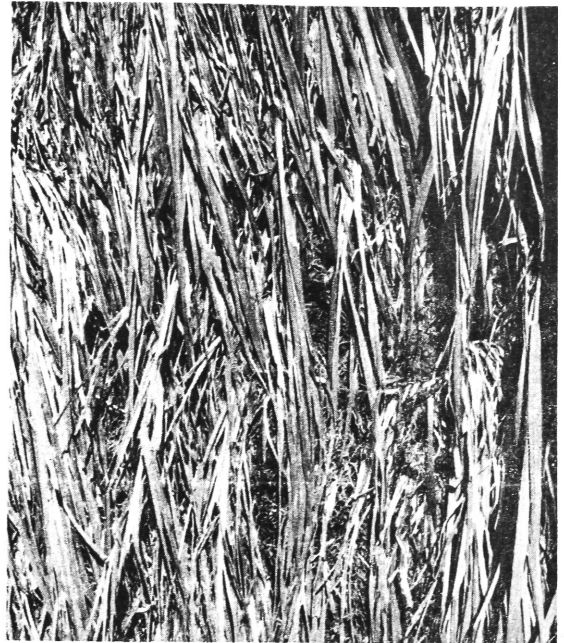
Figure 19: Rhodes grass tests.

(a) Before test with bare patches

(b) After test

(c) After piping failure

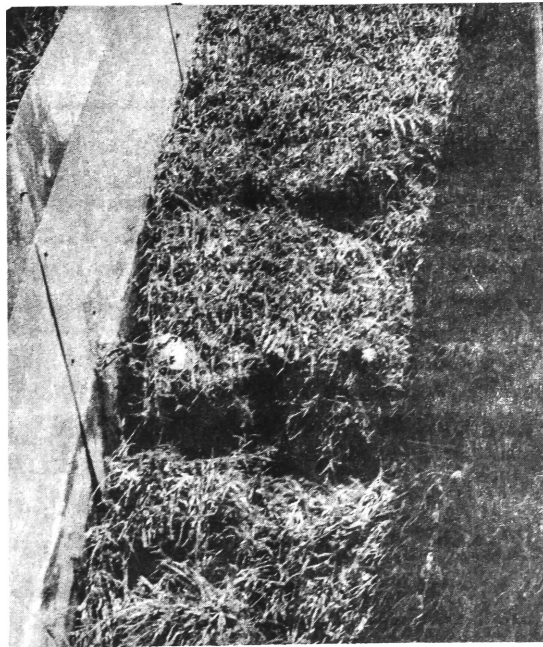
Figure 20: Couch grass tests (with Mullumbimby Couch)

(a) Couch grass (with Mullumbimby Couch).

(b) After test

(c) After piping failure
