Preliminary
Study of Beach Erosion on
Cronulla Beach

D. N. Foster, D. M. Stone and C. H. Munro

Report No. 59

Prepared for The Sutherland Shire Council

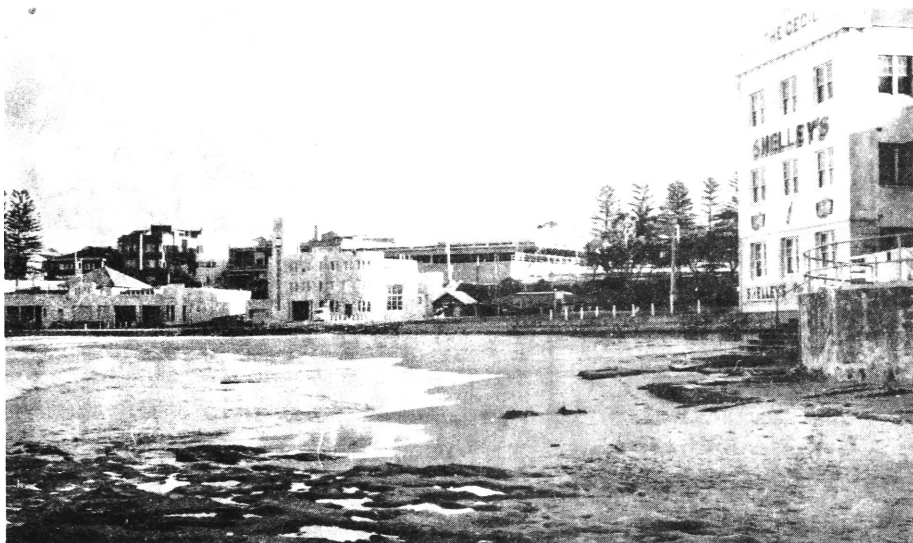
Plate 1: View of South Cronulla Beach from rocks between South and North Cronulla Beaches. Taken 25.7.62 at 1500 hrs. high tide and calm seas.

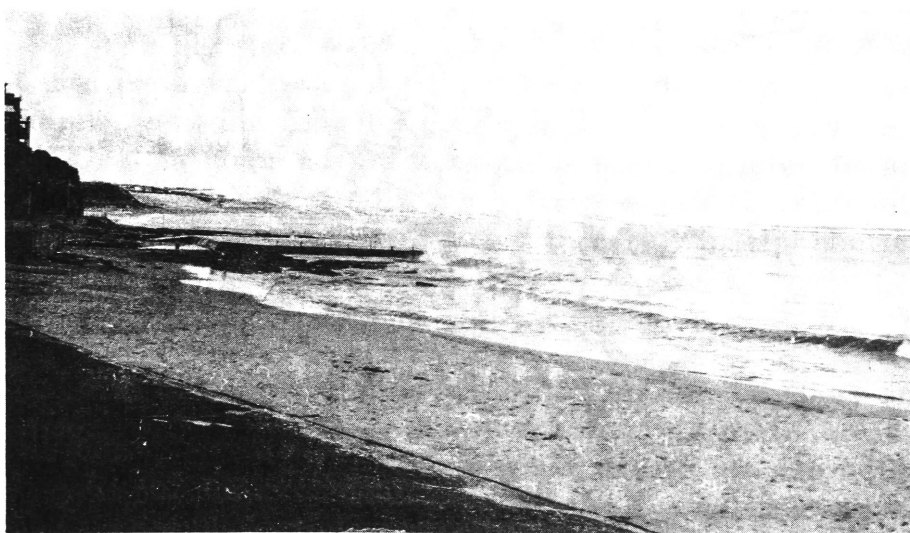
Plate 2 - View North from South Cronulla Beach showing sea baths and sandhills in the background. Taken 25.7.62 at 1500 hrs. , high tide and calm seas.

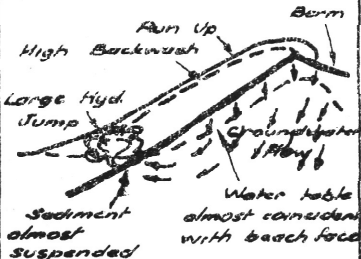
<p>NARROW & LOWER WAVE SPECTRUM</p>
HYDRAULIC CONDITIONS AT BEACH FACE

BEACH PROFILE

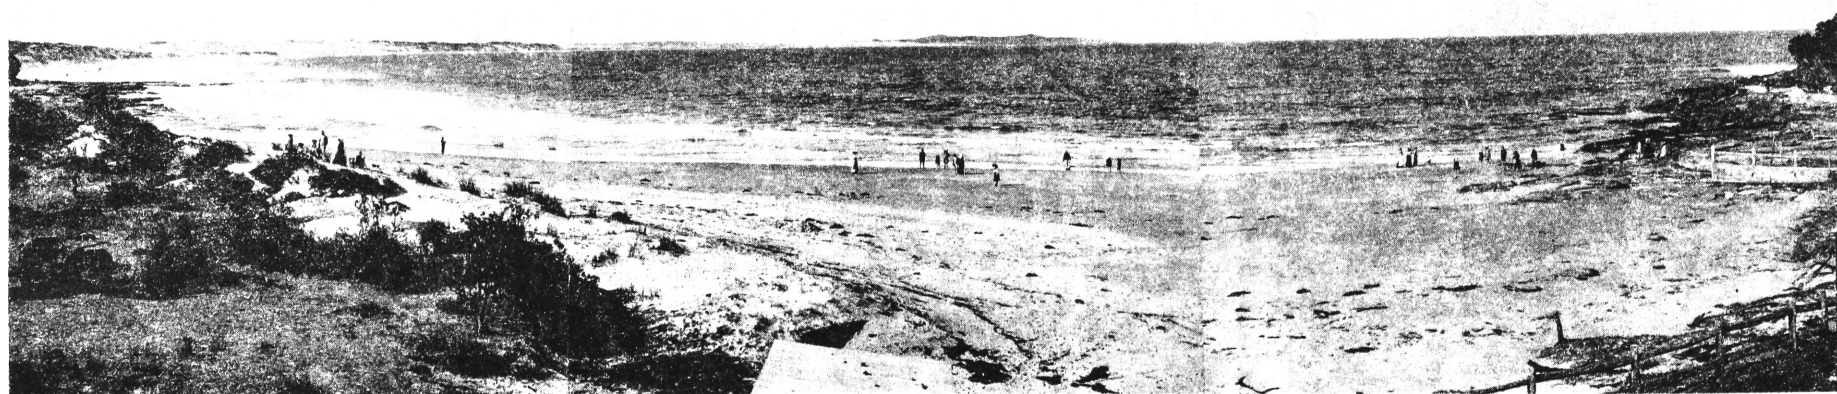
South Cronulla Beach 1905.
(By courtesy N. S. W. Govt. Printer)

verticals. The aerial photograph of the Cronulla Peninsula included in this pamphlet shows an expanse of rock between South and North Cronulla Beaches with some sand behind it in front of the cliffs. There is also in this pamphlet a photograph of the new sea wall which had been built at South Cronulla. The number of steps showing above the sand level in this photograph may be compared with the number of steps showing on photographs taken in recent years.
