Fault detection during the impulse testing of transformers

FAULT DETECTION DURING THE IMPULSE TESTING

TRANSFORMERS

A thesis submitted to the University of New South
Wales for the Degree of Master of Engineering.

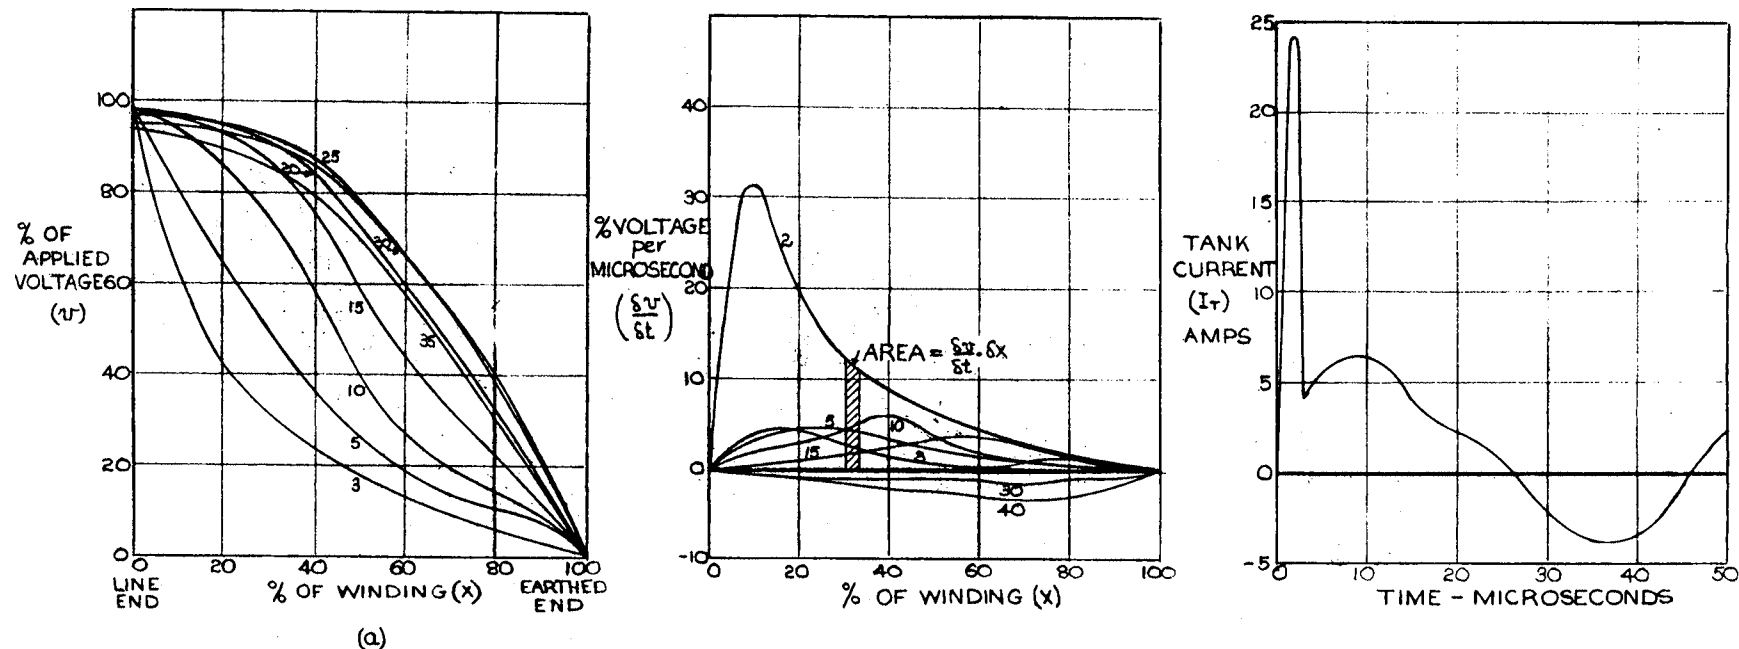
FIG 7 - ILLUSTRATION OF THE VOLTAGE DISTRIBUTION - TANK CURRENT RELATIONSHIP

Multiplying this expression by the total shunt capacitance, it becomes an element of tank current. By integrating under each curve in Fig. 7(b) in turn and plotting the results to a suitable scale against time, one obtains the tank current wave-form shown in Fig. 7(c). It is shown later that this waveform has the same basic shape as actual oscillographic records obtained during experiments on distribution transformers.

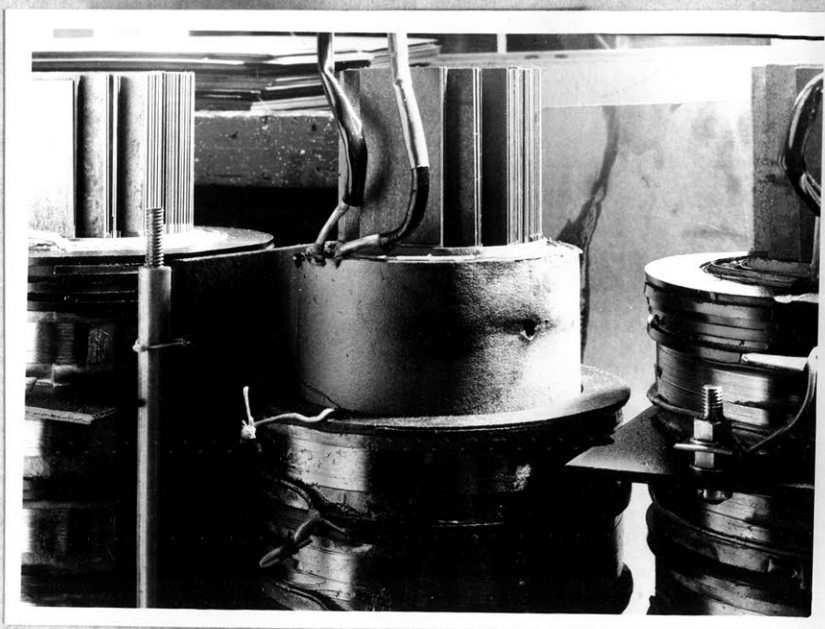
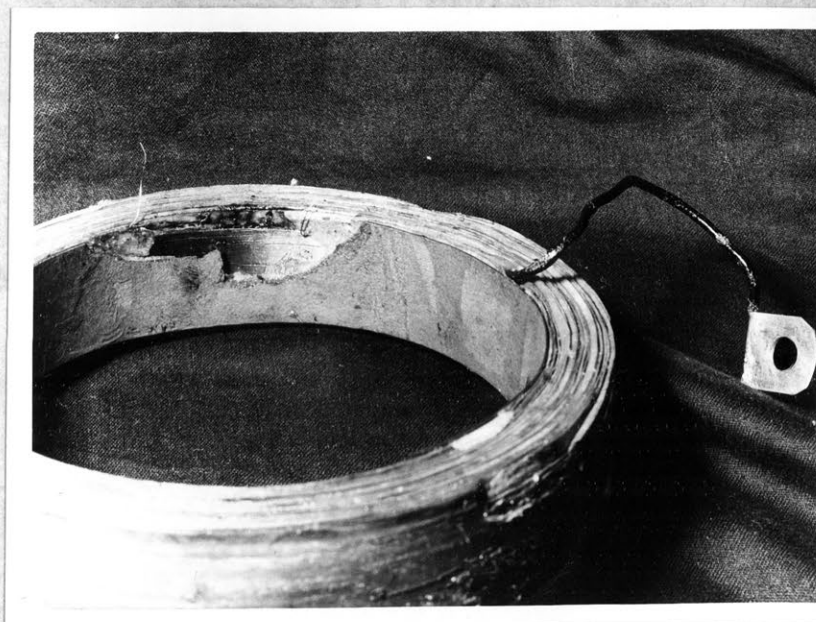
The possible nature, magnitude and location of the fault, as indicated by the test results, should guide the stripping operation. Fig.28 shows the damage to the major insulation of transformer "B" when B phase HV winding stack was partly stripped. The carbonised hole in the main insulating cylinder was made by both impulse and power frequency testing (See section 2.5). However, the insulation resistance readings after impulse testing and the behaviour of the winding at the start of the power frequency tests, indicate that a definite radial core of carbon had been formed through the cylinder by the impulse tests.

Fig.28 - Photographs of major insulation failure which occurred during 113% Test Level Chopped Wave Impulse Test on 11,000/110 volt voltage transformer (Transformer B).
