H.M.A. NAVAL DOCKYARD, GARDEN ISLAND: A BUILDING CONSERVATION STUDY OF THE HISTORIC BUILDINGS

ERIC J. MARTIN  
M. B. ENV. 1980,  
U.N.S.W.

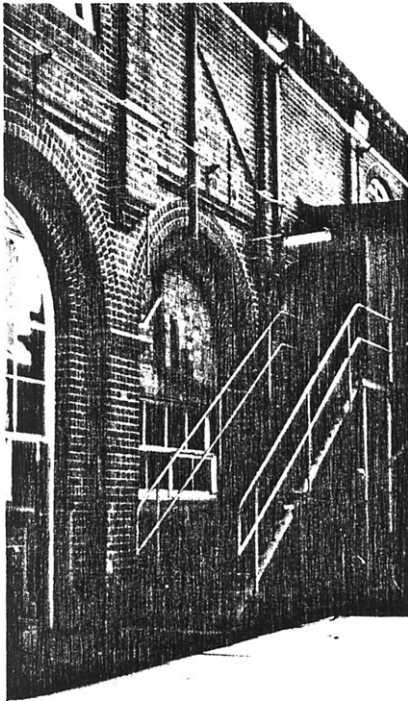
Figure 68 Building 7 & 8  
East Side Alterations

- (a) Building 1 has been added to the north end.
- (b) Building 4 has been added to east side northern end.
- (c) A first floor painted pressed steel extension supported on a pipe frame together with stairs has been added to the east side.
- (d) A stair providing access to the first floor and associated alterations have occurred on the west side.
- (e) Several doorways have been constructed through the external walls - one on west side, three on east side.
- (f) The circular window in the north gable end has been bricked up while that on the south has been blocked up.
- (g) The windows in two bays on the east side have been partly bricked up.
- (h) Many windows have been altered including:-  
 Louvres incorporated into semicircular windows (4 off west side).

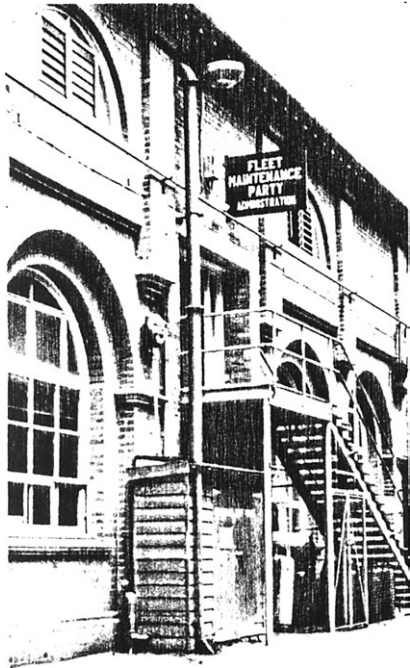
Figure 69 Building 7 & 8  
West Side Alterations

- (i) The arch over one window on the east side has been cut back to suit an air conditioning unit which has since been removed.
- (j) Pipework has been added to the face of the building on all sides including the addition of sprinklers under the eaves. In some locations this has resulted in damage to rendered dressings.
- (k) A small box like shed housing sprinkler valves has been added to the western side. Pipes emanating from this have penetrated the wall and rendered dressings.
- (l) Area lighting and associated cables/conduits have been fixed to the western side of the building.
- (m) A large vent has been built through the roof.
- (n) Internal lightweight partitioning has been added in several areas for offices.

- (a) Foundations - sound.
- (b) External walls - in good condition except for minor brickwork cracking around circular window south side, one bay on the east side, through central arch on the north side and in one bay on the west side.

Damage to rendered dressings occurs in several places. It is generally small and in some cases due to pipes being placed on the external walls.

- (c) Windows - the frames are basically sound although paint is peeling off in many areas. Many panes of glass are cracked and several windows have glazing smashed and removed (especially on the east side, southern end).
- (d) Doors - there is minor damage to the doors and the paintwork is in only fair condition.
- (e) Roof - the tiles are in good condition although minor sagging

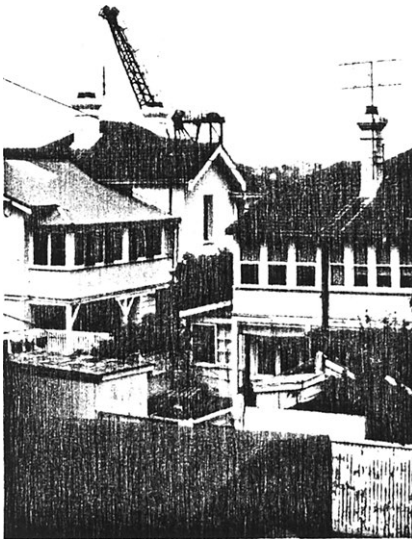
Figure 73 Buildings 16-20  
From the West

- (e) The roof tiles have been replaced with modern tiles and the west side of Building 16 and 17 has corrugated galvanised iron roofing. Finials, special ridge tiles and other details have been removed.

- (f) The buildings have been painted externally.
- (g) The timber fence to Building 16 and 17 has been replaced.
- (h) The sculptured tops of all fence posts have been removed.

(b) External Walls - in good condition except the paintwork which is peeling off, especially in Building 18-20.

(c) Windows - in good condition except the paintwork on Building 18-20 which is in poor condition.

(e) Roof - the tiled roof sags a little, but is quite sound. The corrugated galvanised roof over western sections of Building 16 & 17 is in good condition. The copper gutters and downpipes as well as the timber fascias and barge boards are in good condition.

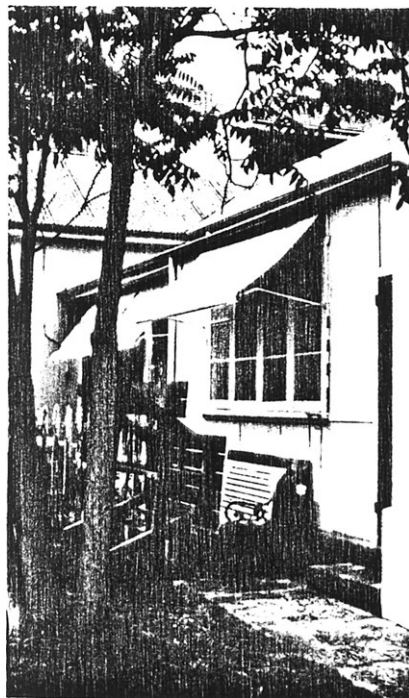
Figure 77 Building 21 & 22  
Western Verandahs

- (a) Foundations - sound.
- (b) External Walls - in good condition and the paintwork reasonable, although there is some evidence of crazing paintwork. Pipes and conduits have been added to face of the wall in several locations:
- (c) Windows & Doors - good condition and paintwork satisfactory.
- (d) Roof - the corrugated asbestos cement roof is in satisfactory condition although old and brittle with minor damage at the gutter ends.

The flat galvanised iron roofs over the eastern alterations are in fair condition but show evidence of ponding, and rust is beginning to appear.

Painted galvanised iron gutters and downpipes are in good condition although discharging onto footpaths. Paint is peeling off metal roof flashings. The timber fascias are in satisfactory condition.

The top of the central chimney has a minor crack through the rendered brickwork.

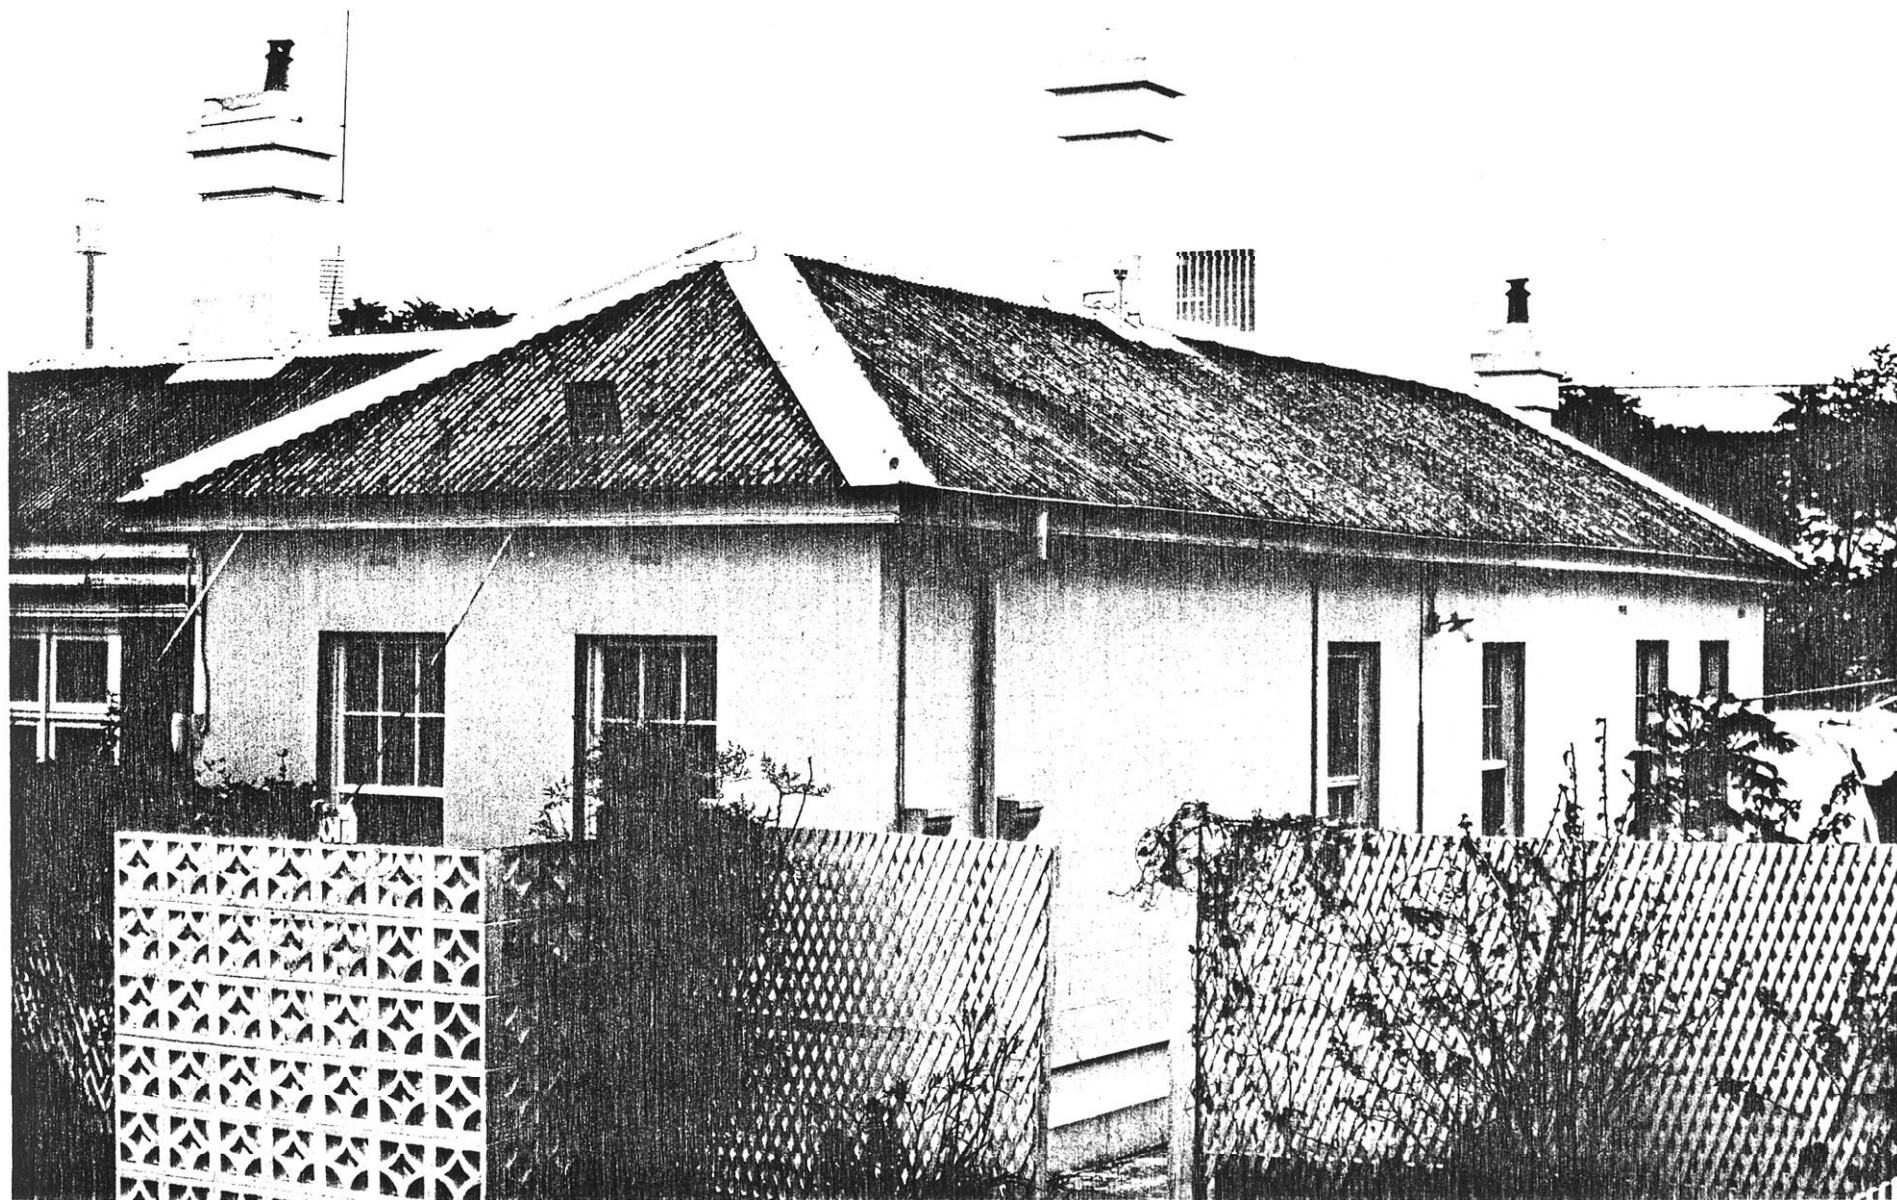
Figure 79 Building 21 & 22 from the North East

The large building to the north (Building 103) is quite imposing and out of scale with the residences. Other nearby buildings are constructed at a much lower level and do not dwarf Building 21 & 22 to the same extent.

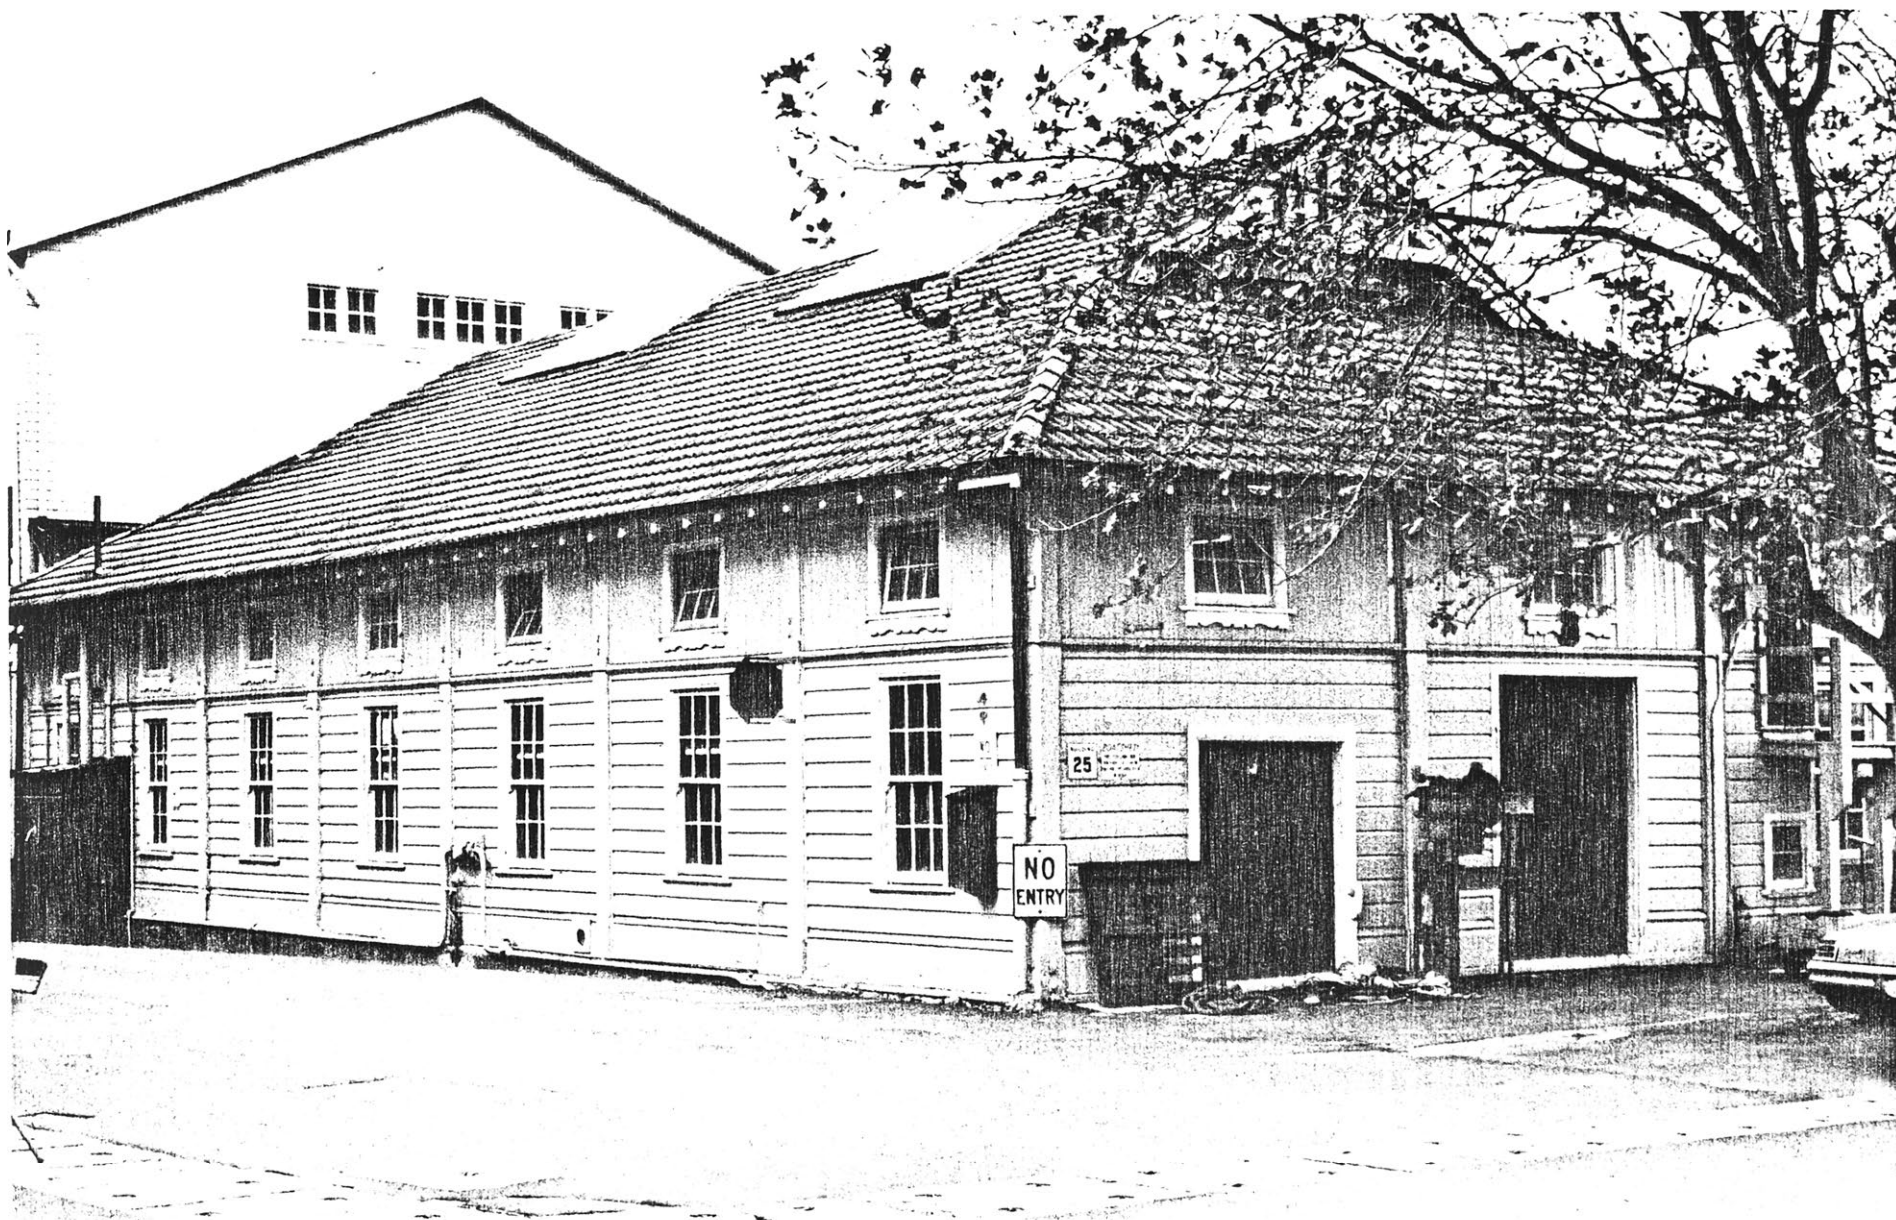
Figure 82 Building 25 from the South West

The only change near to Building 25 has been the addition of Building 24 across the road which conflicts in scale and appearance with this small simple timber boat shed. However, this has been the story of Garden Island from the beginning and so the imposition is not a major concern.

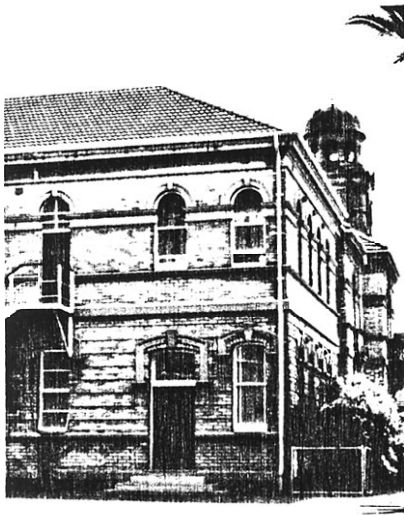
Figure 84 Part of South  
Elevation, Building 27

Small gaps in gutters left to permit thermal movement have

permitted water to run off onto the sandstone and discolour it slightly.

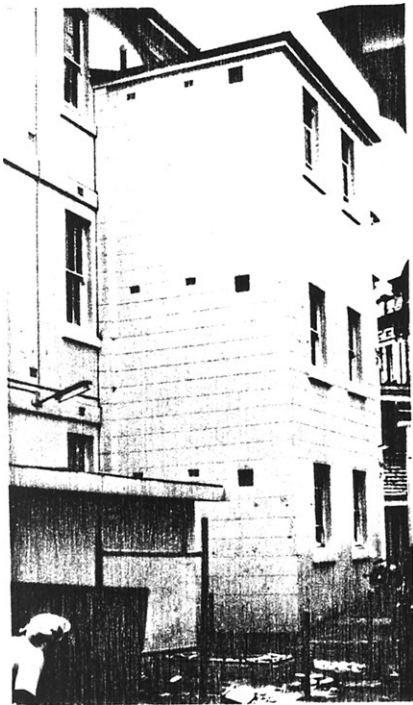
Figure 88 Building 32  
East Side Extensions

- (a) A three storey extension has been added to the east side to accommodate toilets. This extension has rendered brick, simulating stone, walls and a flat roof.
- (b) Additional doors have been constructed through former window openings to the ground floor west side second window from northern end; to the first floor on the north side (both windows although one has been further altered), south side (2 off) and west side second window from northern end and to the second floor on the north side eastern end, west side northern end and south side western end.
- (c) The main front doors on the ground floor have been glazed and modified.
- (d) A window mounted air conditioner has been included in the first floor east side southern end window.
- (e) A double window mounted air conditioner has been built into

(b) External Walls - in good condition except for paintwork on the east side which is extensively crazed and flaking off.

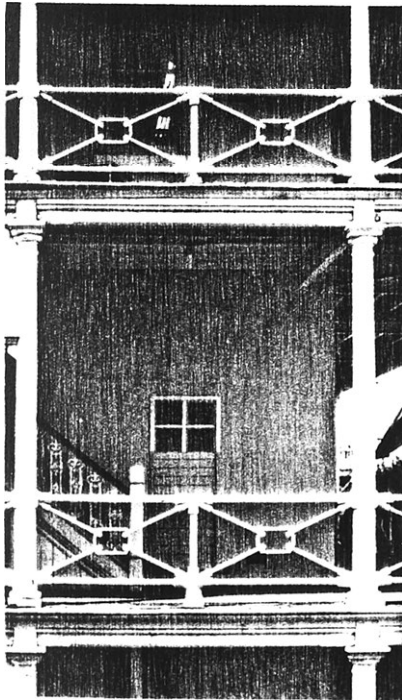
Figure 89 Building 32  
Detail of Nth Elevation

(f) Verandahs - some rust appears on the cast iron columns. Paint is flaking off the nosing flashing and balustrades (especially on the western side). Paint on the west face of the unprotected columns is crazed. The bituminous fabric is breaking down along the outer edge and timbers near the outer edge are rotting.

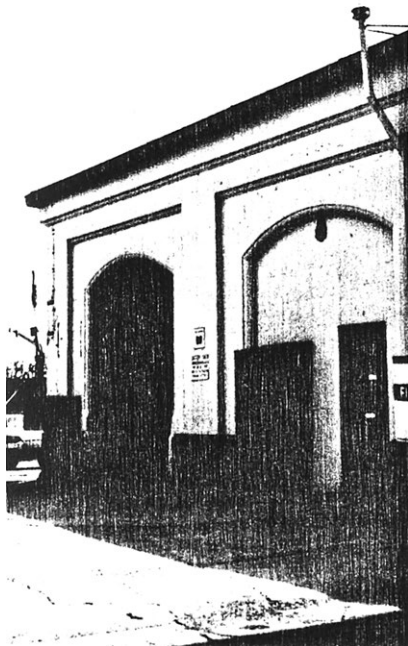
Figure 92 Building 88  
Part of South Elevation

bay has been bricked up and one modified to include an observation window from an office behind.

Where bays have been bricked up the painted render continues to ground level compared with just to top of lower stone course as in the original detail.

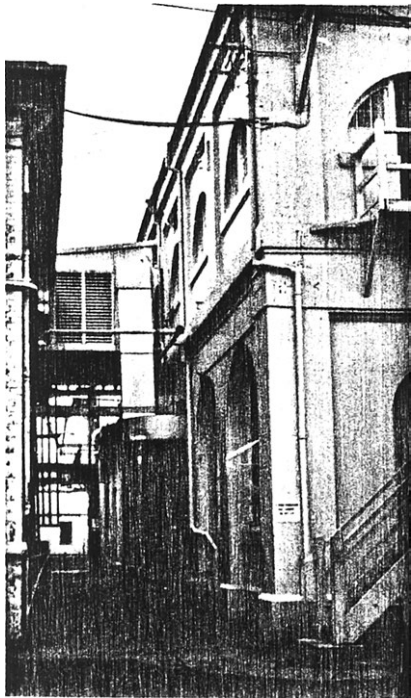
Figure 101 View Between  
Buildings 95 & 93

is in reasonable condition with sections of the asbestos cement being replaced as it deteriorates. Painted galvanised iron gutters and downpipes are also in reasonable condition except on the east side adjacent to Building 26 where several are rusted out, sections are missing and all discharge into an open channel. .

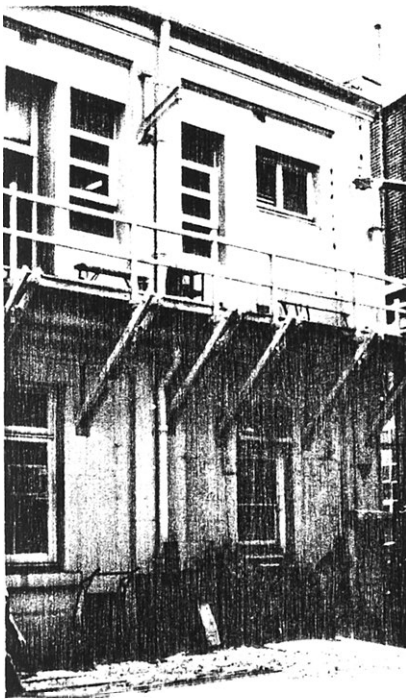
Figure 110 Building 99  
East Side North Bay

- (a) Foundations - sound.
- (b) External Walls - in good condition except the paintwork which is crazed and peeling off in several areas (east side ground

- (c) Windows - the frames are in good condition but the paintwork is poor and peeling off especially on west side.
- (d) Doors - in satisfactory condition.
- (e) Roof - the corrugated asbestos cement roof is in good condition although brittle. One section of the cast iron gutter on the west side is missing and a few sections are separating from each other on the east side. The painted asbestos cement and galvanised iron downpipes have lower sections damaged. In some cases on the east side the lower section of the downpipe is missing.
- (f) Interior - in good condition.
- (g) Other comments - a detailed structural analysis and report is included in Appendix 7(d).

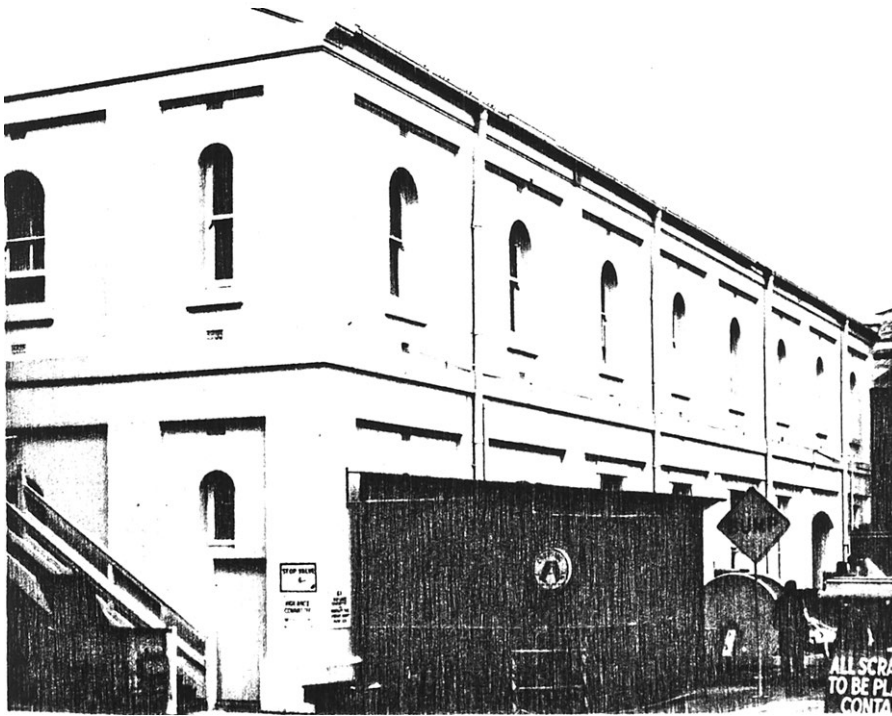
Building is in fair condition but requires some maintenance work.

Figure 111 Building 99 from the North West

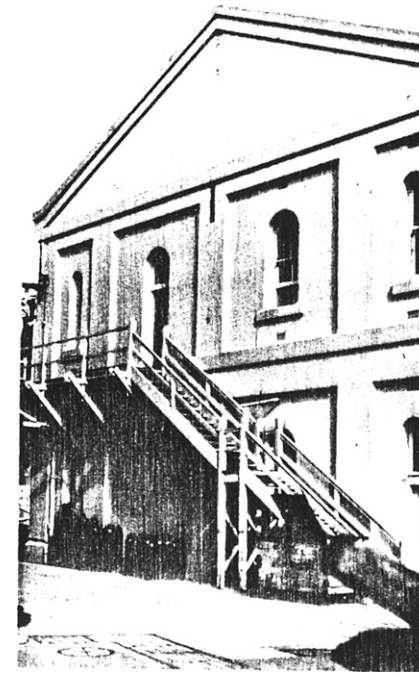
Figure 112 Northern Side of Building 99

Examples of this are the rusting out of gutters and downpipes (Building 95 and 98), sections of gutters and downpipes are not replaced when they are damaged or removed (Building 99) and gutters become blocked and water enters the building (Building 90).

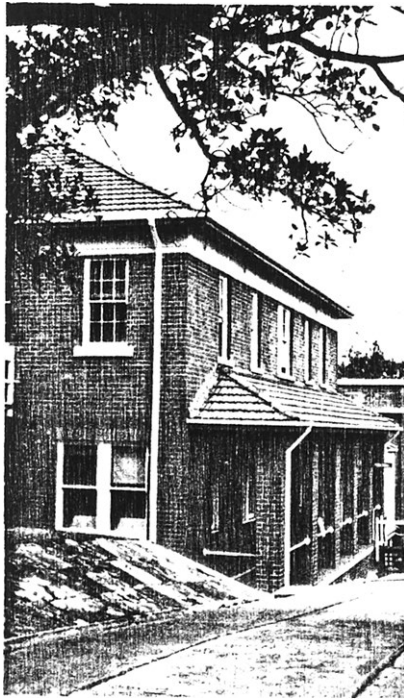
- (a) Foundations - sound.
- (b) External Walls - the brickwork is in good condition but the paint work is peeling off the asbestos cement clad tea room enclosing the south west corner of the verandah.

- (c) Verandah - the floor timbers are beginning to rot. Paint is peeling off the few remaining timber posts, the balustrading near the south east corner, the pipe handrail between the brick columns and the handrail to the timber steps.

- (d) Windows - the timber framed windows are in good condition. The sandstone sills and lintels on the ground floor are likewise in good condition. The rendered lintels on the first floor have crazed but are quite sound.

- (e) Doors - in reasonable condition.
- (f) Roof - the tiled roof, PVC gutter and downpipes are all in good condition. Downpipes discharge into an open channel directly onto the paving. Paintwork on the eaves lining is in fair condition.

Figure 113 Building 9  
from North West

skirtings, plaster ceilings with coverstrips, lightweight office partitioning and a simple attractive timber internal stair with timber balusters. Generally, it is in good condition although paint is flaking off some internal walls particularly in the stair hall.

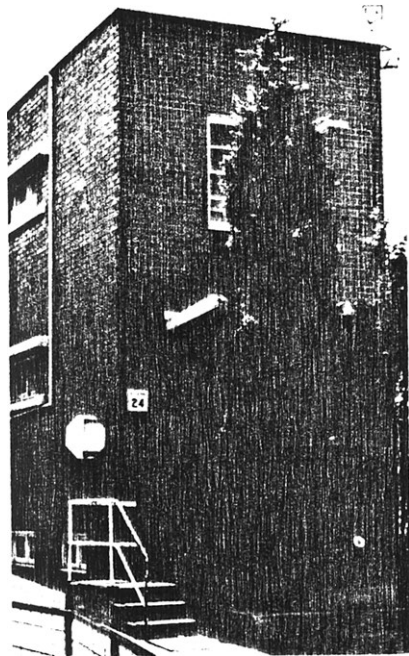
Figure 114 Building 24  
from the South West

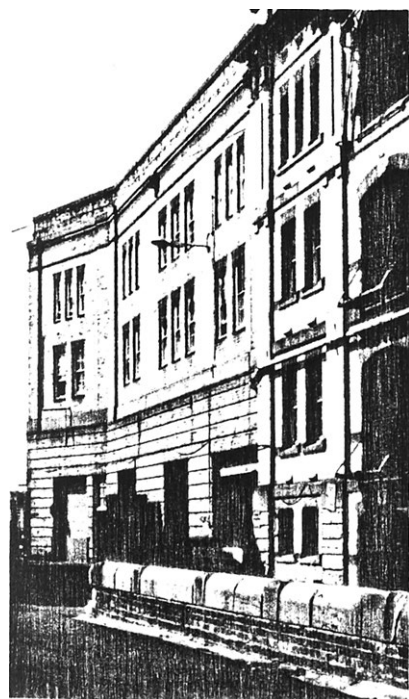
The box gutters to the flat roof are blocked up due to debris on the roof and water has penetrated to the inside resulting in deterioration of the painted walls internally.

A few ground floor brick walls have been damaged.

Figure 117 Building 90  
from the North West

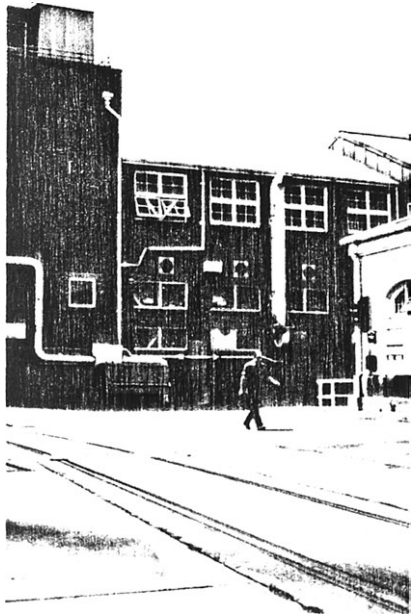
Generally, the condition of this building is reasonable although some areas have deteriorated.

Paint is peeling off most areas including windows, doors, eaves, eastern facade. Several corners at the lower levels have been damaged. Many pipes, cables and services have been added to all sides of the building especially the north. The cast iron downpipes on the south side have rusted.

Figure 118 Building 93  
from South West

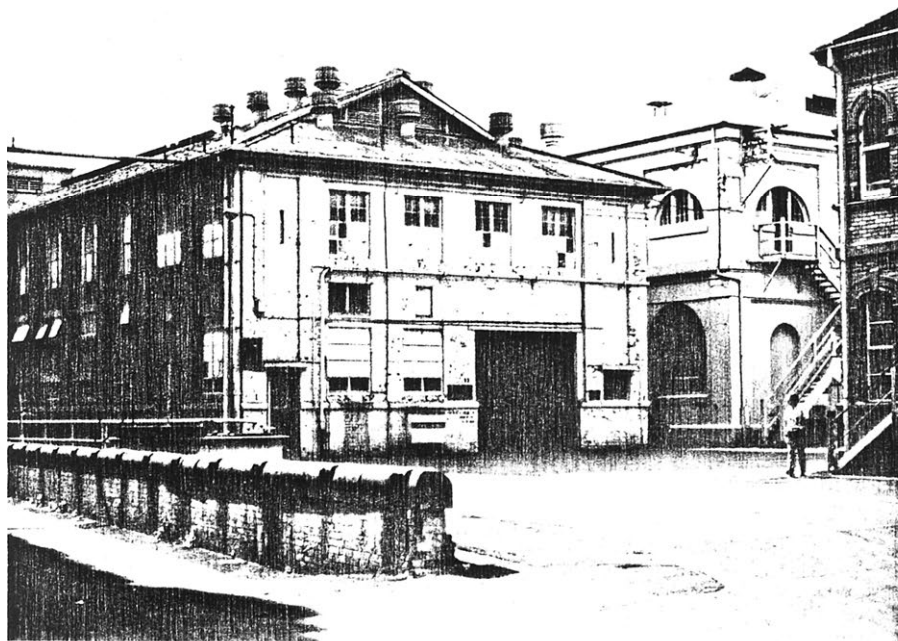
Figure 119 East side of Building 93

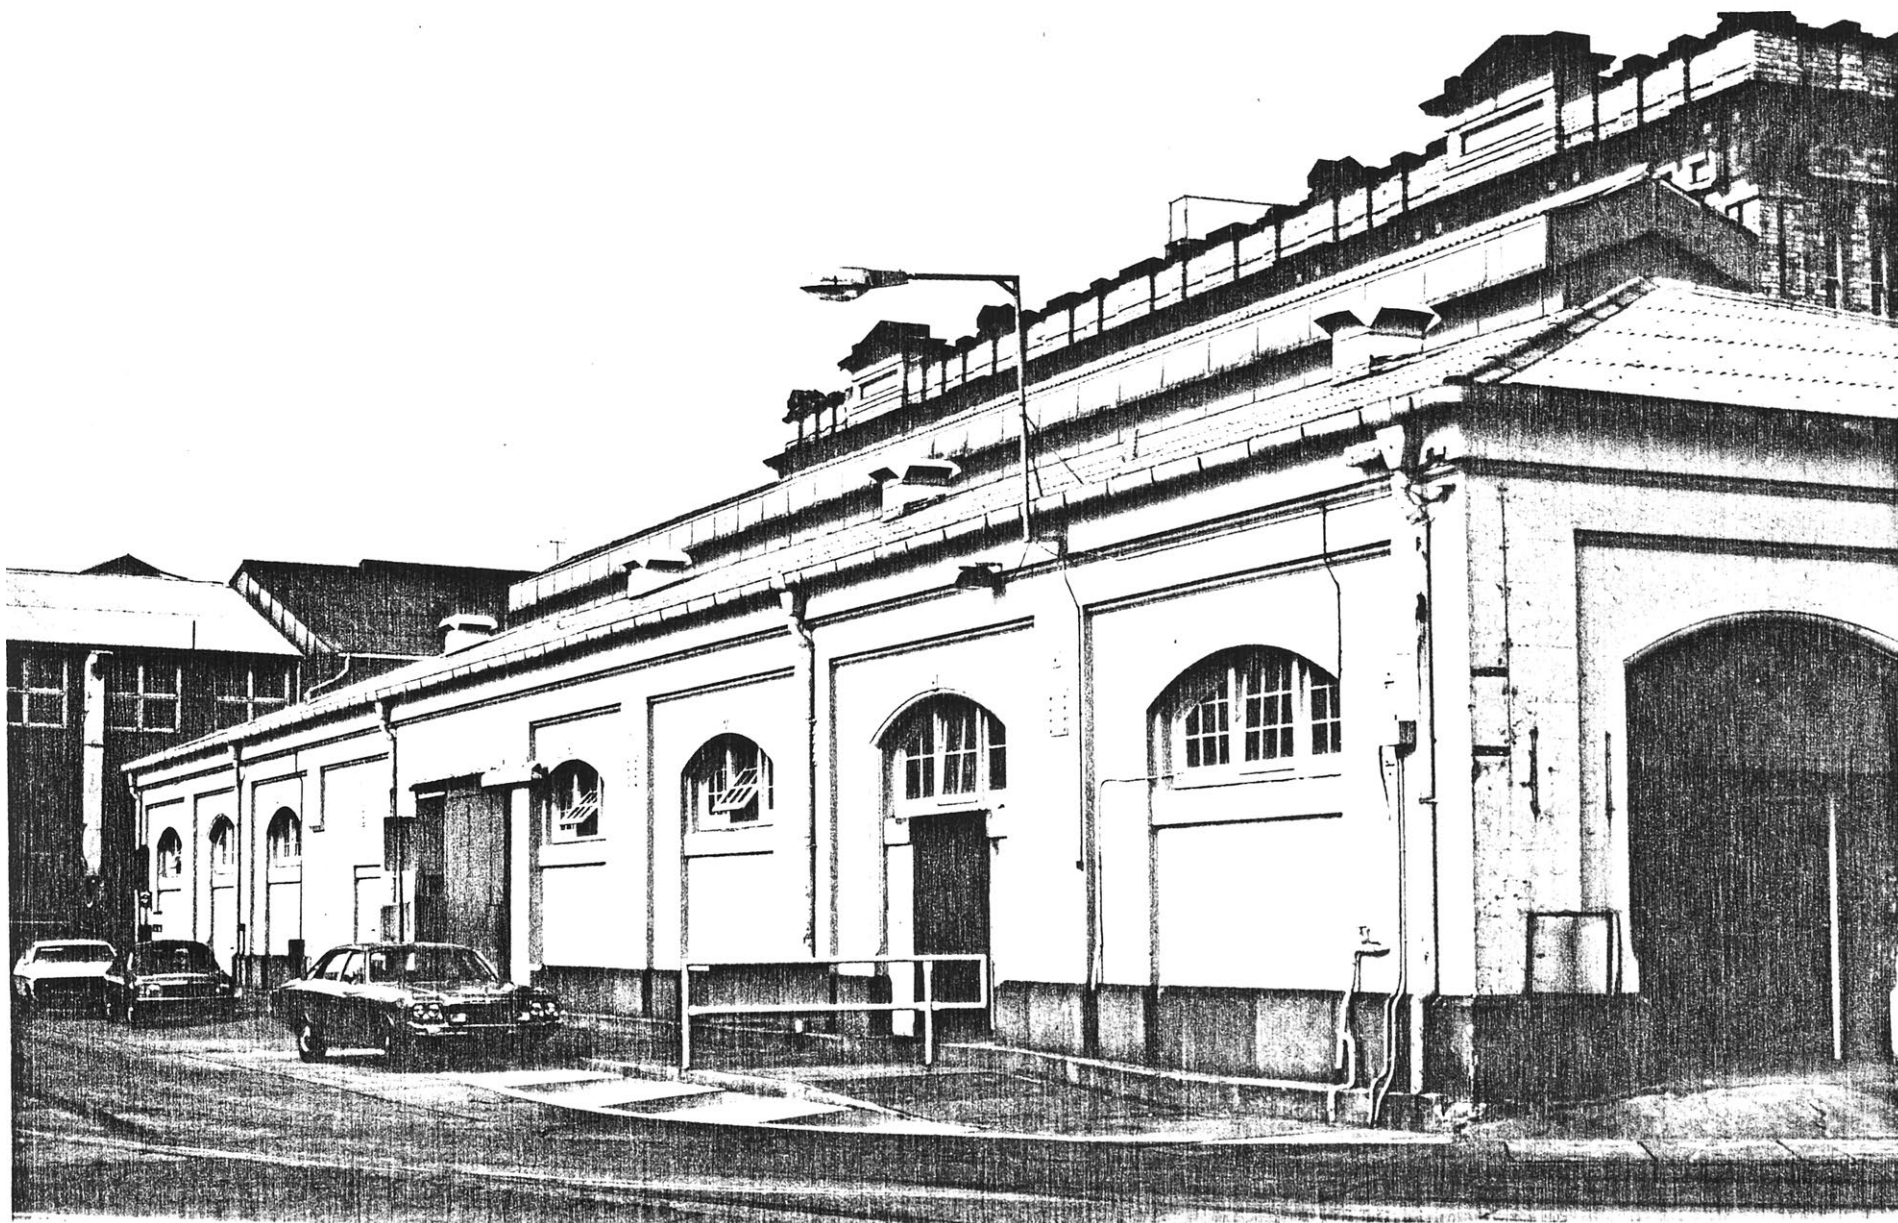
As this issue is contentious it is discussed in some depth. Figure 129 gives of view of the building from the south west. The problem or question relating to Building 88 is 'does the

Figure 129 Building 88 from the South West

- (i) demolish the building entirely;
- (ii) remove the southern part of the building so that the south end aligns with the south side of Building 89; or
- (iii) retain the building adapting it for a new use.
