**YAMBA HILL GROUNDWATER LEVEL MONITORING
ASSESSMENT TO MID-2007**

Technical Report 2007/32
December 2007

THE UNIVERSITY OF NEW SOUTH WALES
SCHOOL OF CIVIL AND ENVIRONMENTAL ENGINEERING
WATER RESEARCH LABORATORY
in association with
JEFFERY AND KATAUSKAS PTY LTD
and
GROUNDWATER DATA COLLECTION SERVICES

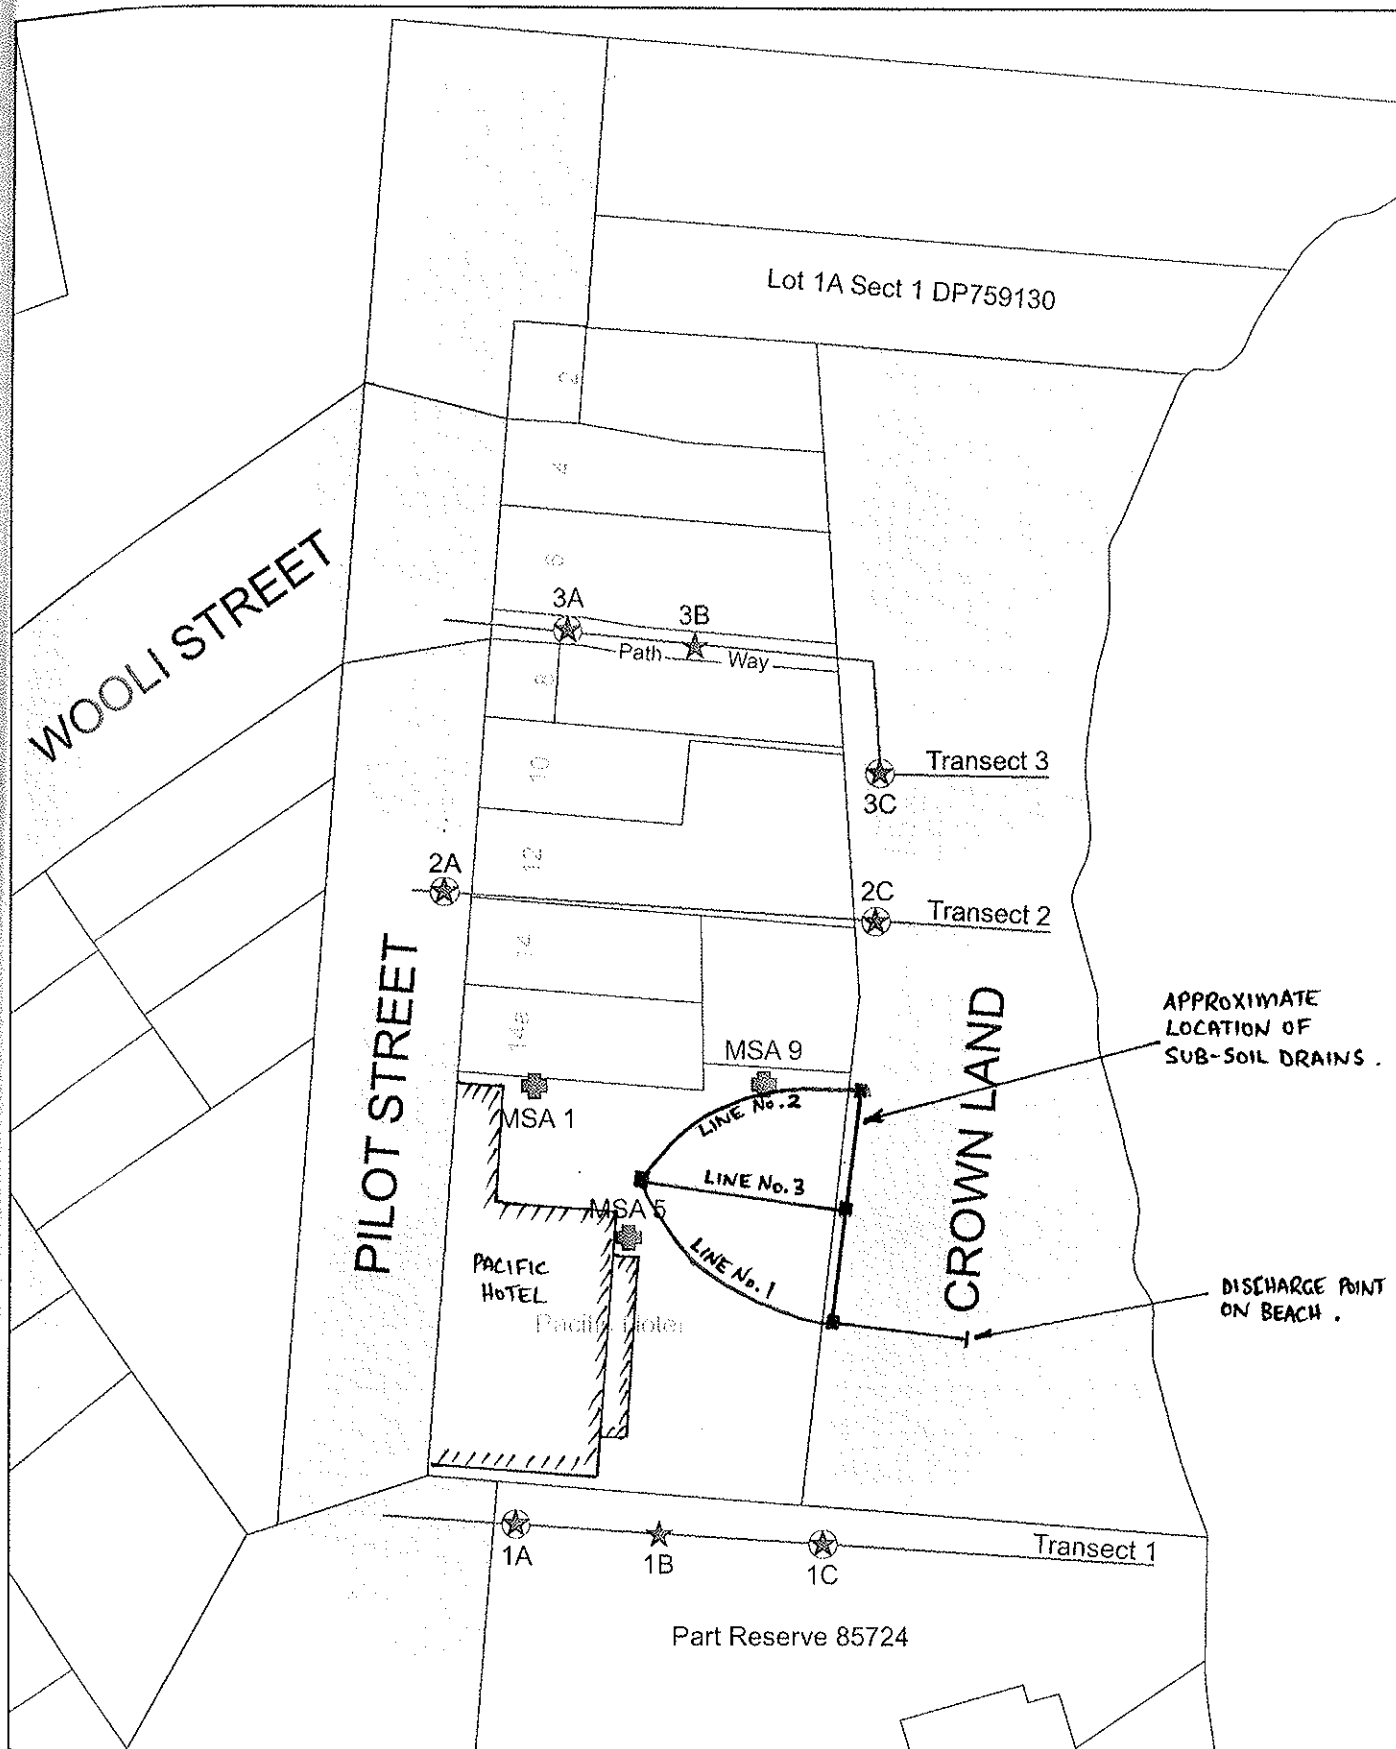
Report No. 19314WL2 Figure No. 3

MSA5 is located about 3.5m from the sub-soil drains and close to the Pacific Hotel as shown on Figure 3. While there was not much data obtained from MSA5 during the current monitoring period; it is likely that this is due to the groundwater being below the base of the data logger. Nevertheless, comparison of the results indicated

LEGEND: * LOCATION OF DRAINS HAS BEEN
 O Inclinator TAKEN FROM:
 ★ Piezometer DRAWING No. 99-629/09
 ■ Existing monitoring site REVISION B DATED 1/2/02
 AS DRAWN BY
 MICHAEL SAMMS & ASSOC.

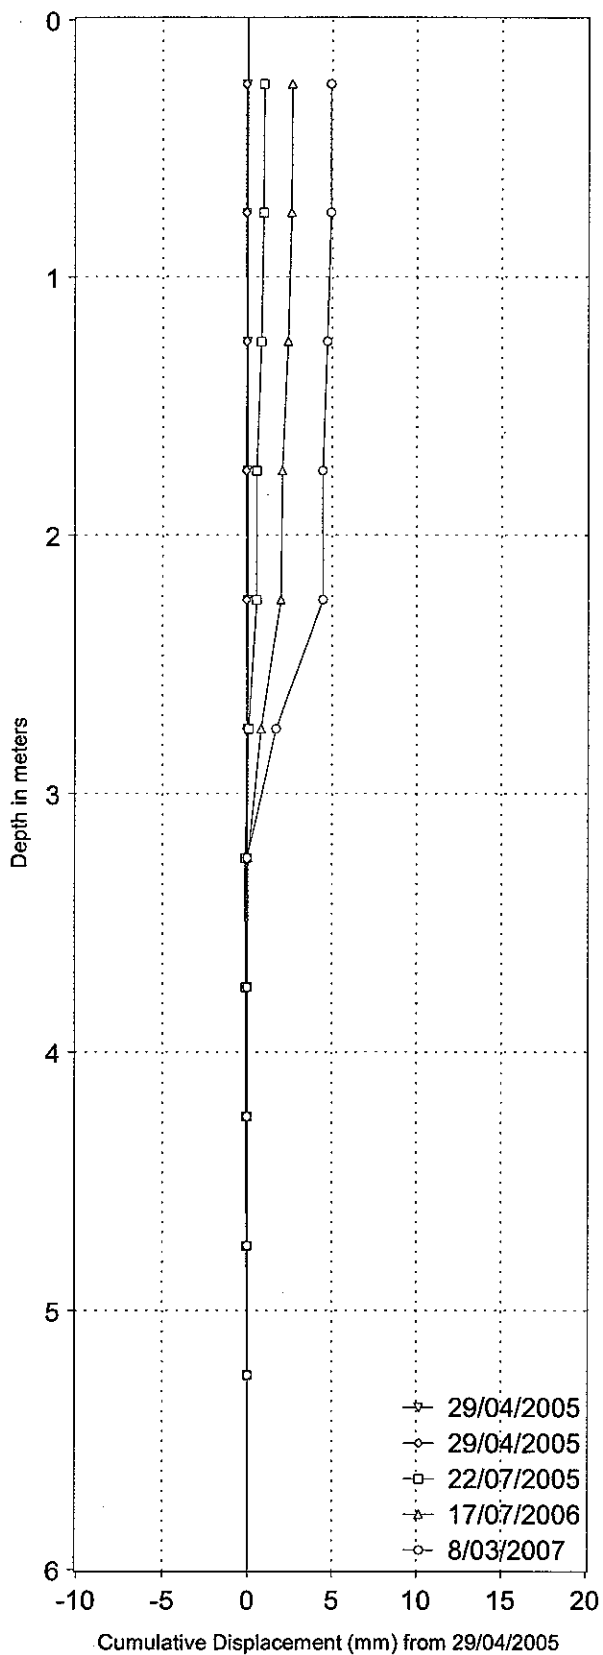
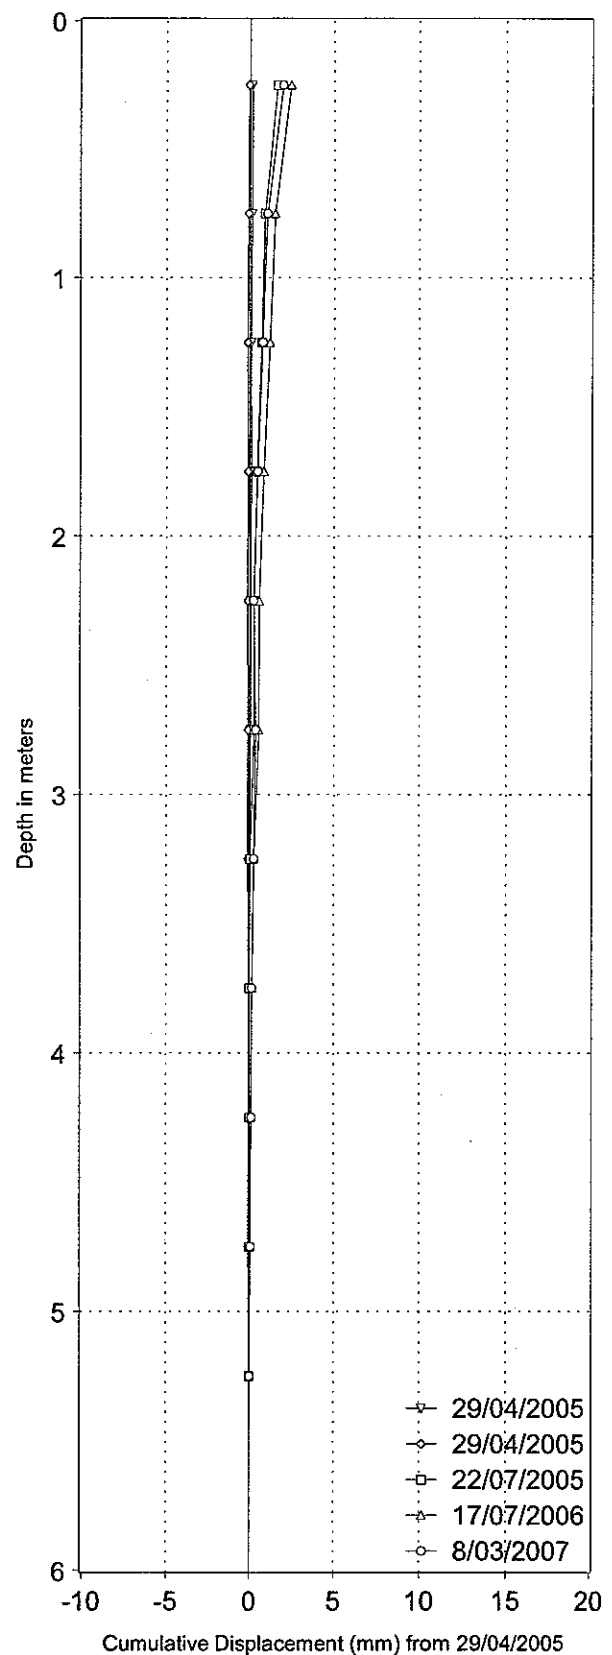
Figure No: 5

with the exception of Inclinator 2C. Inclinator 2C is showing signs of some downhill movement in the order of 5mm. This movement is probably indicative of localised creep of the soils. At this stage we do not consider this movement to be critical to warrant any immediate action, however further monitoring is recommended and if the trend continues then action may be required.
