The Pre- and Post-Failure Deformation Behaviour of Soil Slopes

Gavan James Hunter

**A thesis submitted in partial fulfilment
of the requirements for the degree of
Doctor of Philosophy**

**School of Civil and Environmental Engineering
The University of New South Wales**

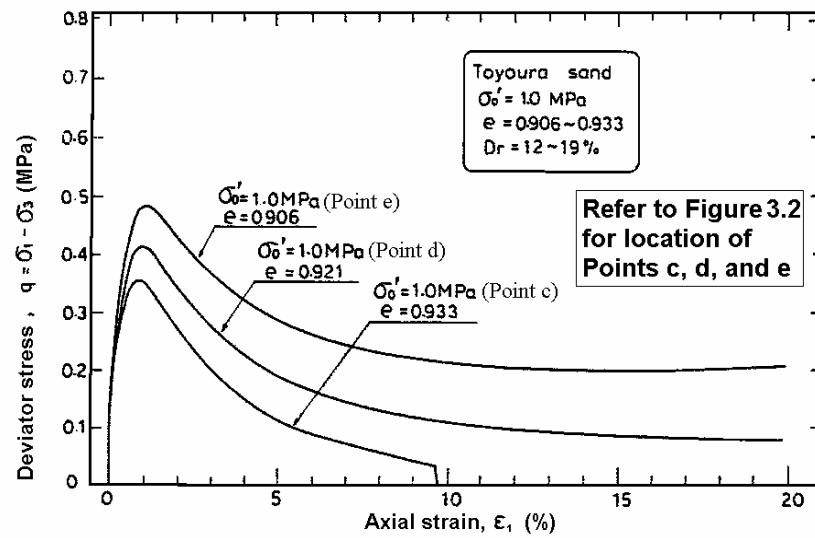
Figure 3.3: Undrained behaviour of states on the contractive side of the steady state line (Ishihara 1993)

- At very high void ratios, corresponding to sands in a very loose condition, complete static liquefaction (i.e., zero residual undrained strength) is observed, as typified by Point c in Figure 3.3. Ishihara (1993) defined the threshold void ratio, e_o (refer Figure 3.2), as the void ratio at or above which samples exhibit zero residual strength. It corresponds to the void ratio at steady state for zero effective stress.

- At a void ratio slightly less than the threshold void ratio (Points d and e in Figure 3.2) static liquefaction is observed with low residual undrained strength (Figure 3.3). This corresponds to contractive states located above the steady state line.

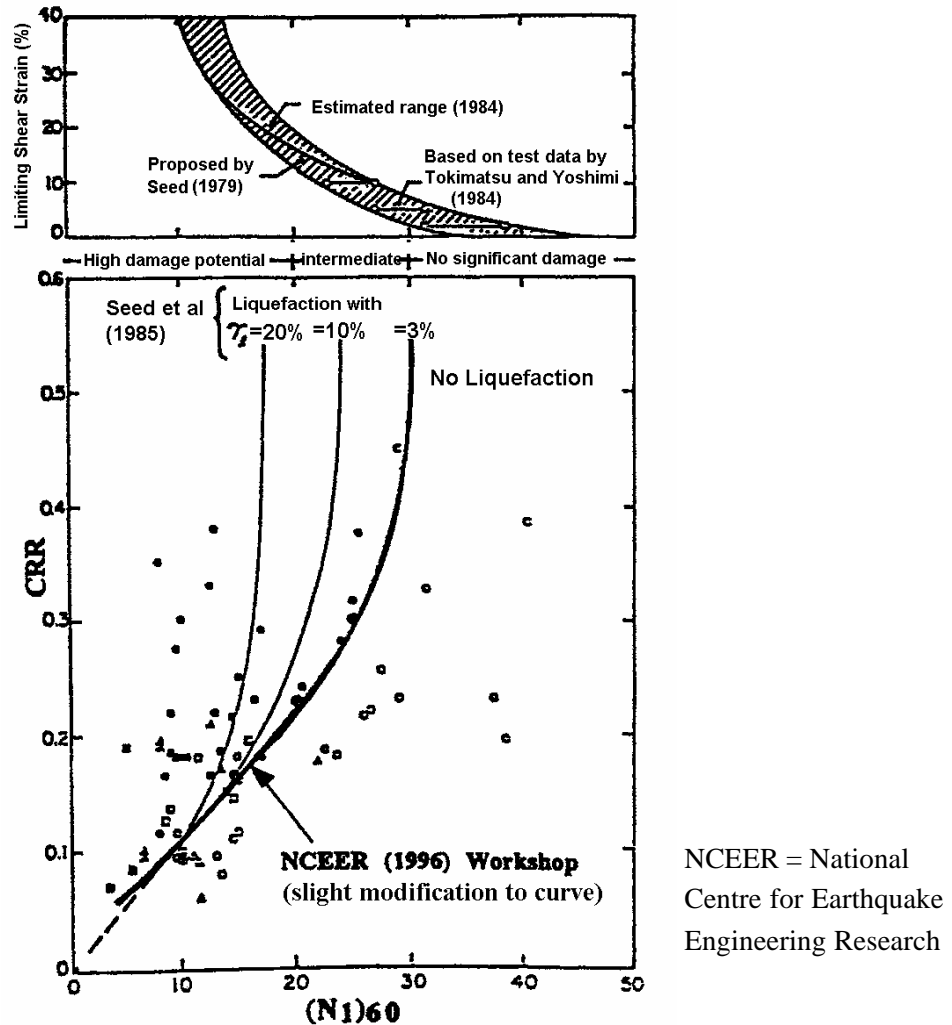
Figure 3.8: Correlation for cyclic resistance ratio (CRR) based on corrected SPT blow count, $(N_1)_{60}$, for clean sands under level ground conditions (Robertson and Wride 1997)

Seed (1979) developed a correlation between the cyclic stress ratio to cause cyclic liquefaction and the N value of the SPT test based on field data of sand deposits for essentially level ground condition subject to strong shaking from earthquakes. Seed et al (1985), recognising that the amount of shear strain observed was dependent on the relative density of the sand, further developed the correlation to provide guidelines on the level of shear strain (Figure 3.8) with respect to SPT and cyclic resistance ratio for clean sands. Robertson and Wride (1997) comment that much larger shear strains can be expected for loose sands ($(N_1)_{60} < 15$), where effective stresses may reduce to zero under dynamic loading, than for denser sands ($(N_1)_{60} > 15$) where large pore pressures may develop but effective stresses may not fully reduce to zero. The line on Figure 3.8 for shear strains of 20% could be considered as representing a boundary of flow liquefaction conditions.

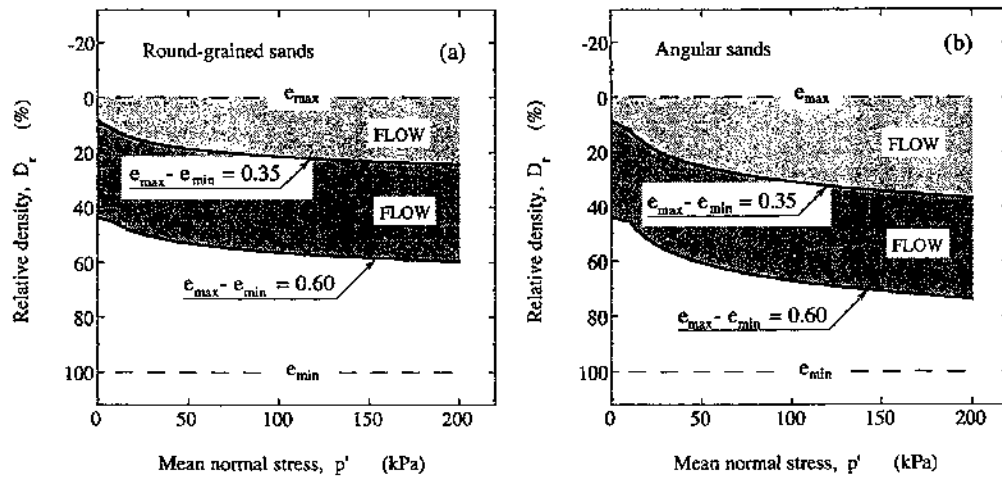
liquefaction no flow boundary increased with increasing void ratio range. Figure 3.11 presents the comparison of flow liquefaction potential (Cubrinovski and Ishihara 2000) for the void ratio ranges 0.35 and 0.60 for both round-grained sands and angular grains. The shaded area above the line (in density ratio to mean normal stress space) defines the zone of flow liquefaction potential. For a void ratio range of 0.60 the relative density, at a given mean normal stress, below which the sand is susceptible to flow liquefaction is much greater than for a sand with a void ratio range of 0.35.

Figure 3.11: Influence of void ratio range on flow potential of sandy soils for (a) round-grained sands and (b) angular grains (Cubrinovski and Ishihara 2000)

Cubrinovski and Ishihara (2000) also defined the region of flow liquefaction at zero residual undrained strength (i.e., for void ratios at or above the threshold void ratio, defined in Section 3.3.2) in terms of SPT N value, using Equations 3.3 and 3.4. From Figure 3.11 the region of flow liquefaction at zero residual undrained strength is at relative densities less than at the intercept of the liquefaction flow no-flow boundary; i.e., at zero effective mean normal stress. For example, from Figure 3.11a flow liquefaction at zero residual strength would be at relative densities less than about 10% for a void ratio range of 0.35 and less than about 43% for a void ratio range of 0.6 (both for round-grained sands). Figure 3.16 is an example showing the liquefaction flow no-

liquefaction potential of sands as indicated by Figure 3.11 and Figure 3.17. Lade and Yamamuro (1997) comment that the fines have a significant role in the particle structure, resulting in highly compressible soils with increased liquefaction potential. They also recognised the findings of field-testing correlations with actual earthquake induced liquefaction events that indicated sands with significant fines content were more resistant to cyclic liquefaction. Lade and Yamamuro (1997) considered that the effects of stress history and aging (creep or cementation) are likely to increase the field resistance of silty sands. However, for newly constructed hydraulic fills and very recent natural deposits they considered that fines content would decrease the liquefaction resistance.

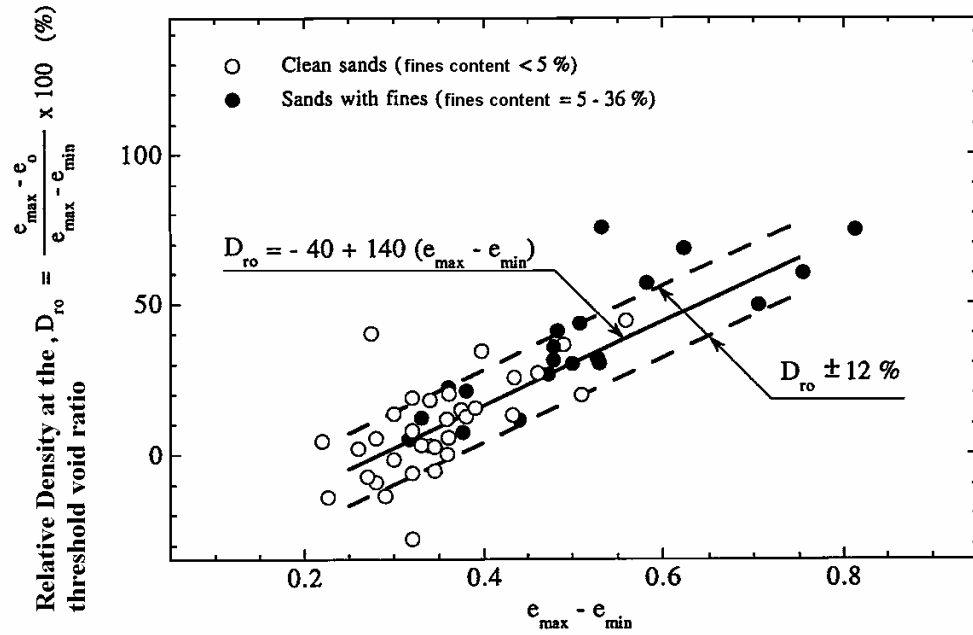
Cubrinovski and Ishihara (2000), from their database, derived empirical correlations of relative density (at the threshold void ratio) and slope of the steady state line, I , with respect to the void ratio range. As shown in Figure 3.12 and Figure 3.13, whilst the data correlate reasonably well with the trendlines, there is a significant scatter. Cubrinovski and Ishihara (2000) then, using their derived correlation of relative density to SPT N value corrected for over-burden pressure, N_I , (Figure 3.14), derived empirical relationships to define the flow liquefaction no-flow boundary in terms of field measured SPT blow count. These equations (Equation 3.3 for round-grained sands and

Figure 3.12: Relationship between relative density, D_{ro} , at the threshold void ratio, e_o , and void ratio range ($e_{\max} - e_{\min}$) for sandy soils (Cubrinovski and Ishihara 2000).

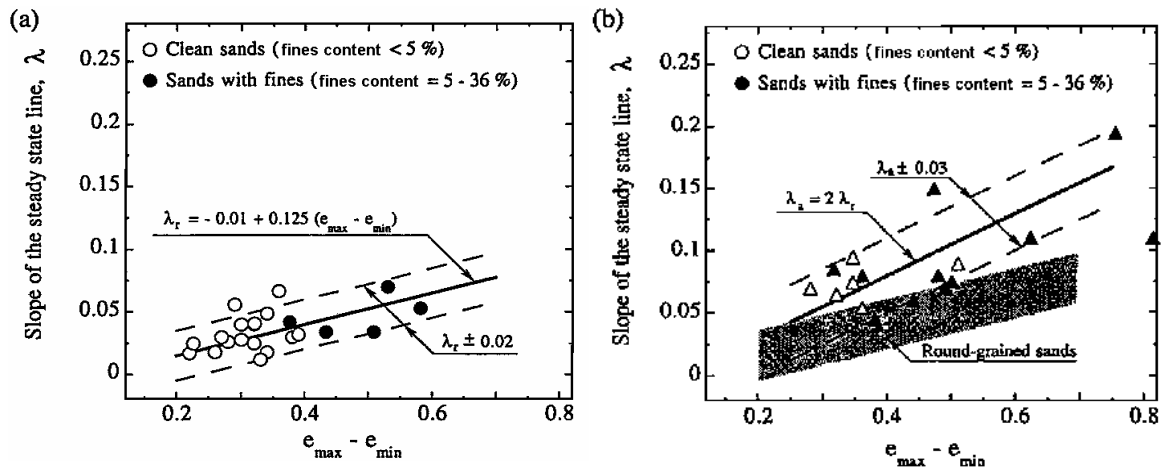
Figure 3.13: Relationship between the slope of the steady state line, λ , and void ratio range for (a) round-grained sands and (b) angular grained sands (Cubrinovski and Ishihara 2000).

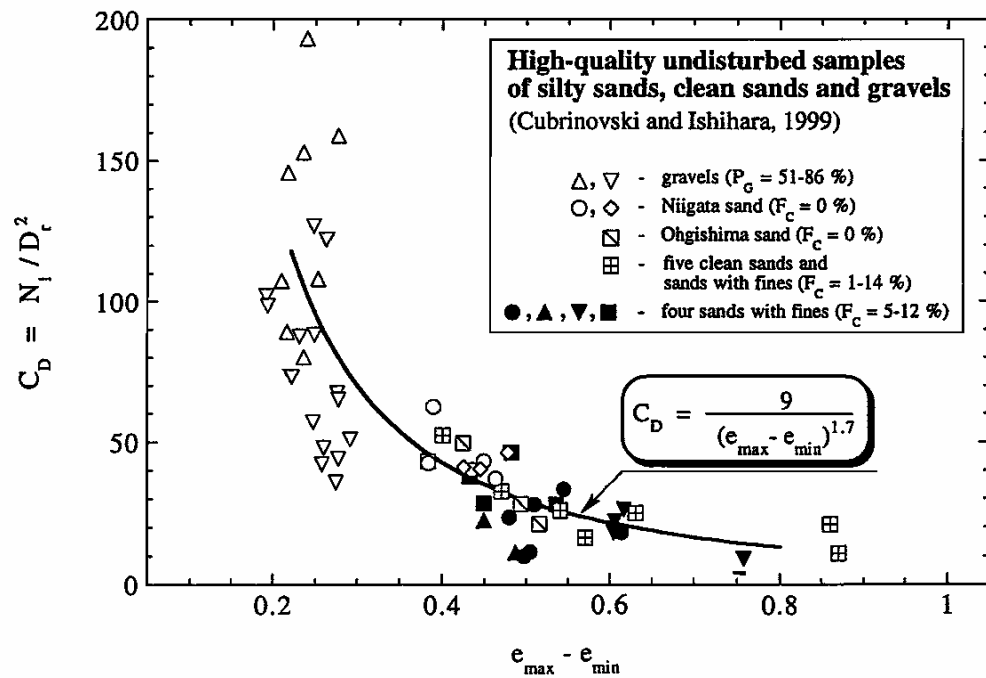
Figure 3.14: Correlation between N_1 / D_r^2 (N_1 = SPT blow count corrected for overburden pressure, D_r = relative density) and void ratio range for cohesionless soils (Cubrinovski and Ishihara 2000).

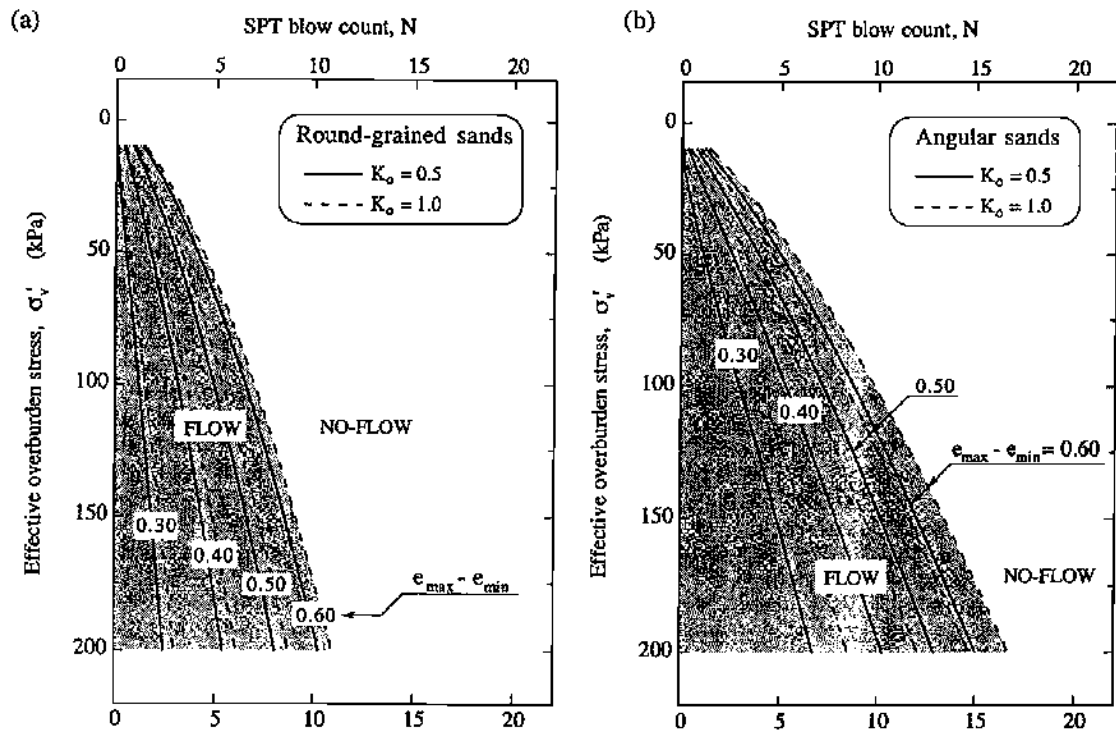
Graphical representations of the flow liquefaction no-flow boundary for both round-grained and angular sands according to Equations 3.3 and 3.4 are shown in Figure 3.15 for void ratio range from 0.3 to 0.6 and lateral stress ratios, K_o , of 0.5 and 1.0.

Figure 3.15: Field measured SPT blow count boundaries differentiating flow liquefaction no-flow conditions for void ratio range of 0.3 to 0.6 for (a) round-grained sands and (b) angular sands (Cubrinovski and Ishihara 2000)

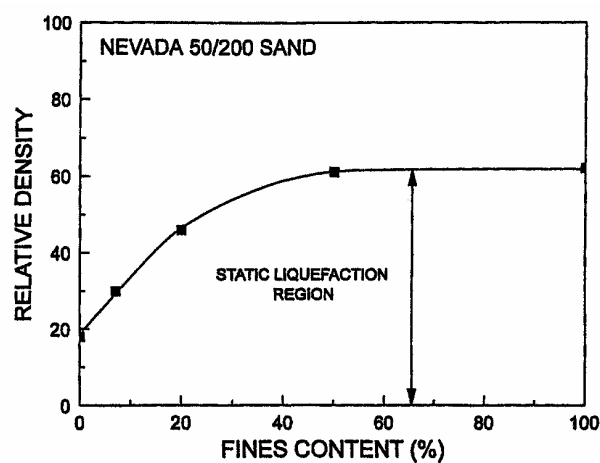
Figure 3.17: Increase in liquefaction potential (as measured by relative density) with increasing content of non-plastic fines (Lade and Yamamuro 1997)

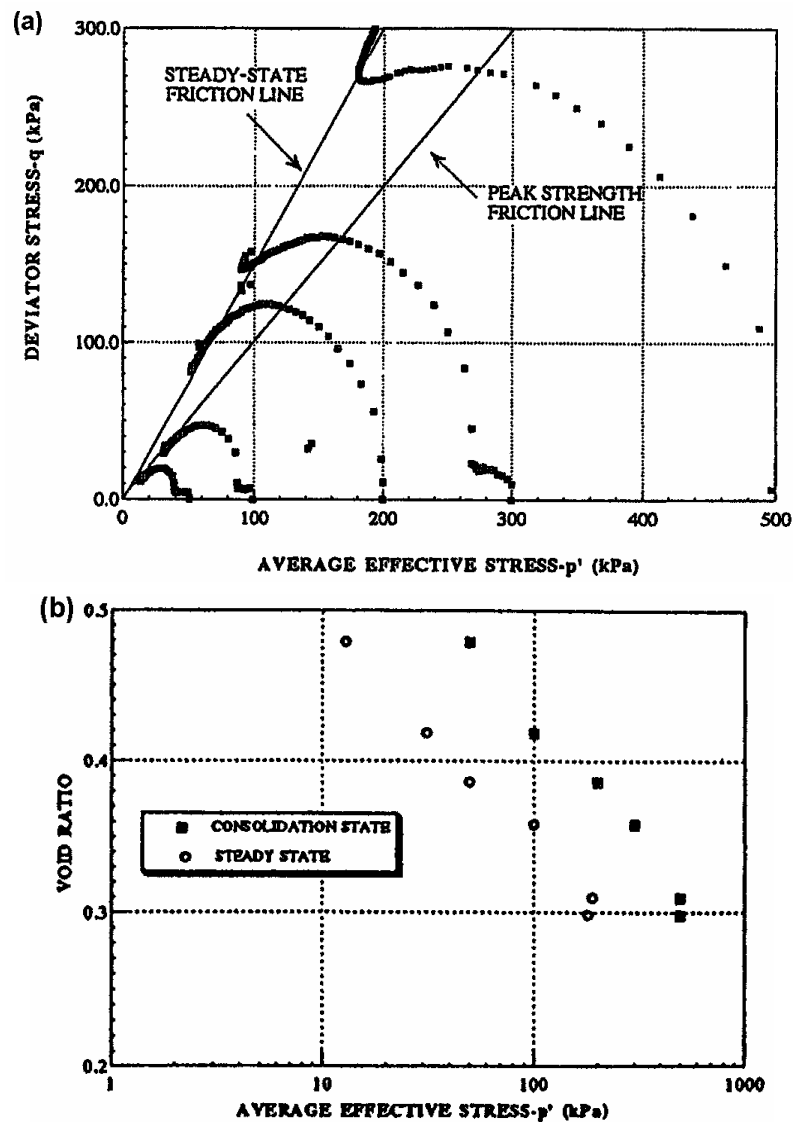
Figure 3.18: Fording sandy gravel sample (a) undrained triaxial compression test results and (b) consolidation and steady states (Dawson et al 1998).

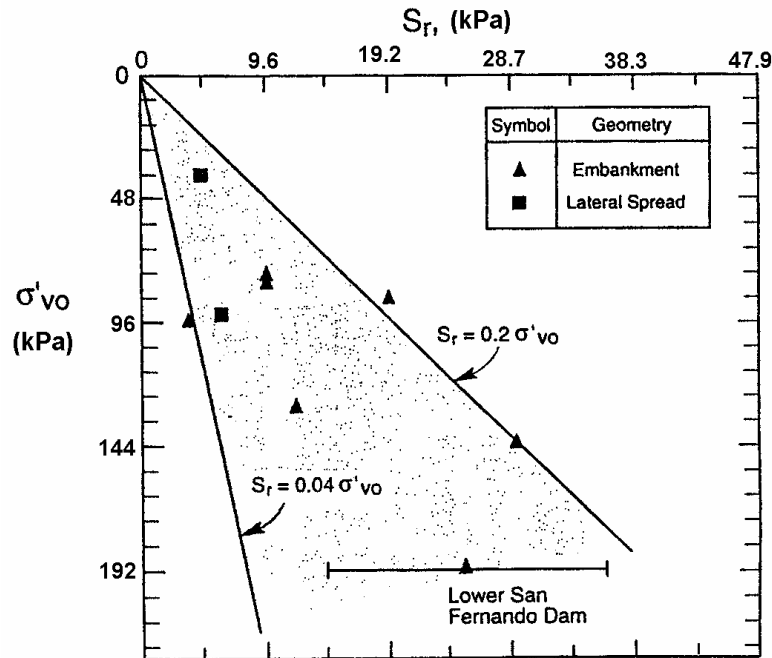
Figure 3.21: Residual undrained shear strength, S_r , to vertical effective over-burden pressure for silty sand deposits ($\geq 10\%$ fines), triggered by earthquake, that have experienced large deformation (Baziar and Dobry 1995)

analysis was related to the initial effective over-burden pressure, with the limits of S_r/s'_{vo} in the range 0.04 to 0.2 (Figure 3.21).
