The corrosion characteristics of galvanized reinforcing bars

THESIS

FOR THE DEGREE OF MASTER OF ENGINEERING

HENRY HERZOG, B.E December, 1976

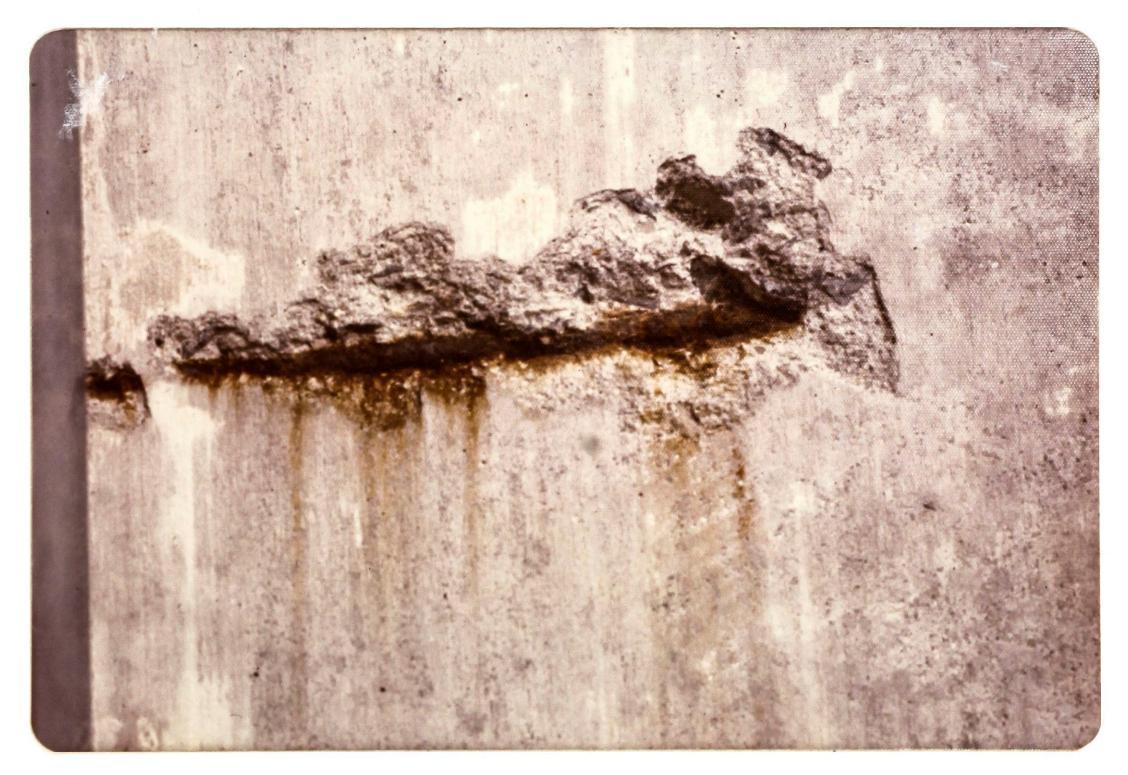
FIGURE 1.1

Concrete columns reinforced with untreated steel - situated on the lower campus of the University of N.S.W.

Corrosion of the reinforcing bar causes the build up of corrosion products which produce cracks in the concrete beams (Figure 1.1). For example reinforced concrete beams used in the construction of a building on the lower campus of the University of New South Wales showed the formation of cracks on the surface of the beams. To combat this corrosion of the reinforcement, the concrete was removed from around the reinforcement bar and zinc chromate paint was applied to the bar (Figure 1.2). The concrete was then restored and a tar based paint was applied.

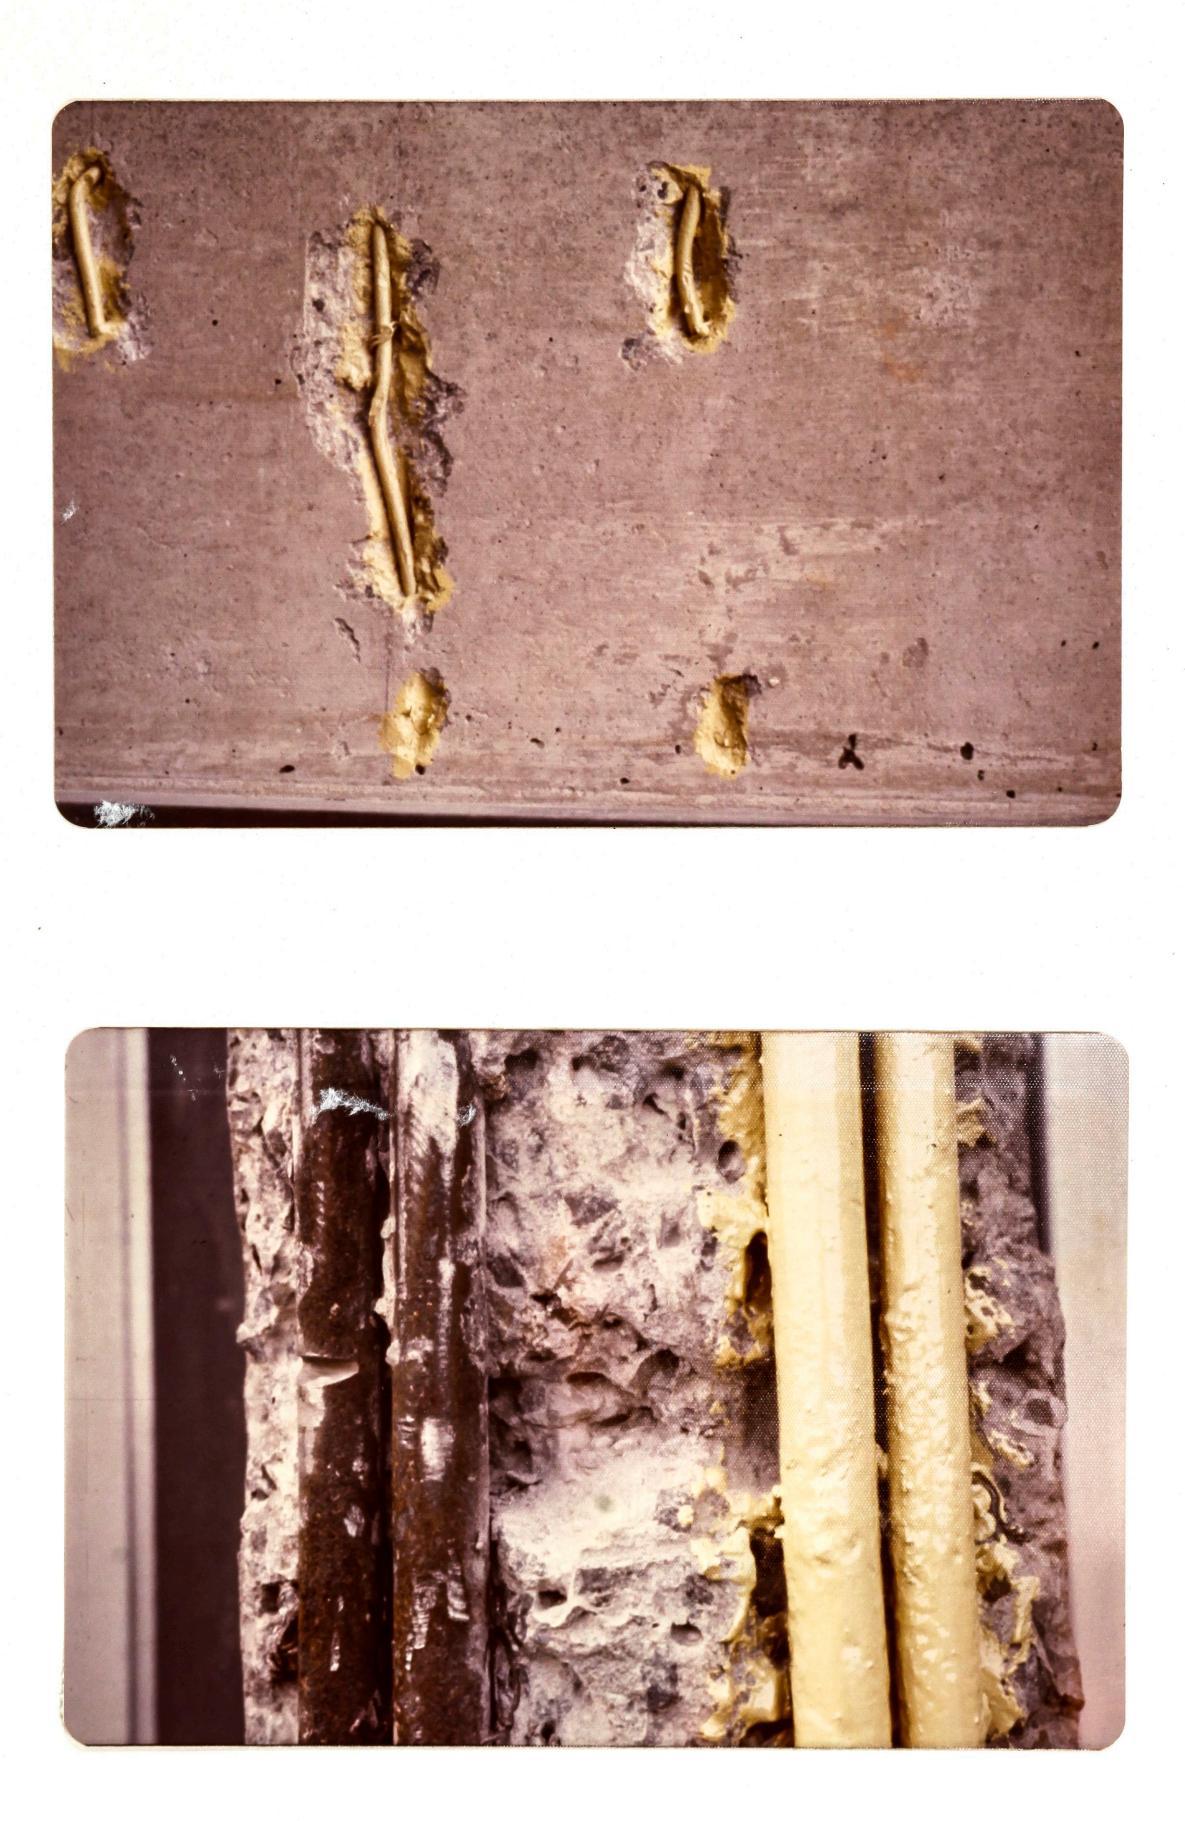
FIGURE 1.2 Concrete columns on the lower campus of the University of N.S.W. where the concrete was removed from the corroding reinforcing bars, and the bars were coated with zincchromate paint. of chromates in the concrete had been observed to eliminate these effects, thus providing added protection.

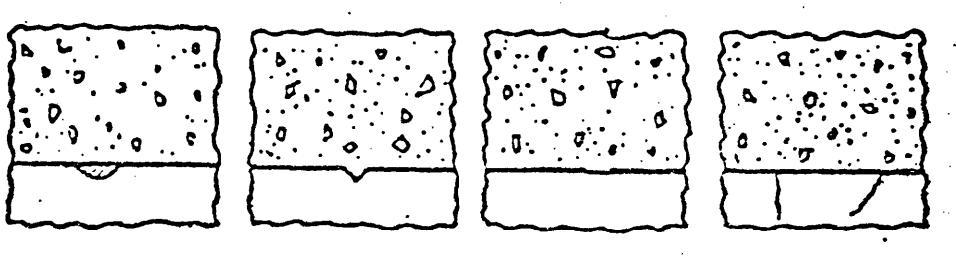
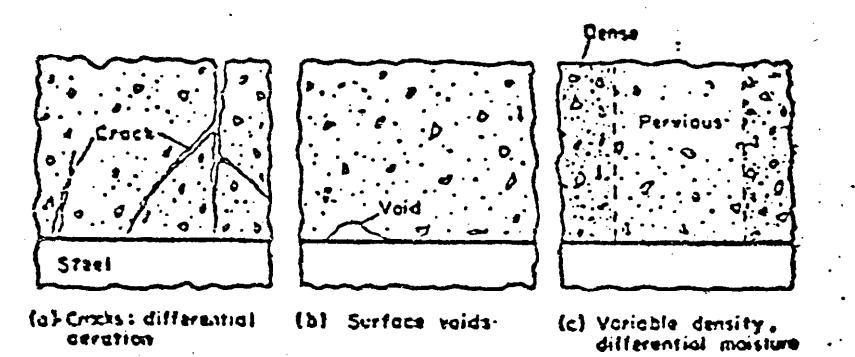
FIGURE 4.1

(a) Inclusion on surface (b) Scratch on surface

(c) Break in mill scale

(d) Grain boundaries.

Potential differences that may be formed by variations in cement or steel quality. After Bresler (65). bar) and an electrolyte (the concrete). All these will satisfy the requirements necessary for an electrochemical reaction; thus corrosion of steel will occur. (Figure 4.2) (37).

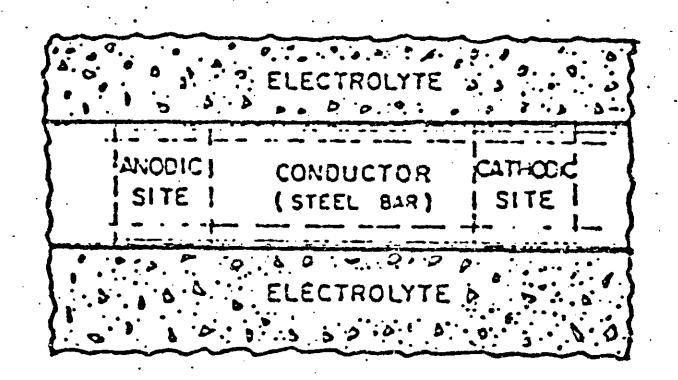
FIGURE 4.2

Electrochemical corrosion cell in reinforced concrete. After Bresler (65). adsorbed at random on the iron surface, independent of the presence or absence of impurities in the metal. The oxidation reaction proceeds as rapidly as oxygen reaches the metal surface. The overall equation for the oxidation reaction is:

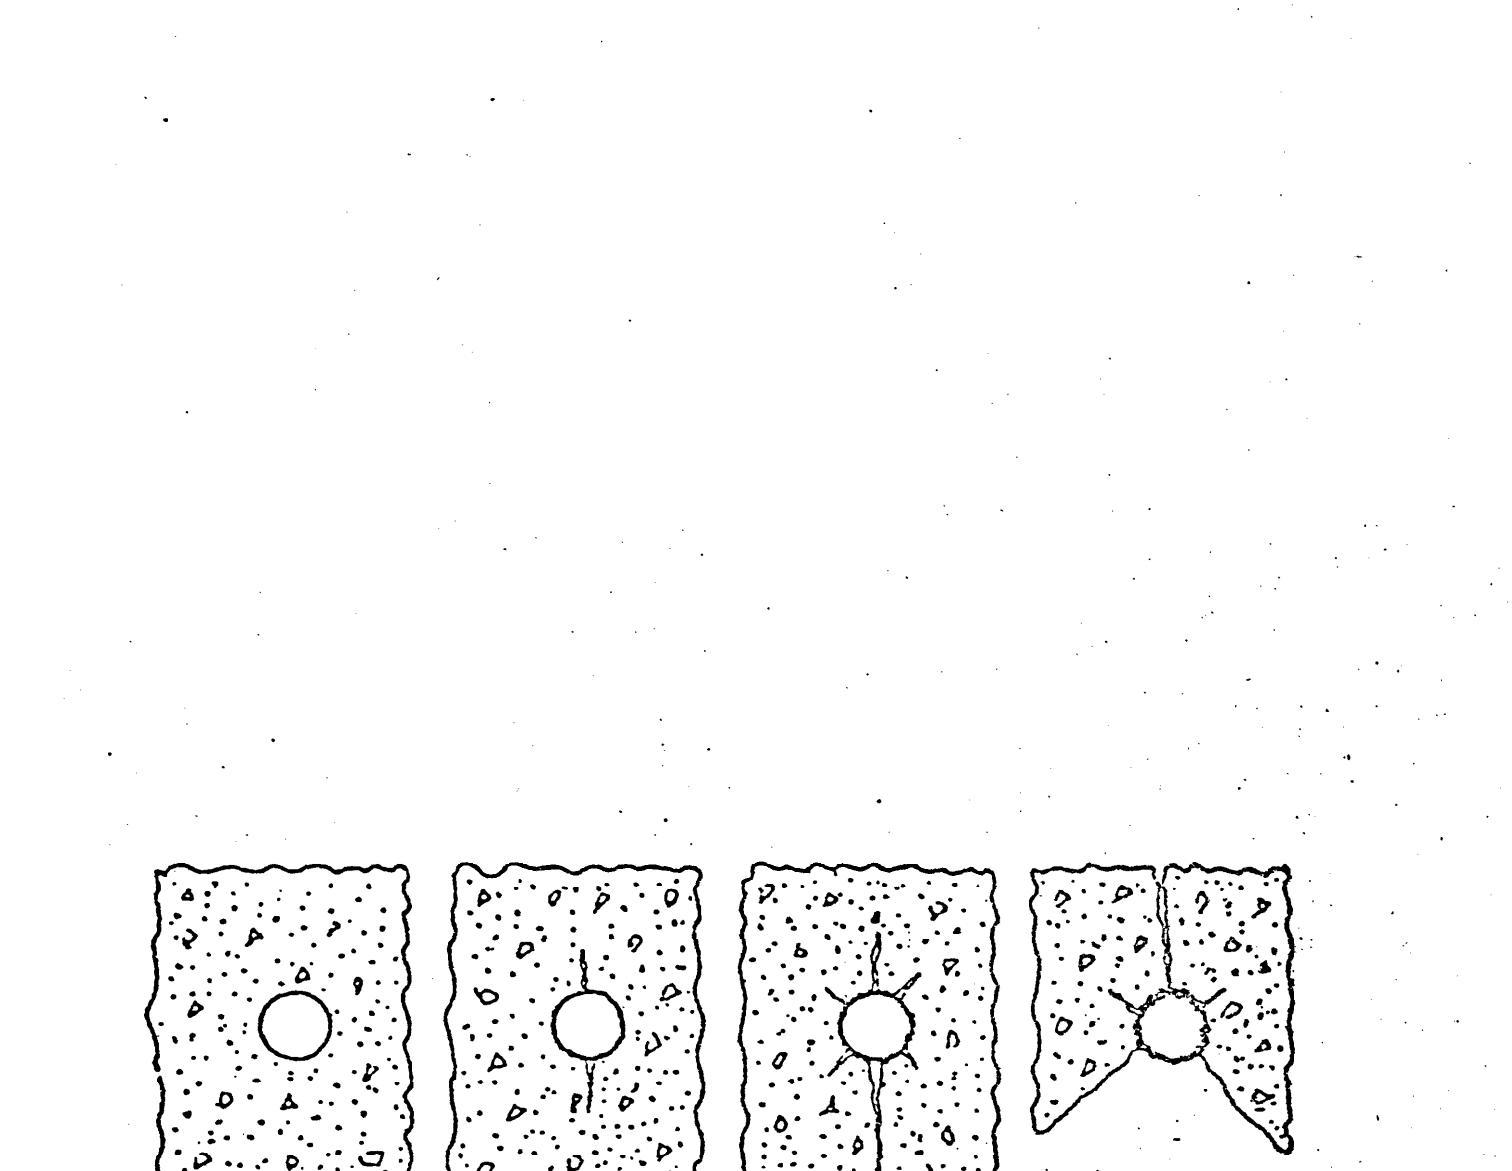
FIGURE 4.3

(a) Before corrosion (b) Build-up of (c) Further corrosion, (d) Eventual spalling corrosion surface cracks, —corroded ber products stains exposed.

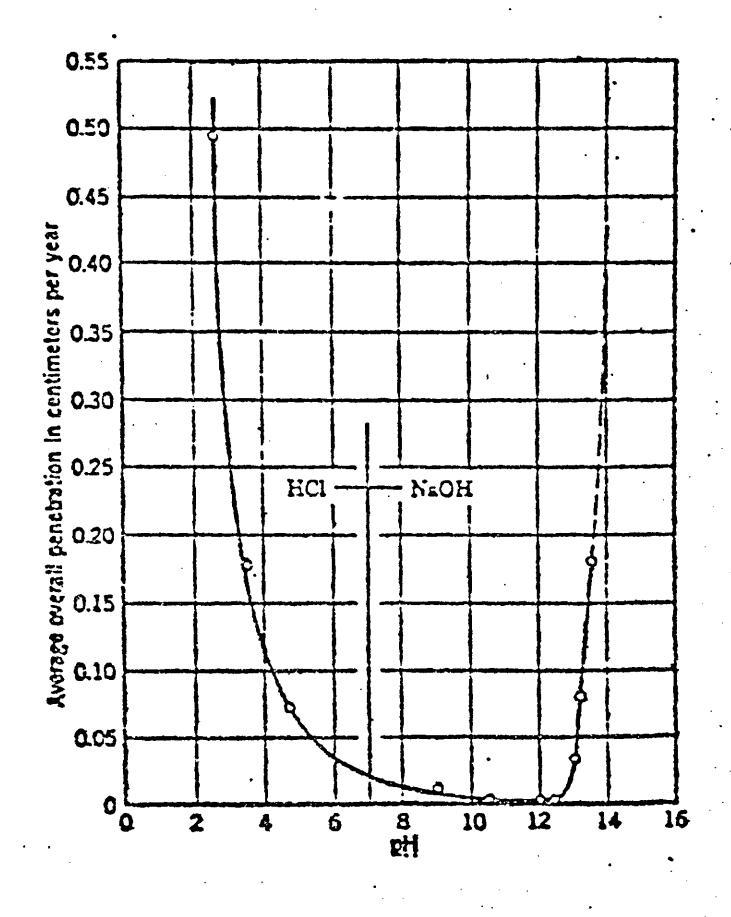
FIGURE 4.6

Effect of pH on corrosion of zinc in aerated solutions at 30°C. After Roetheli et al. (88).

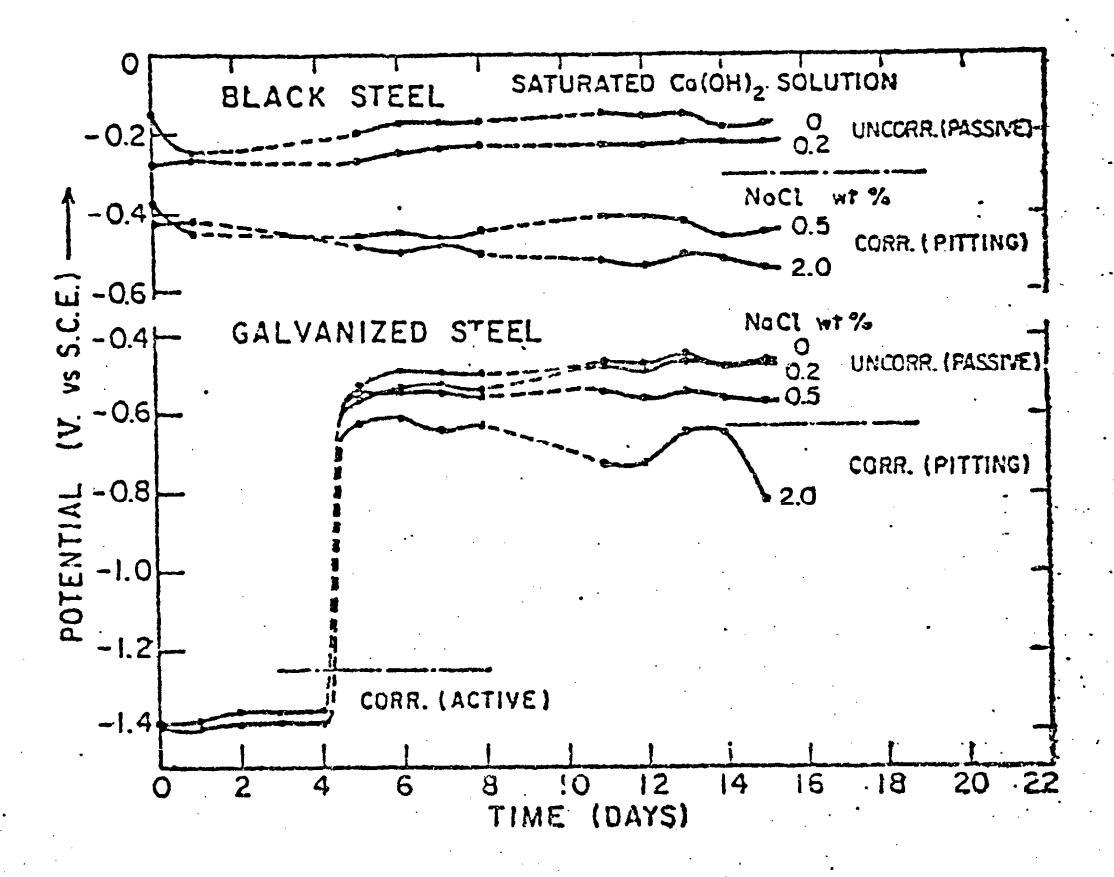
FIGURE 4.8

Graph showing the ability of galvanized steel to withstand high chloride concentration. These potential-time curves are for galvanized steel in saturated calcium hydroxide solutions in the presence of sodium chloride. Passivity of black steel breaks down at concentrations over 0.2 wt % NaCl. Passivity of galvanized steel, established in about four days of exposure, withstands salt concentrations of almost 2 wt %. Note the change in potential scale. After Ishihawa et al. (91).

When the passive zinc hydroxide coating is subjected to a chloride environment, it has been shown that zinc remains passive in chloride solutions of much higher concentration than those eliminating the passivity of steel (89, 90). Cornet et al (91) in their investigation, observed that the passivity of black steel broke down at sodium chloride concentrations of approximately 0.2 wt. per cent, while galvanized steel was able to withstand sodium chloride concentrations of approximately 2 wt. per cent. Once passivity was lost, zinc corroded in preference to steel (Figure 4.8).

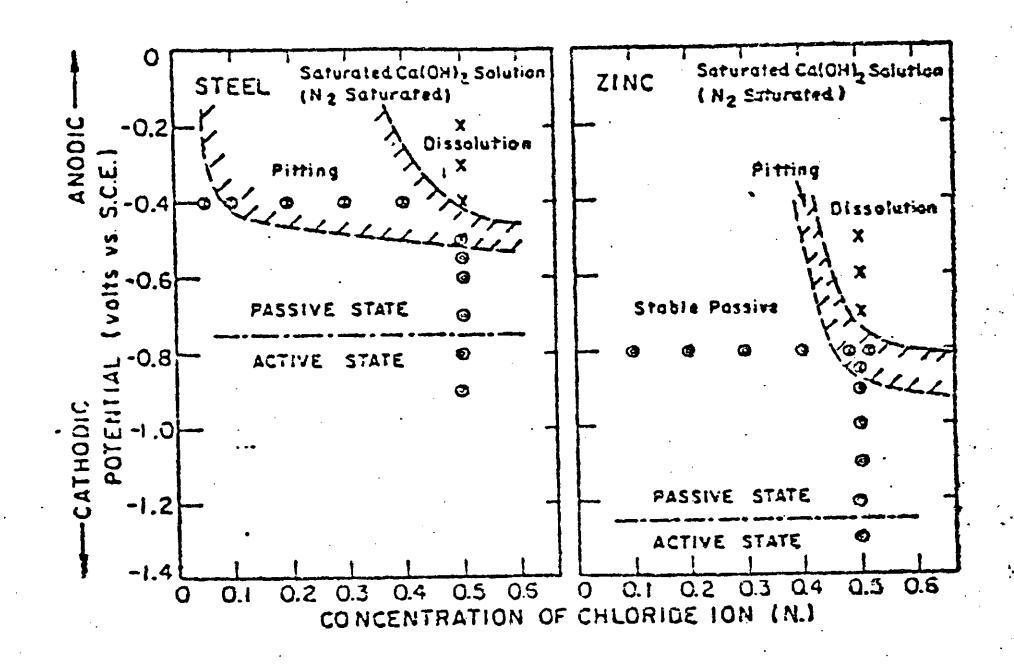
FIGURE 4.9

Corrosion characteristics of steel and of zinc in presence of chloride ion. After Bresler et al. (93) covering layer of zinc oxide. The oxide layer first allows further dissolution of zinc, which leads to the growth of the layer up to the occurrence of visible corrosion products, and at this stage corrosion is negligable.

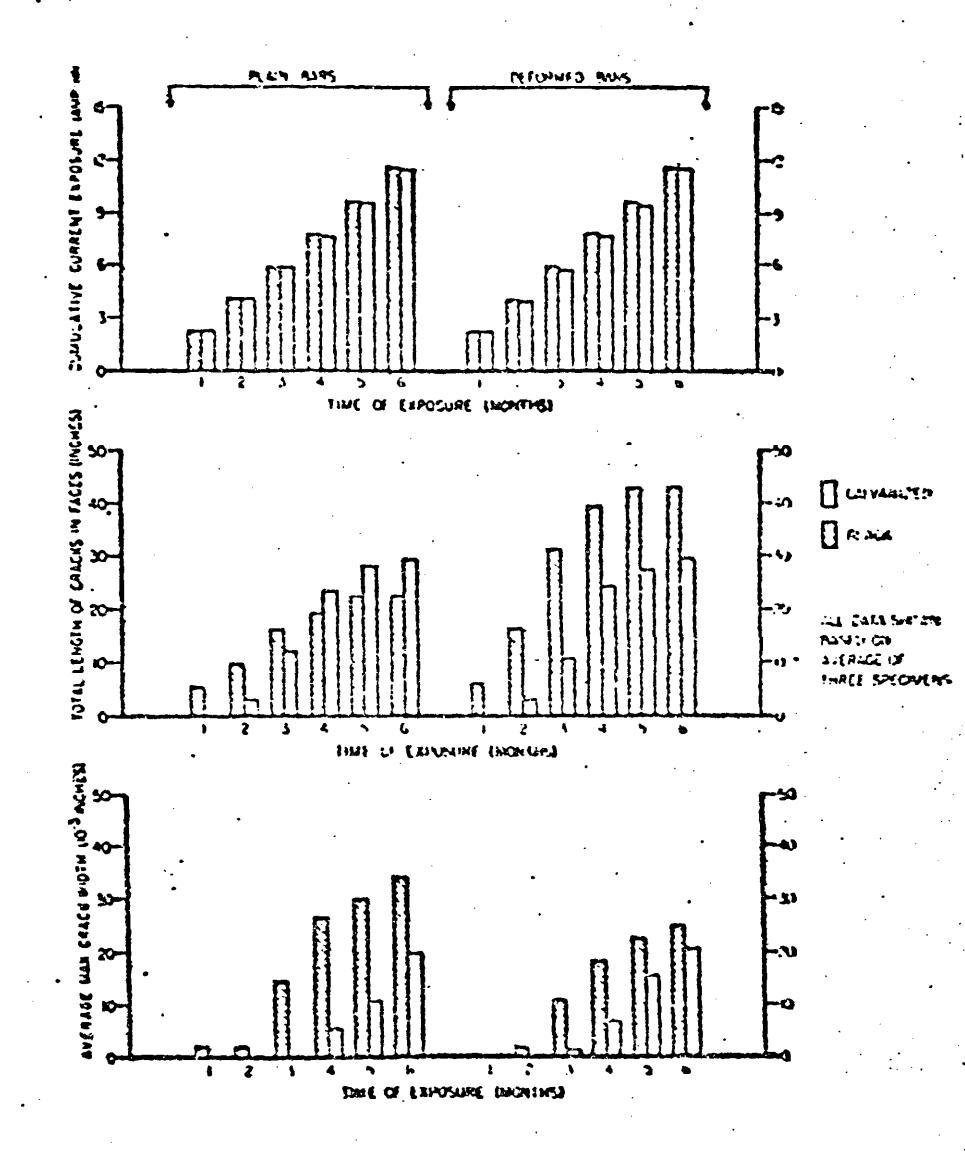
FIGURE 4.10

Corrosion performance of black and galvanized reinforcement under sustained direct current. After Bresler (91).

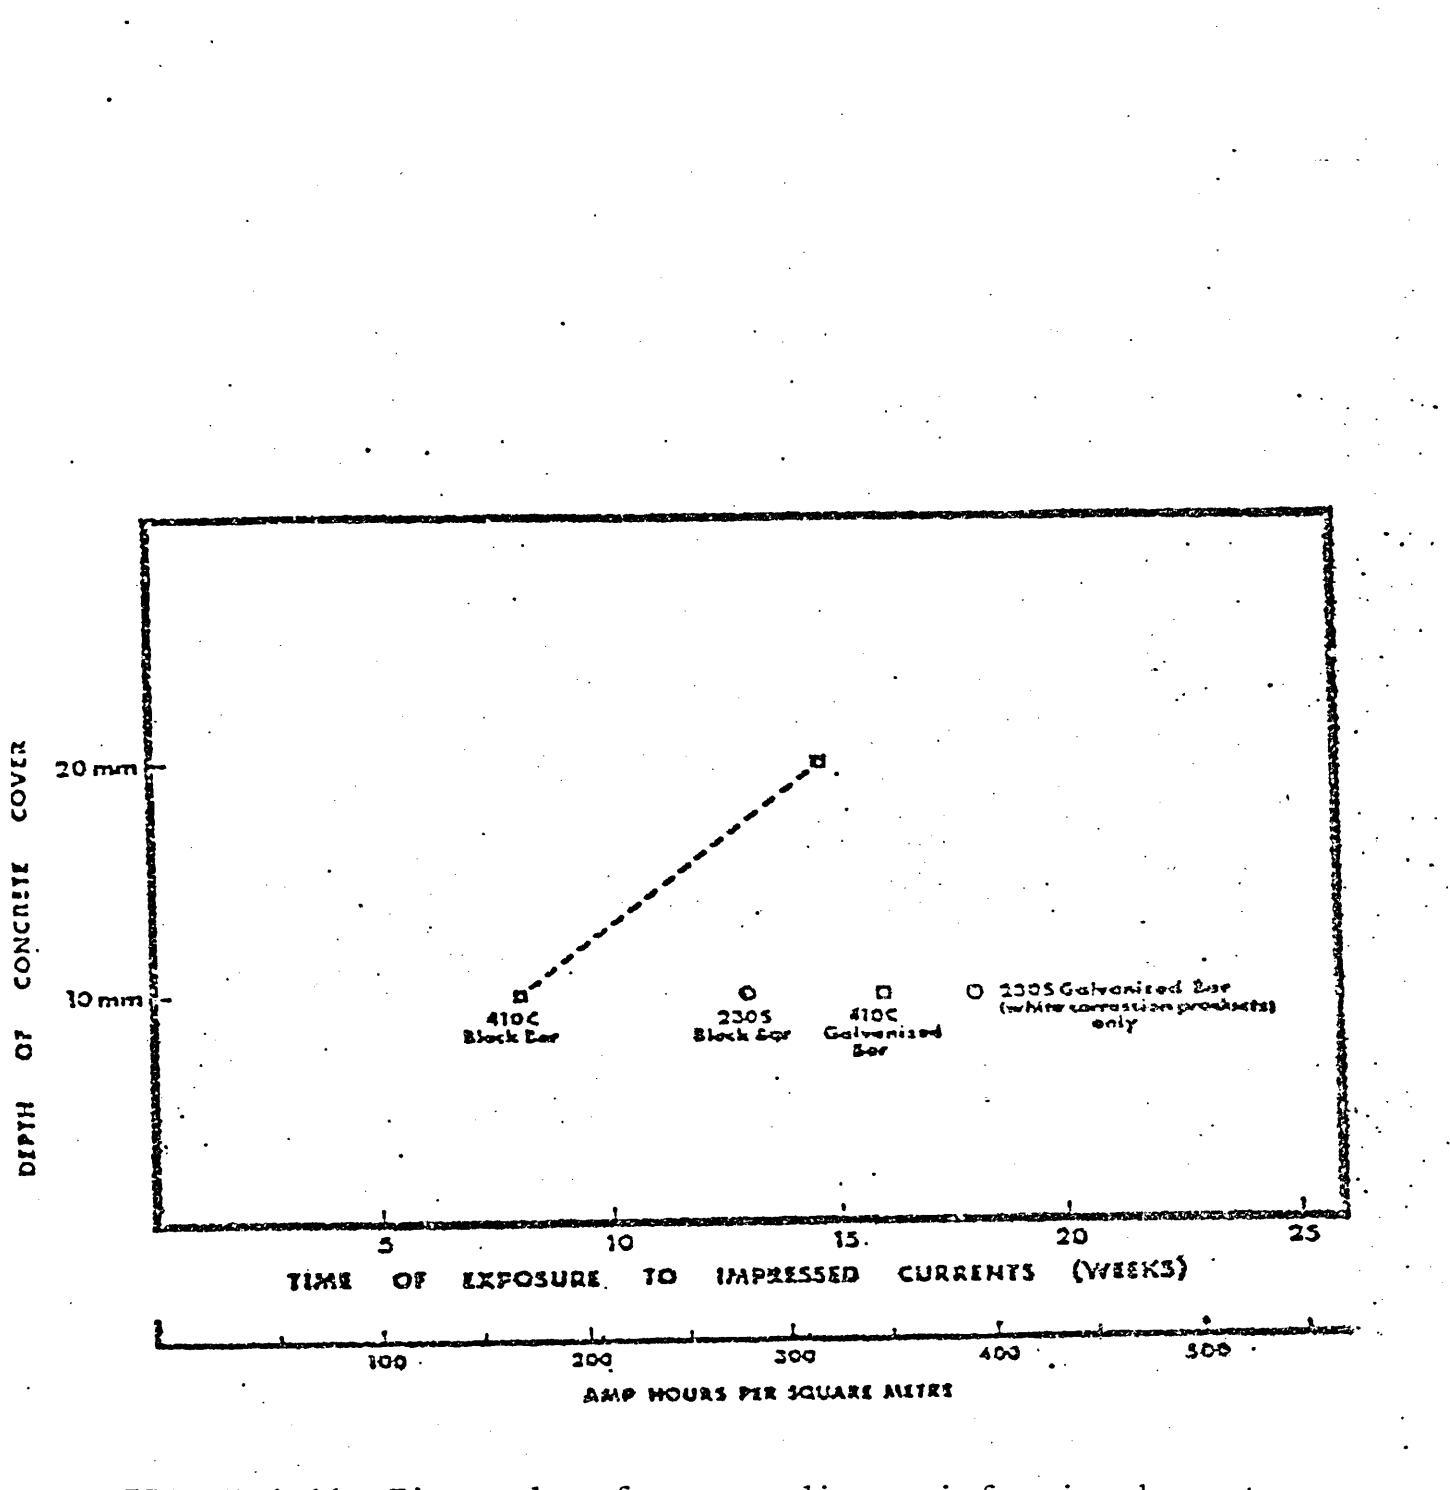
FIGURE 4.11

Time taken for corroding reinforcing bars to stain the concrete surface after exposure to impressed anodic currents. After Ford (37).

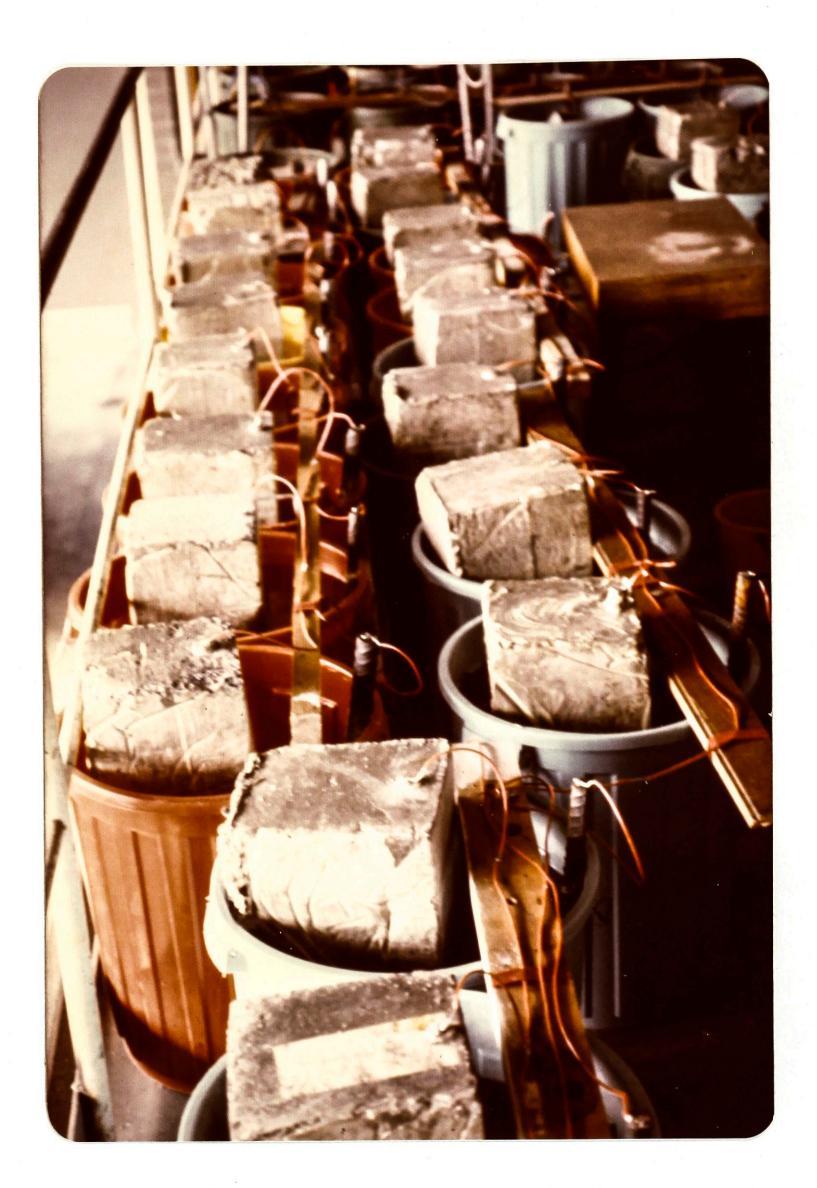
FIGURE 6.1 The accelerated corrosion tests used to determine the corrosion characteristics of different diameter black and galvanized reinforcing bars.

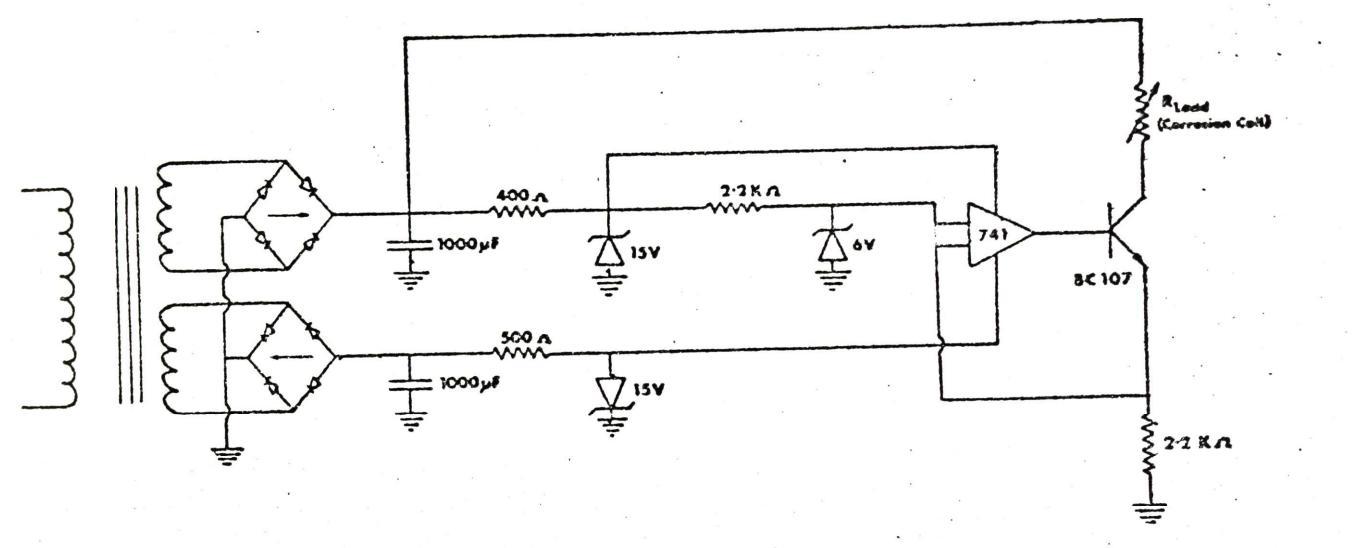
FIGURE 6.2(a) The circuit which provided a constant current for the accelerated corrosion tests.

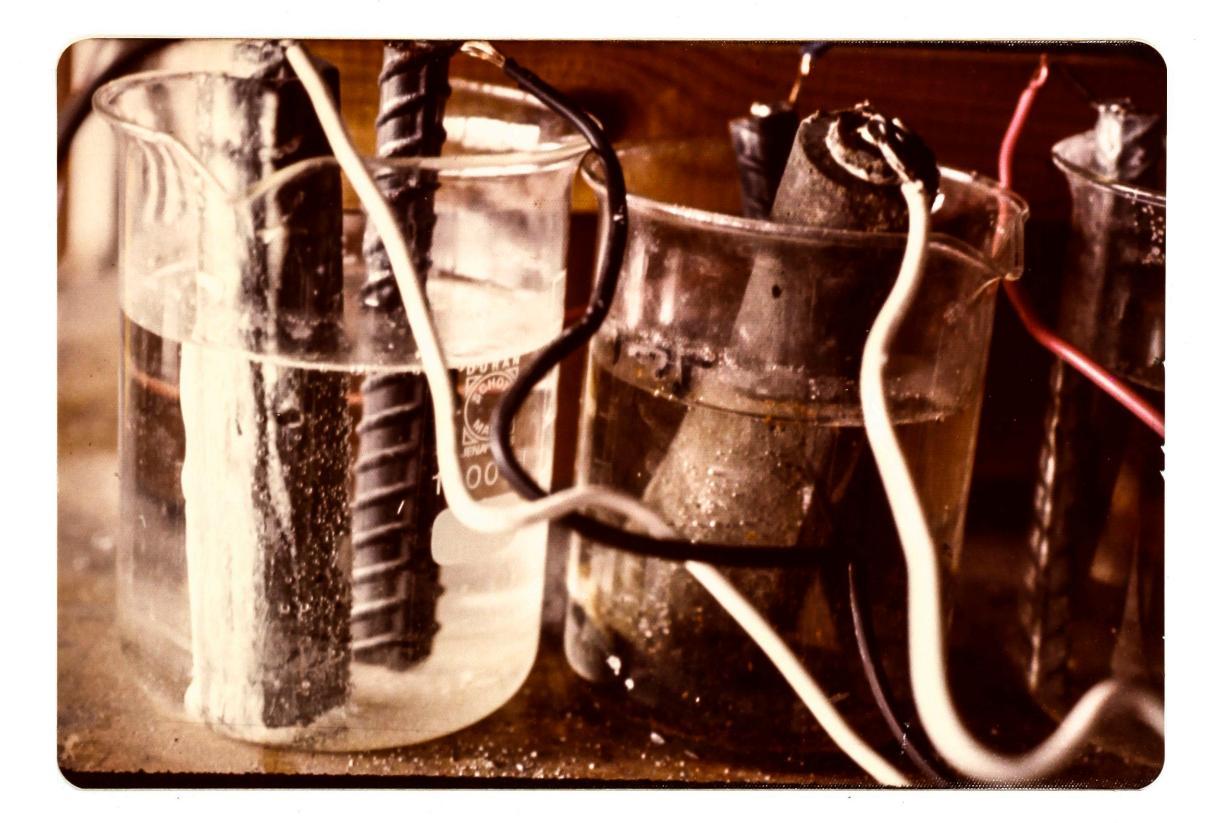
FIGURE 6.3

The accelerated corrosion tests performed to determine and compare the corrosion characteristics of black and galvanized reinforcing bars in the cylindrical concrete beams.

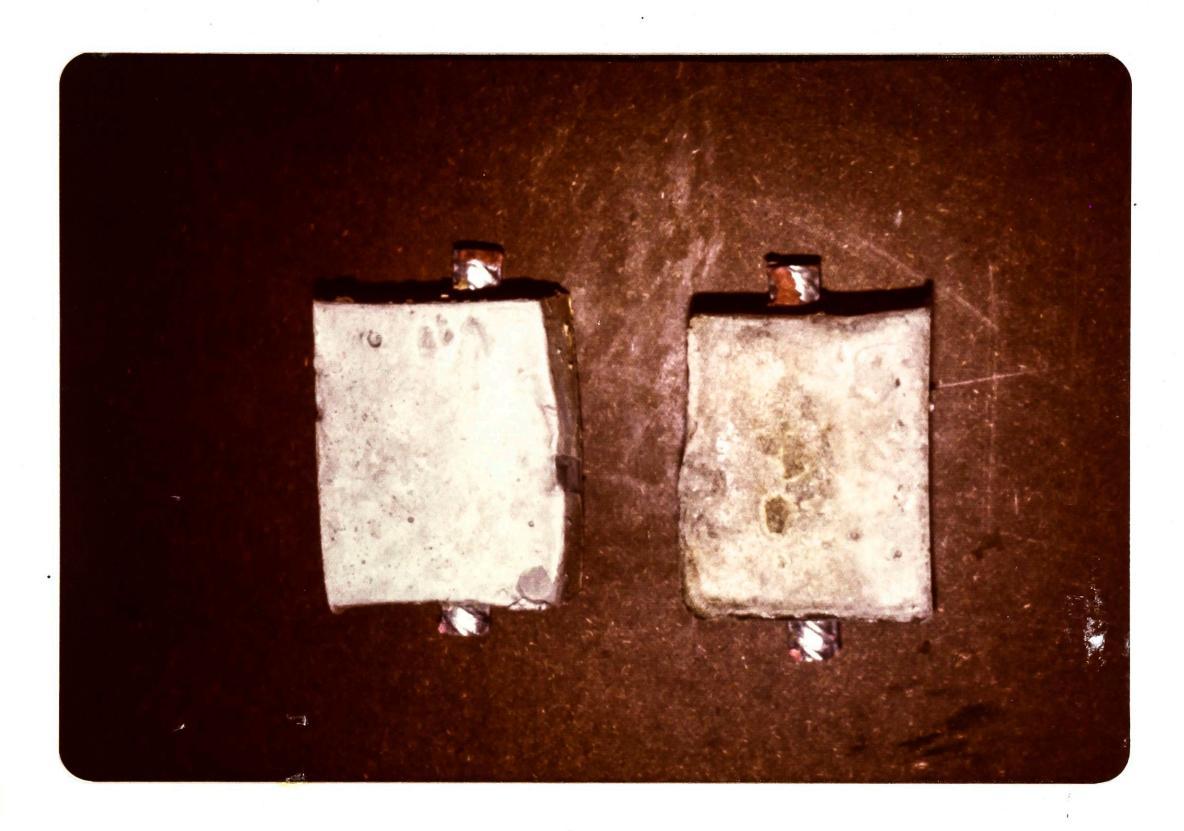
FIGURE 6.4 Concrete blocks with additions of 70 p.p.m. sodium chromate and 70 p.p.m. chromic oxide respectively to determine the effects of these additions on the concrete reinforcing bar interface.

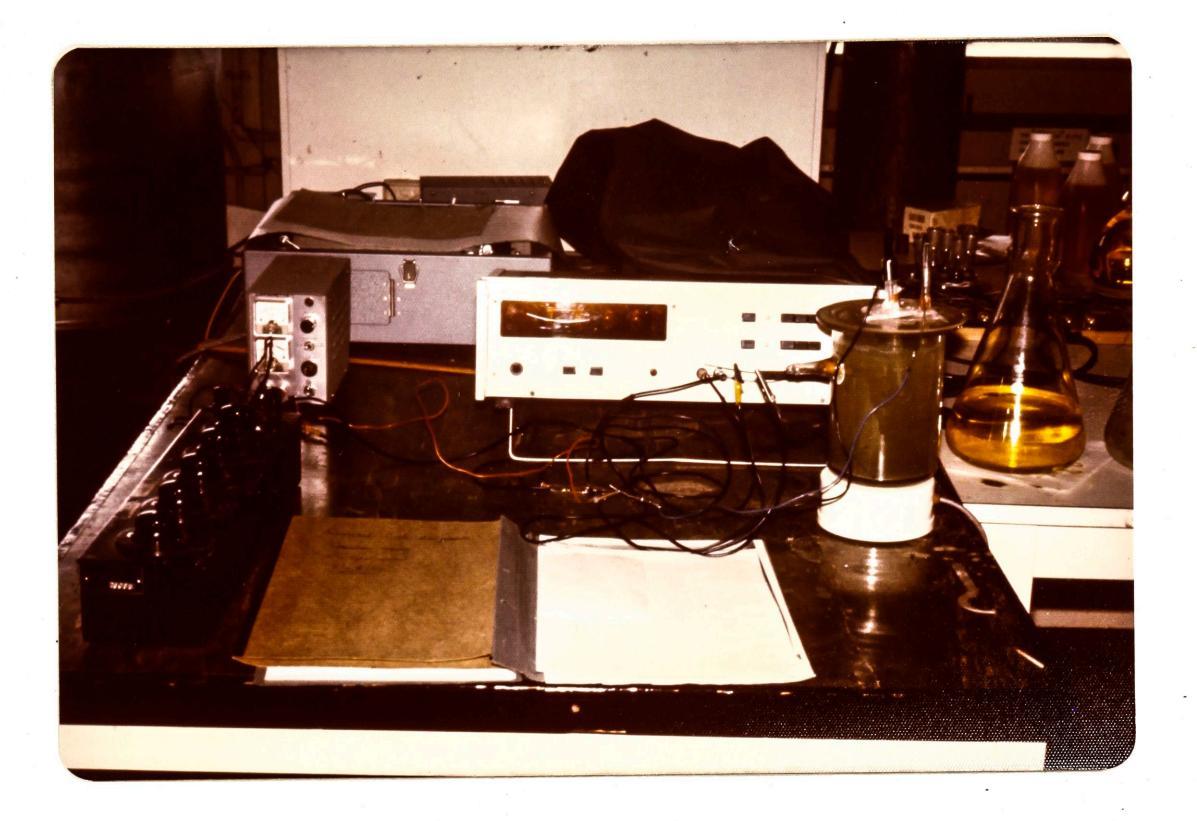
FIGURE 6.5

Equipment used for experiments performed to study the passivity of zinc.

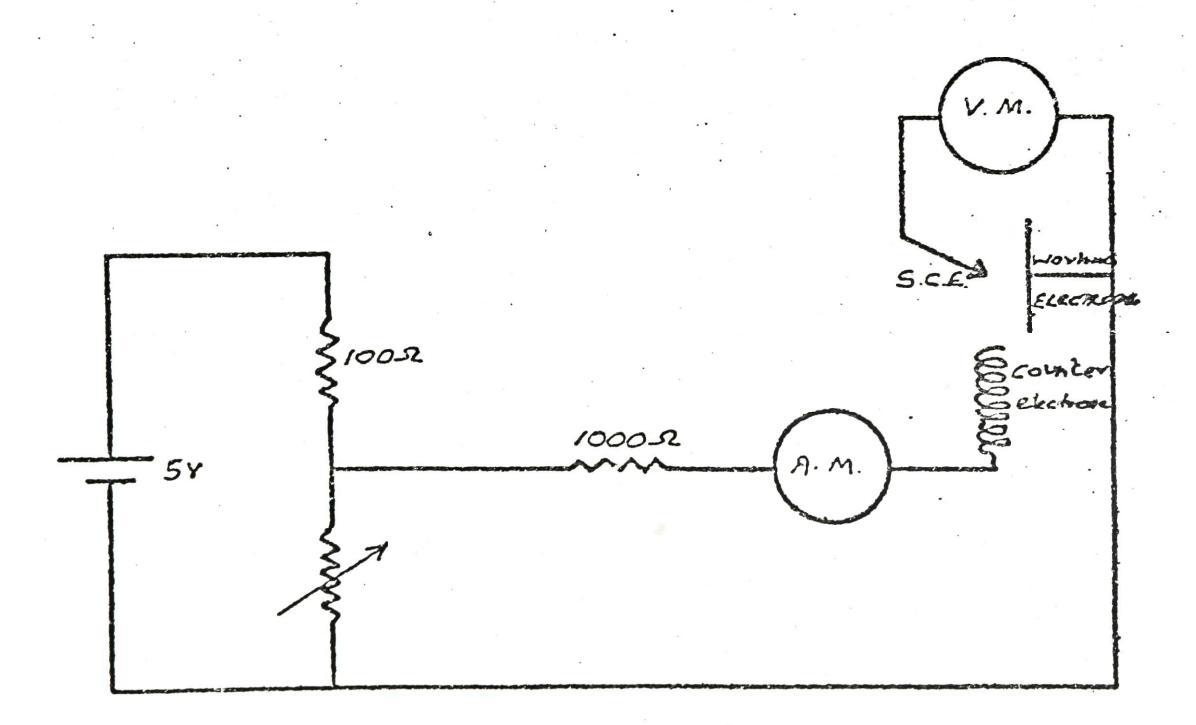
FIGURE 6.6

The circuit used for measuring potential with respect to time, and for performing galvanostatic polarization experiments. The same experiments were performed using 70 p.p.m. and 300 p.p.m. of chromic oxide respectively. Experiments where additions of 70 p.p.m. sodium chromate and 70 p.p.m. chromic oxide were made to the calcium hydroxide solution, were performed on both clean and already passivated zinc electrodes. The electrodes were polished so that a clean equipotential surface was obtained, while the passivated electrodes were the same, except they were allowed to passivate in their respective solutions of calcium hydroxide with either 70 p.p.m. sodium chromate or 70 p.p.m. chromic oxide for five (5) hours. For all these experiments the current through the ammeter was maintained at zero.

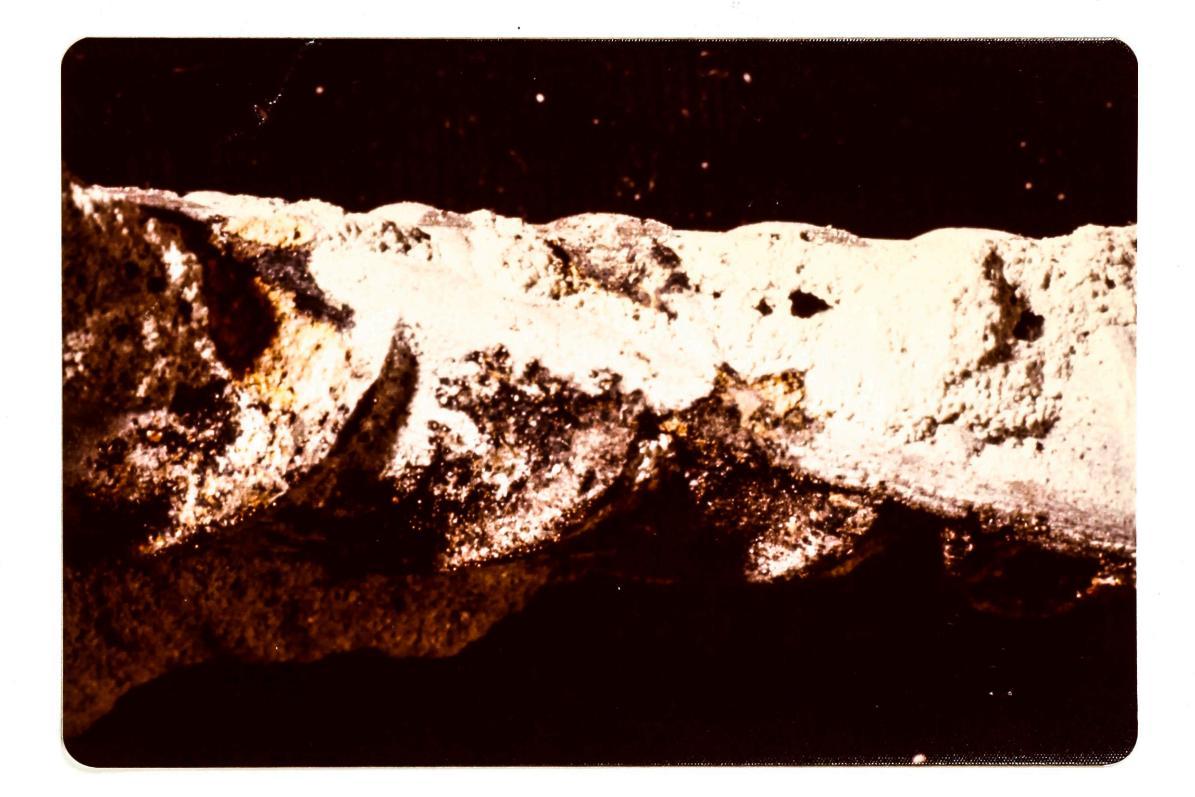
FIGURE 7.1 Corrosion of the 410C 16 mm black reinforcing bar after 4 days exposure to an impressed anodic current where the concrete contained neither sodium chromate nor chromic oxide. of sodium chromate. The same type of stains appeared on this beam as on the first beam. The bar itself corroded more uniformly than the first one, with the most severely attacked areas being on the ridges of the deformation and opposite air voids on the concrete (Figure 7.2). There was a grey film deposited on the reinforcing bars surface and also on the concrete opposite the bar (Figure 7.3), while the concrete opposite the bar of the first cylinder showed rust stains. The time taken for rust stains to appear on the surface of the second concrete cylinder was six (6) days at 52 Amp hours/ m^2 . The third concrete cylinder to show rust stains on its surface was with the deformed structural 230 S black bar. The that concrete contained neither sodium chromate nor chromic oxide and the stains appeared after eleven (11) days or 97.5 Amp hours/ m^2 . Once again the rust stains on the concrete surface were non-uniform, although they were more uniform than those on the previous two cylinders. The stains on the reinforcing bar were relatively uniform and were initiated on ridges at the deformations. A few isolated areas on the reinforcing bar, opposite air voids in the concrete were severely attacked. (Figure 7.4). The stains reinforcing bar and on the concrete opposite the on the reinforcing were red. The fourth cylinder to show rust stains on the concrete surface was that with the deformed structural 230 S black bar and the concrete contained 70 p.p.m. sodium chromate. This occurred after 14 days or 120 Amp hours/m². The rust stains here were more uniform still, while the rust on the reinforcing bar was also relatively uniform (Figure 7.5). A grey film was broken

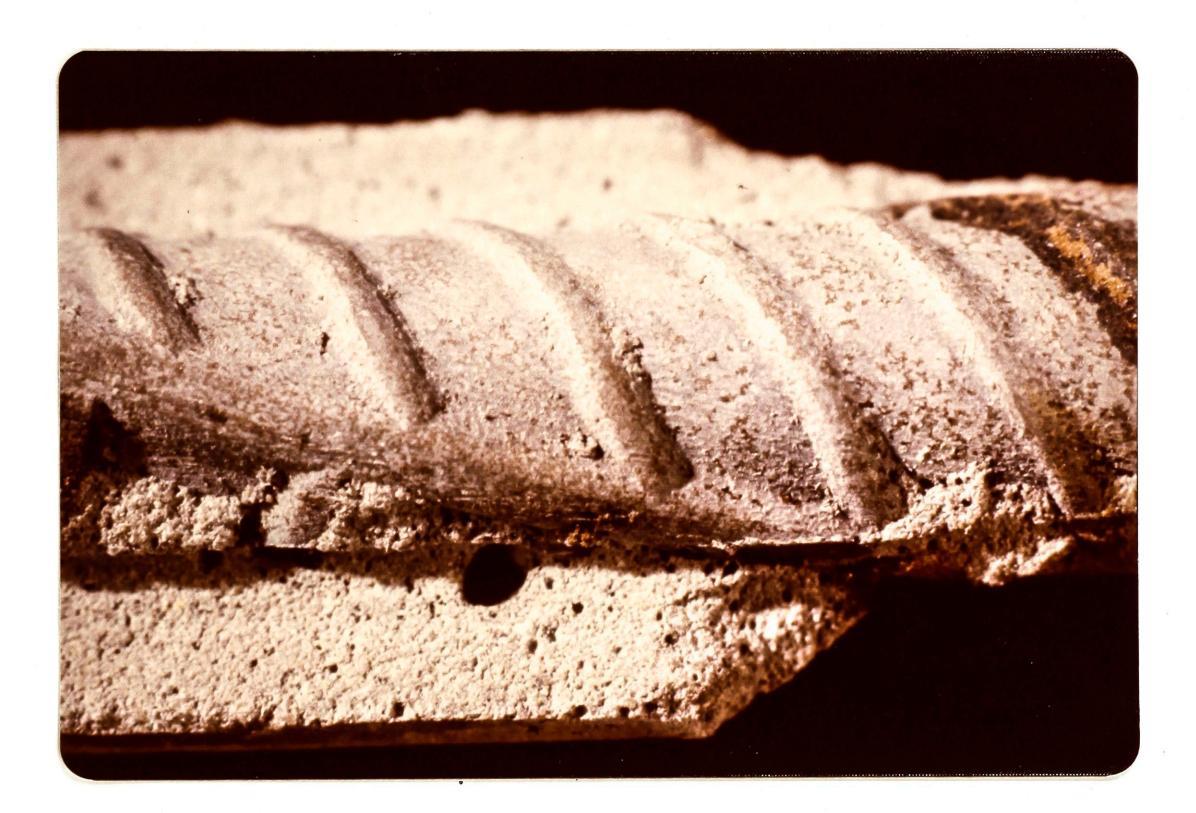
FIGURE 7.2 Corrosion of the 410C 16 mm black reinforcing bar after 6 days exposure to an impressed anodic current, where the concrete contained 70 p.p.m. of sodium chromate.

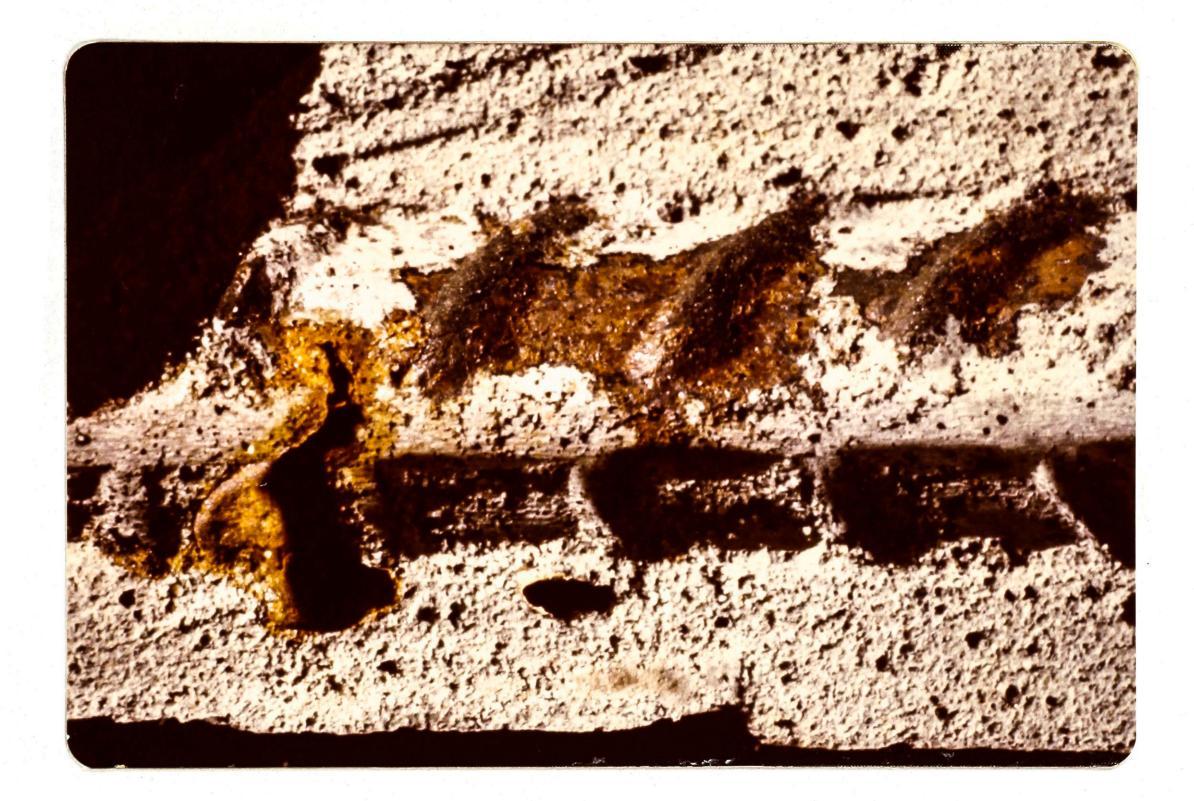
FIGURE 7.3 Corrosion on the concrete, 410C black 16 mm reinforcing bar interface where the cement contained 70 p.p.m. of sodium chromate.

The concrete cylinders with the deformed structural 230 S bars in the galvanized condition showed no signs of rust staining after 21 days. On splitting the concrete cylinders open, the galvanized bar in the concrete cylinder containing no sodium chromate or chromic oxide showed a thick layer of white corrosion products on its surface (Figure 7.6) and in some isolated spots some red iron oxide was coming through the white corrosion product layer (Figure 7.7). A concrete cylinder with a deformed structural 230 S reinforcing bar in the galvanized condition and the concrete containing 70 p.p.m. sodium chromate was split open. Once again a layer of white corrosion products was present but these were quite non-uniform and formed where a grey film was broken (Figure 7.8). The concrete interface had a similar appearance to the interface in Figure 7.3.

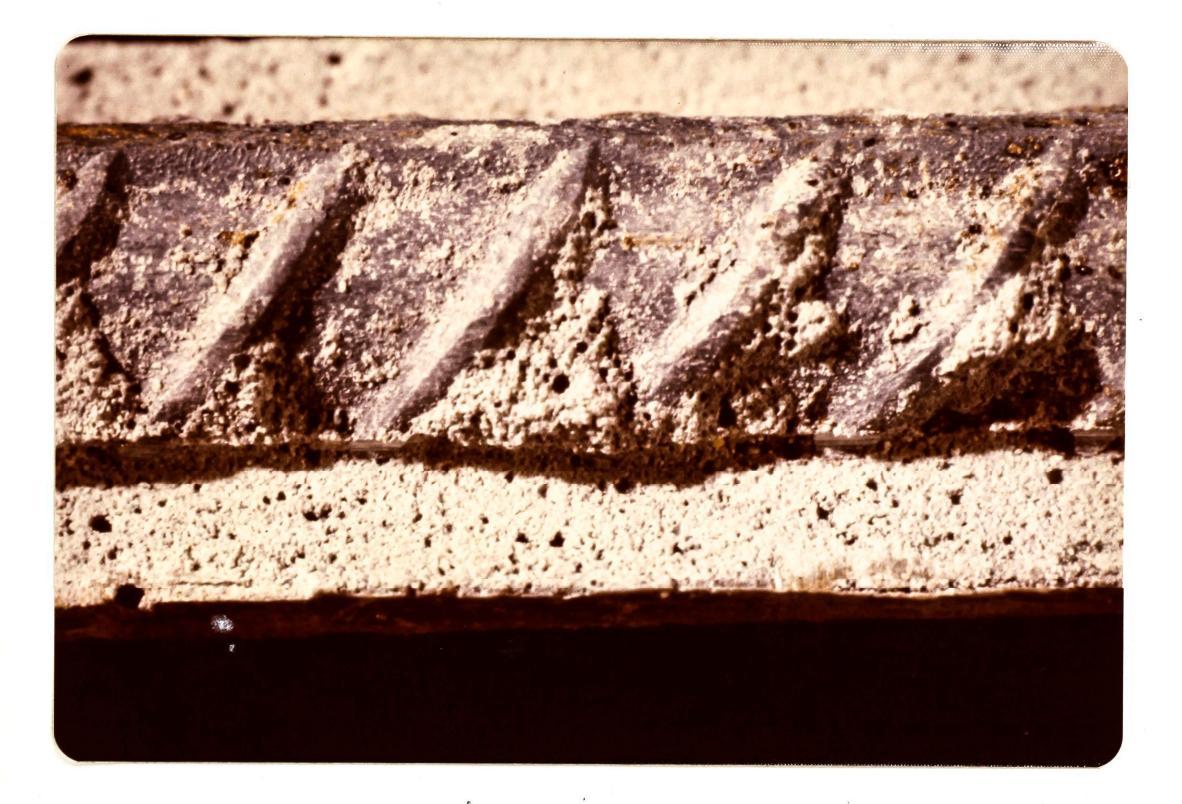
7.4 Corrosion of the 230 S 16 mm black reinforcing bar after 11 days exposure to an impressed anodic current where the concrete contained neither sodium chromate nor chromic oxide.
