The corrosion characteristics of galvanized reinforcing bars

THESIS

FOR THE DEGREE OF MASTER OF ENGINEERING

HENRY HERZOG, B.E December, 1976

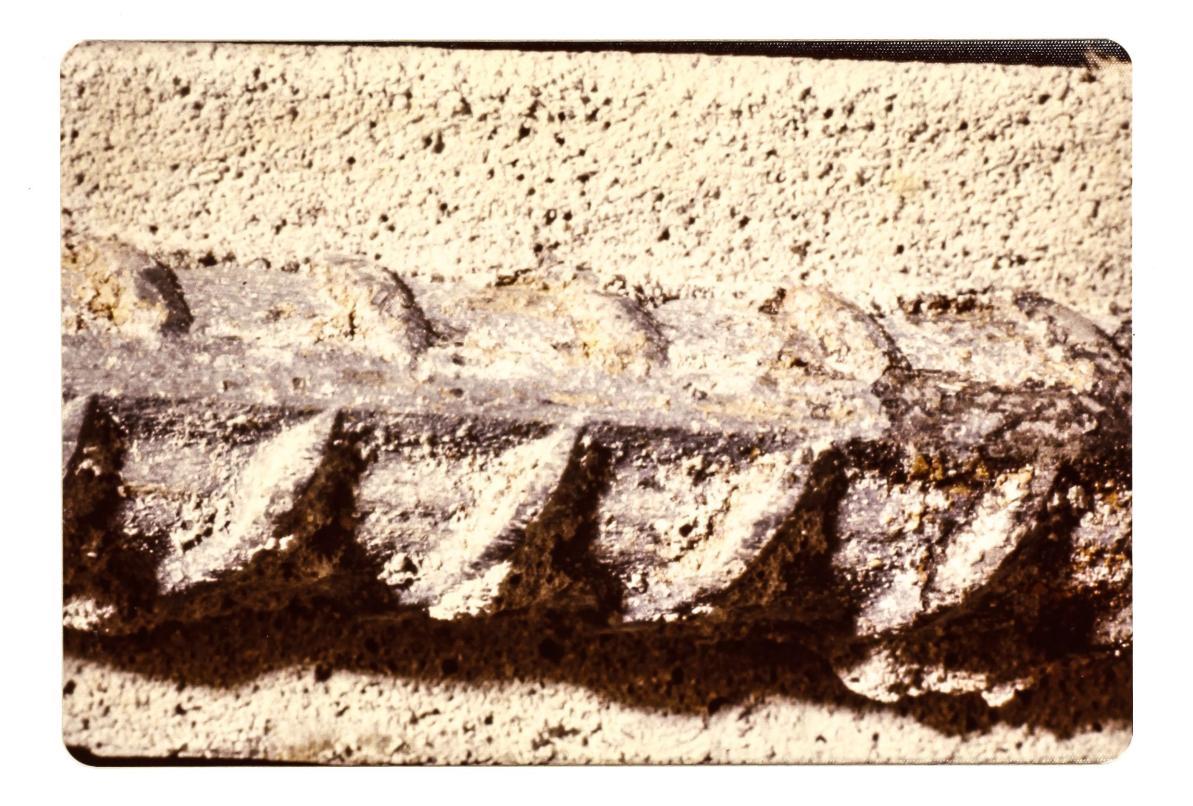
FIGURE 7.5 Corrosion of the 230S 16 mm reinforcing bar after 14 days exposure to an impressed anodic current where the concrete contained neither sodium chromate nor chromic oxide. where corrosion occurred and this was mainly on the ridges of the deformations.

FIGURE 7.1 Corrosion of the 410C 16 mm black reinforcing bar after 4 days exposure to an impressed anodic current where the concrete contained neither sodium chromate nor chromic oxide. of sodium chromate. The same type of stains appeared on this beam as on the first beam. The bar itself corroded more uniformly than the first one, with the most severely attacked areas being on the ridges of the deformation and opposite air voids on the concrete (Figure 7.2). There was a grey film deposited on the reinforcing bars surface and also on the concrete opposite the bar (Figure 7.3), while the concrete opposite the bar of the first cylinder showed rust stains. The time taken for rust stains to appear on the surface of the second concrete cylinder was six (6) days at 52 Amp hours/ m^2 . The third concrete cylinder to show rust stains on its surface was with the deformed structural 230 S black bar. The that concrete contained neither sodium chromate nor chromic oxide and the stains appeared after eleven (11) days or 97.5 Amp hours/ m^2 . Once again the rust stains on the concrete surface were non-uniform, although they were more uniform than those on the previous two cylinders. The stains on the reinforcing bar were relatively uniform and were initiated on ridges at the deformations. A few isolated areas on the reinforcing bar, opposite air voids in the concrete were severely attacked. (Figure 7.4). The stains reinforcing bar and on the concrete opposite the on the reinforcing were red. The fourth cylinder to show rust stains on the concrete surface was that with the deformed structural 230 S black bar and the concrete contained 70 p.p.m. sodium chromate. This occurred after 14 days or 120 Amp hours/m². The rust stains here were more uniform still, while the rust on the reinforcing bar was also relatively uniform (Figure 7.5). A grey film was broken

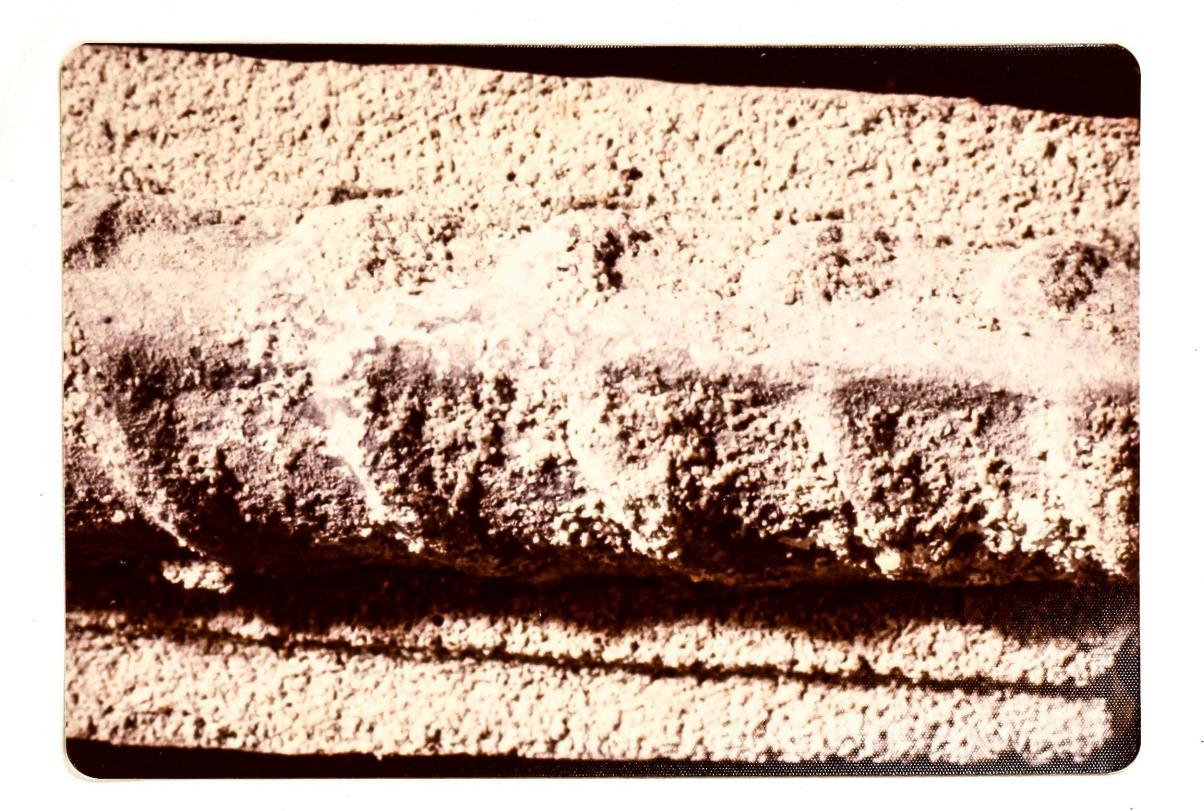
FIGURE 7.6 Corrosion of the 230 S galvanized 16 mm reinforcing bar after 21 days exposure to an impressed anodic current where the cement contained neither sodium chromate nor chromic oxide.

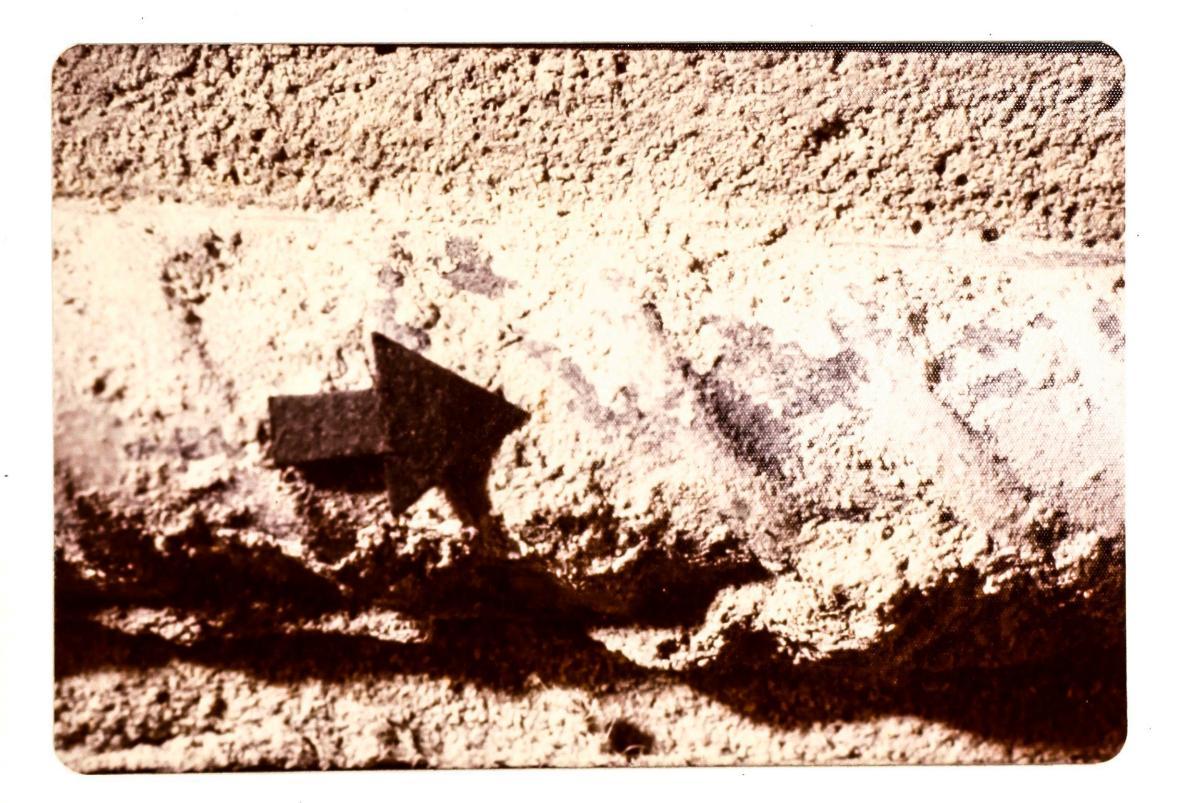
FIGURE 7.7 Corrosion of the 230 S galvanized 16 mm reinforcing bar under the same conditions as those in Figure 7.6, here there are no signs of rust formation.

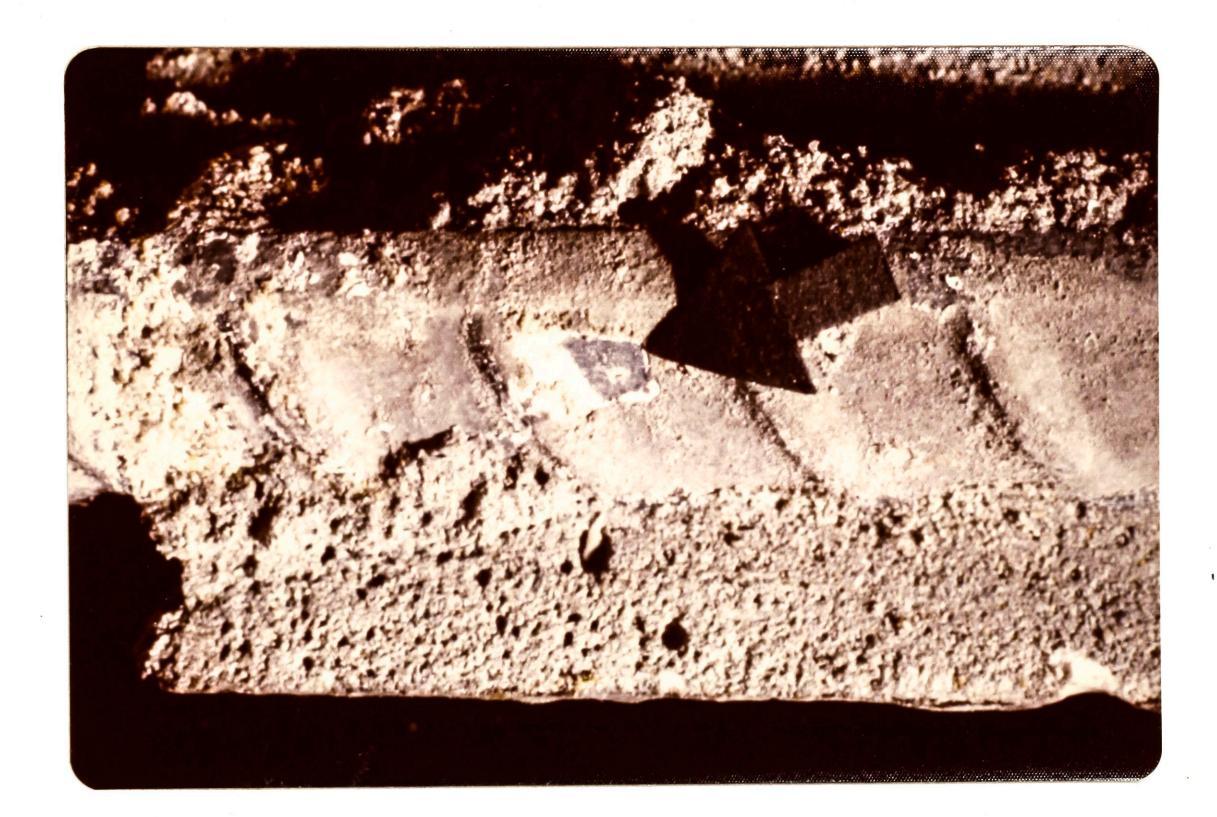
FIGURE 7.8 Corrosion of the 230 S 16 mm galvanized reinforcing bar after 21 days exposure to an impressed anodic current where the concrete contained 70 p.p.m. of sodium chromate.

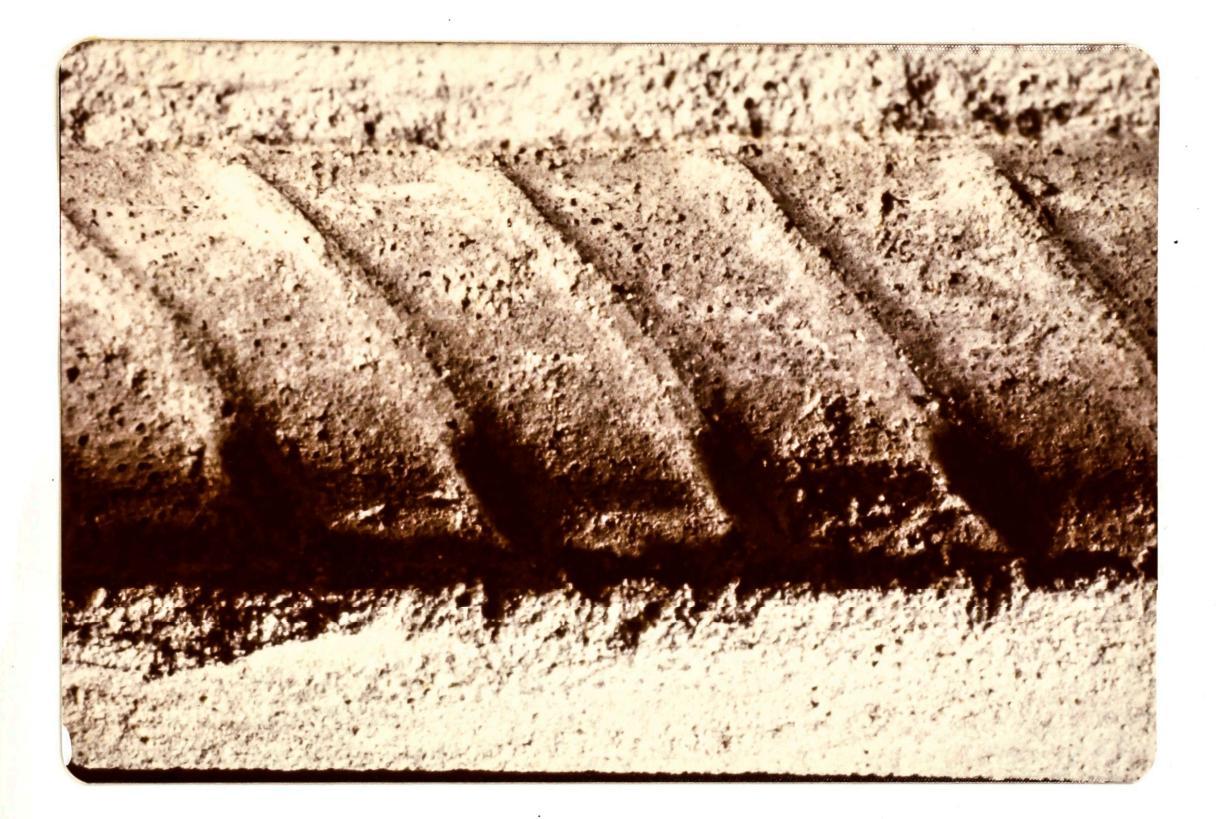
FIGURE 7.9 Concrete surface of concrete galvanized reinforcing bar interface where 70 p.p.m. of chromic oxide was added.

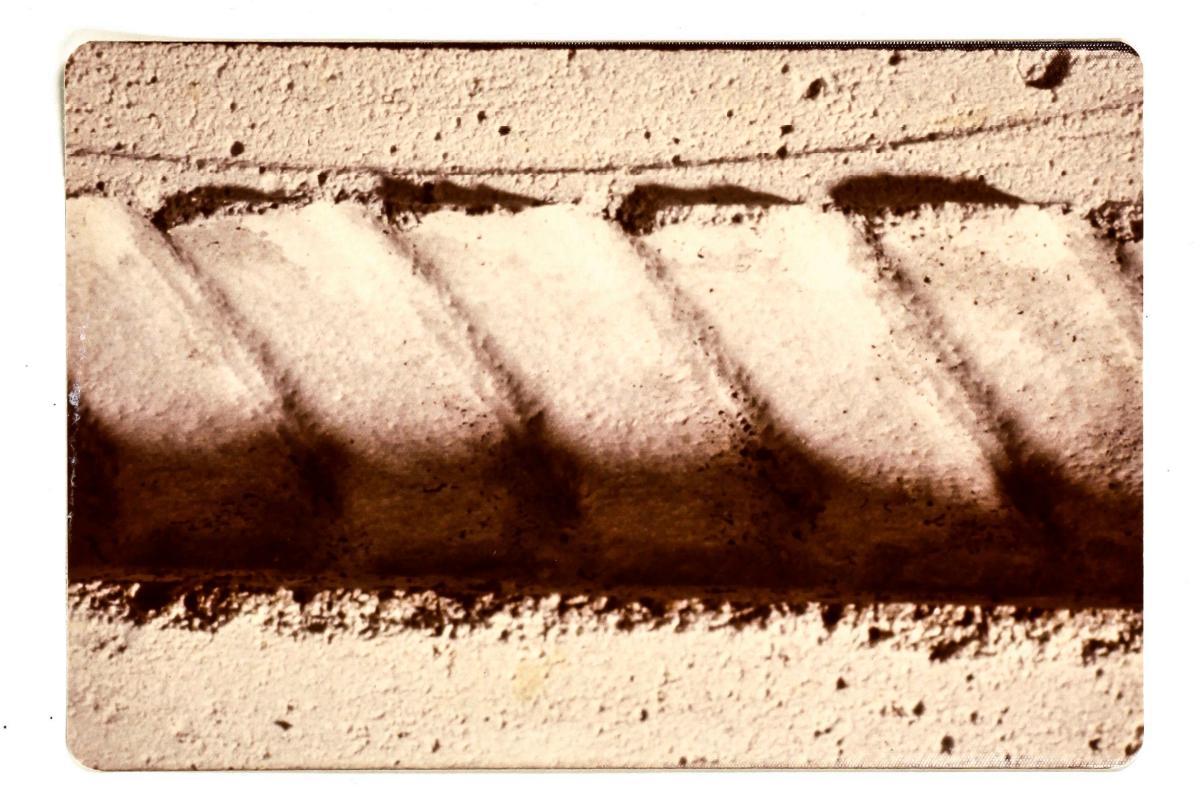
FIGURE 7.10 Concrete surface of concrete galvanized reinforcing bar interface where 70 p.p.m. of sodium chromate was added. nor chromic oxide was added was the most porous (Figure 7.11).

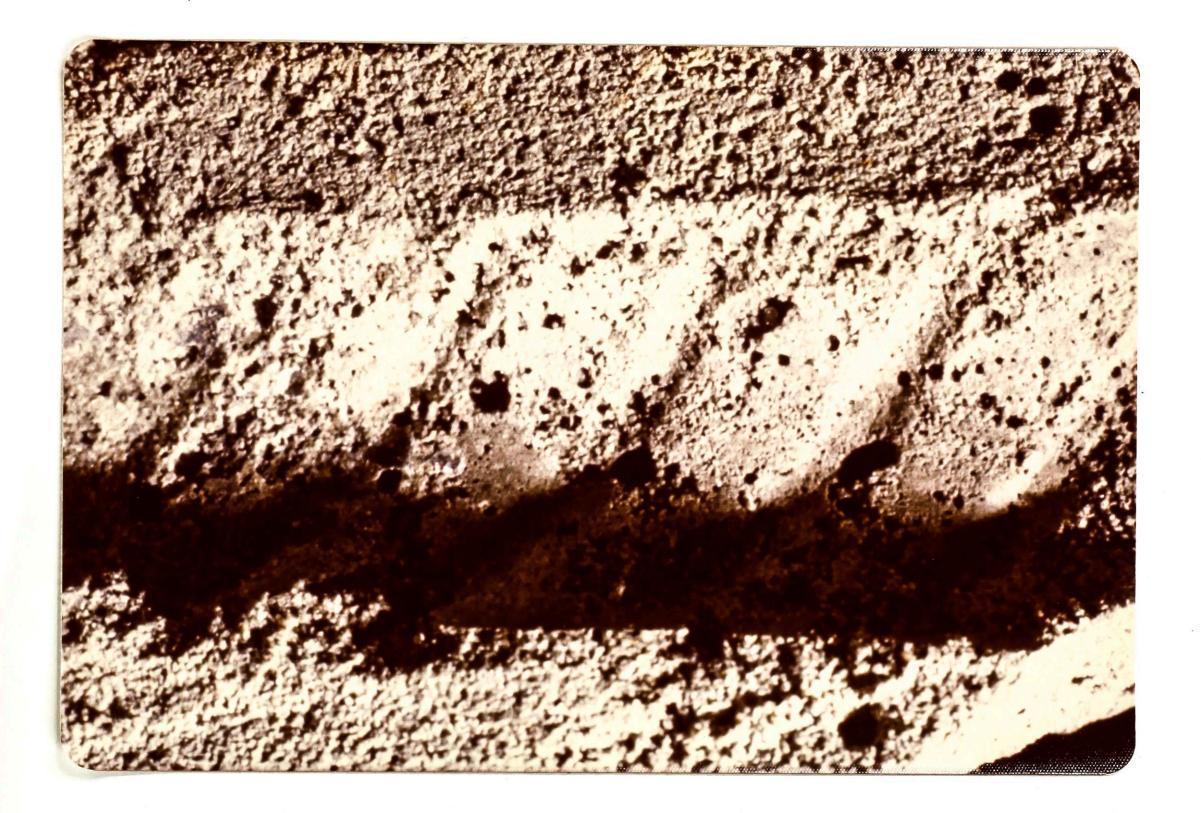
FIGURE 7.11 Concrete surface of concrete galvanized reinforcing bar interface where neither sodium chromate nor chromic oxide were added to the concrete.

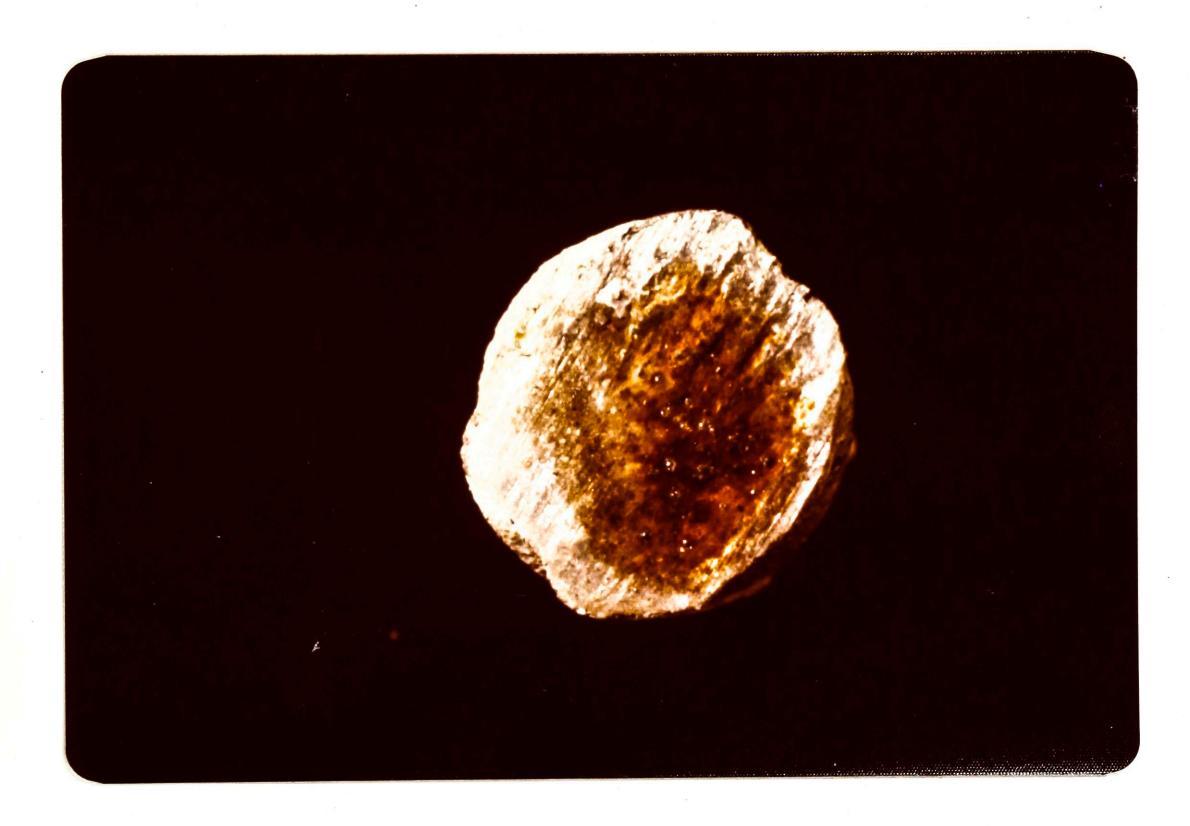
FIGURE 7.12 Section of a 16 mm diameter galvanized reinforcing bar showing rust formation after 6 weeks exposure to a natural corrosive environment.

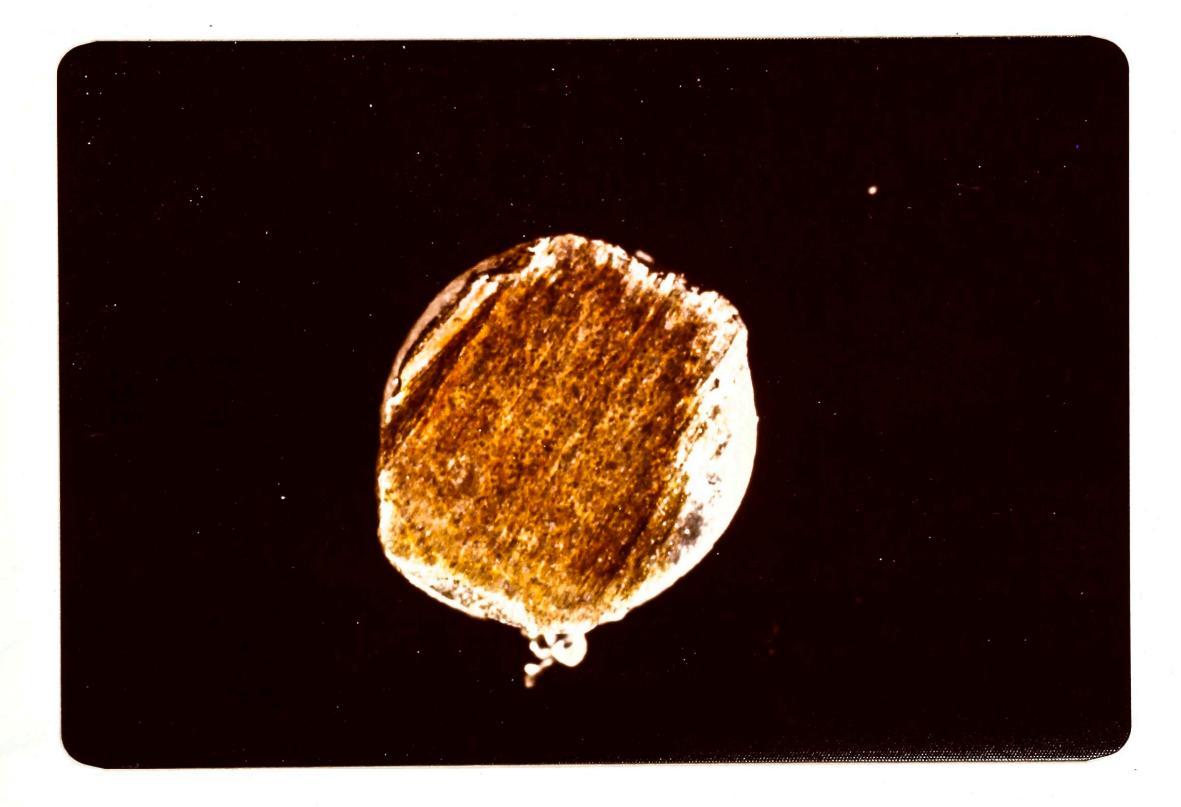
FIGURE 7.13 Section of a 16 mm diameter galvanized reinforcing bar showing corrosion products after 16 weeks exposure to a natural corrosive environment.

A 16mm diameter deformed structural 230 S reinforcing bar in the galvanized condition was exposed to a natural corrosion environment for sixteen (16) weeks. The reinforcing bar was placed against a support such that it was resting in a sloping position. Both ends of the bar were cut off so that the steel was exposed with a thin zinc layer around the The natural corrosion environment was on the perimeter. University of New South Wales lower campus. The purpose of this exercise was to observe the sacrificial protection properties at hot dip galvanizing of reinforcing bars. After six (6) weeks exposure there was a considerable amount of red iron oxide in the centre of the end steel section, while the area around it and the perimeter of the bar was clean (Figure 7.12). After sixteen (16) weeks the appearance of the end at the bar changed quite considerably. The iron oxide in the centre of the steel section thickened and spread out to the perimeter of the bar. There was little iron oxide present at the outermost part of the perimeter but instead a deposit of white corrosion product was present (Figure 7.13).

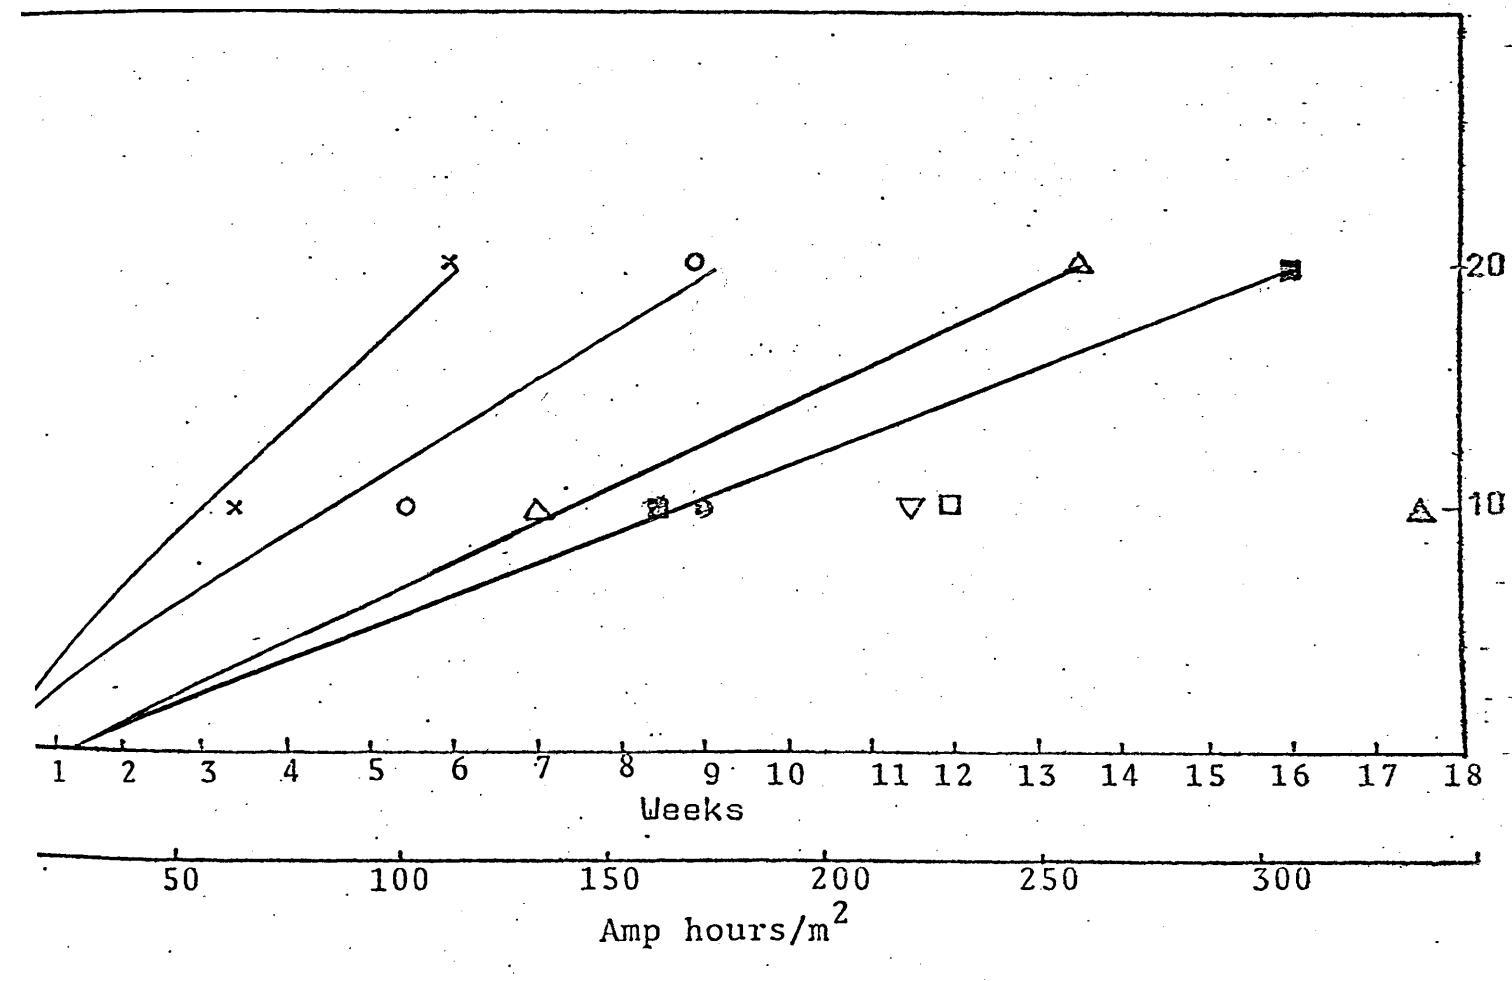
x	16 mm	410C	black	a	20 mm	410C	black
0	16 mm	2305	black	a	20 mm	2305	black
Δ	16 mm	410C	galvanized	A	20 mm	410C	galvanized
٥	16 mm	230S	galvanized	∇	28 mm	410C	black .
				•

RE 7.14 Time taken for corroding reinforcing bars to stain the concrete surface after exposure to impressed anodic current.

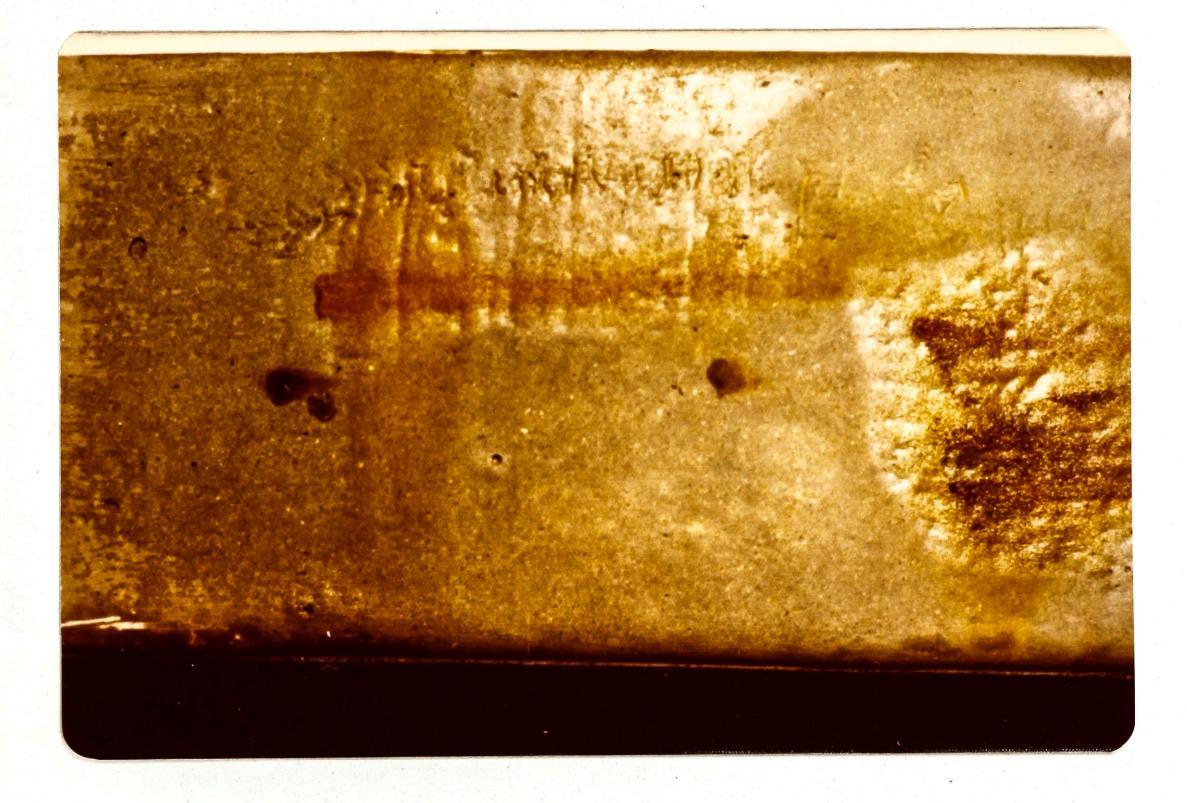
FIGURE 7.15 Rust stains on the surface of a concrete beam reinforced with a 410C 16 mm black reinforcing beam.

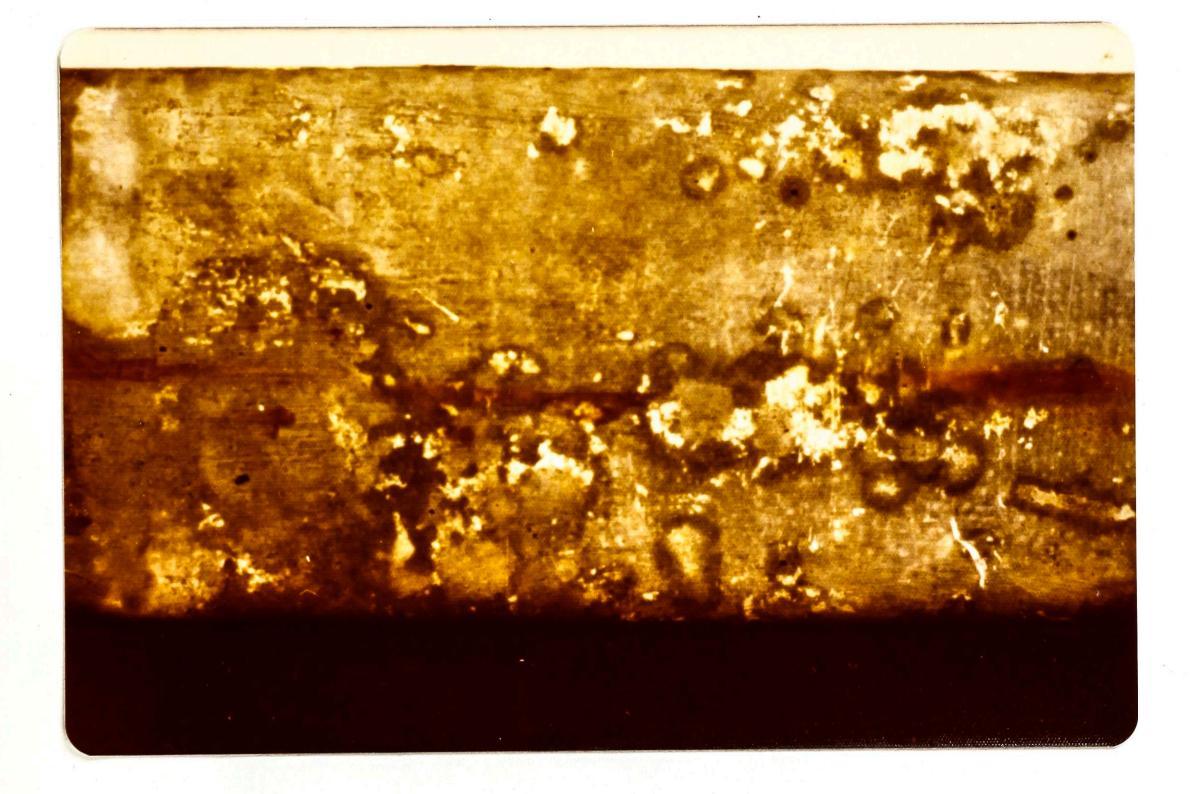
FIGURE 7.16 Rust stains on the surface of a concrete beam reinforced with a 230S 16 mm black reinforcing bar.

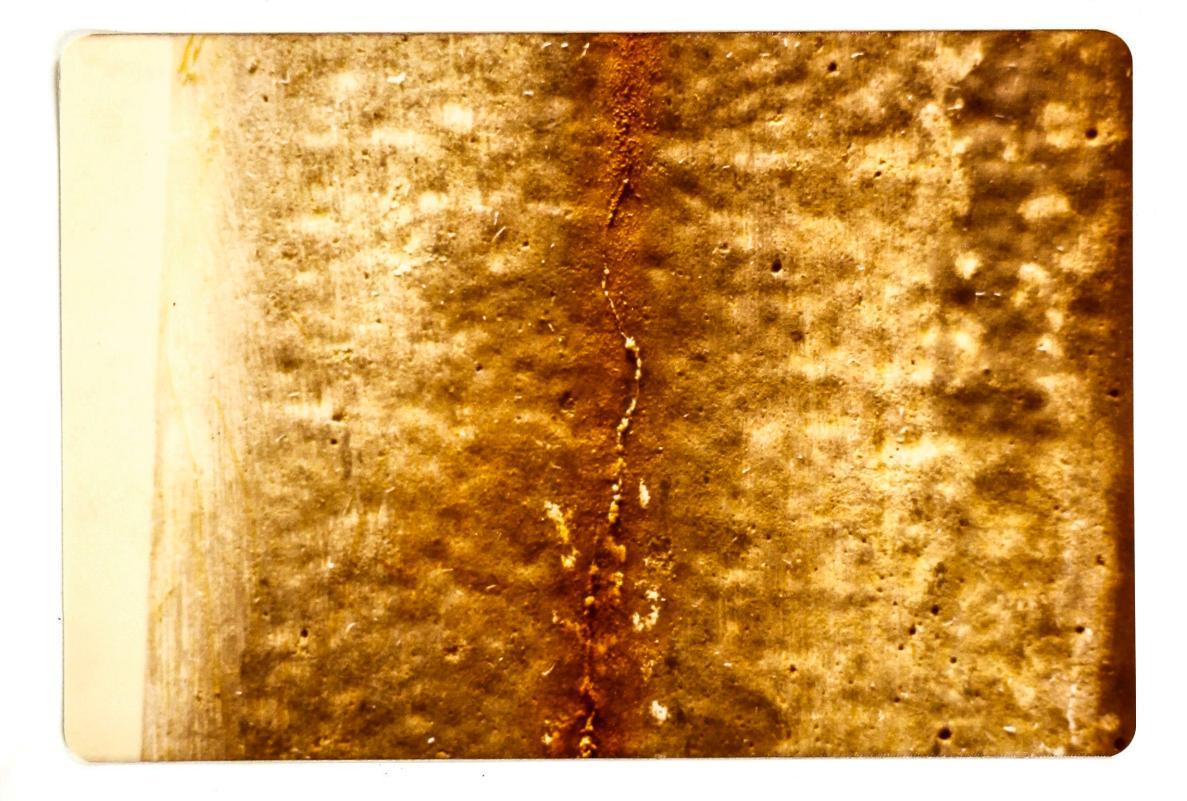
FIGURE 7.17 Longitudinal rust stains on the surface of a concrete beam reinforced with a 410C 16 mm galvanized reinforcing bar.

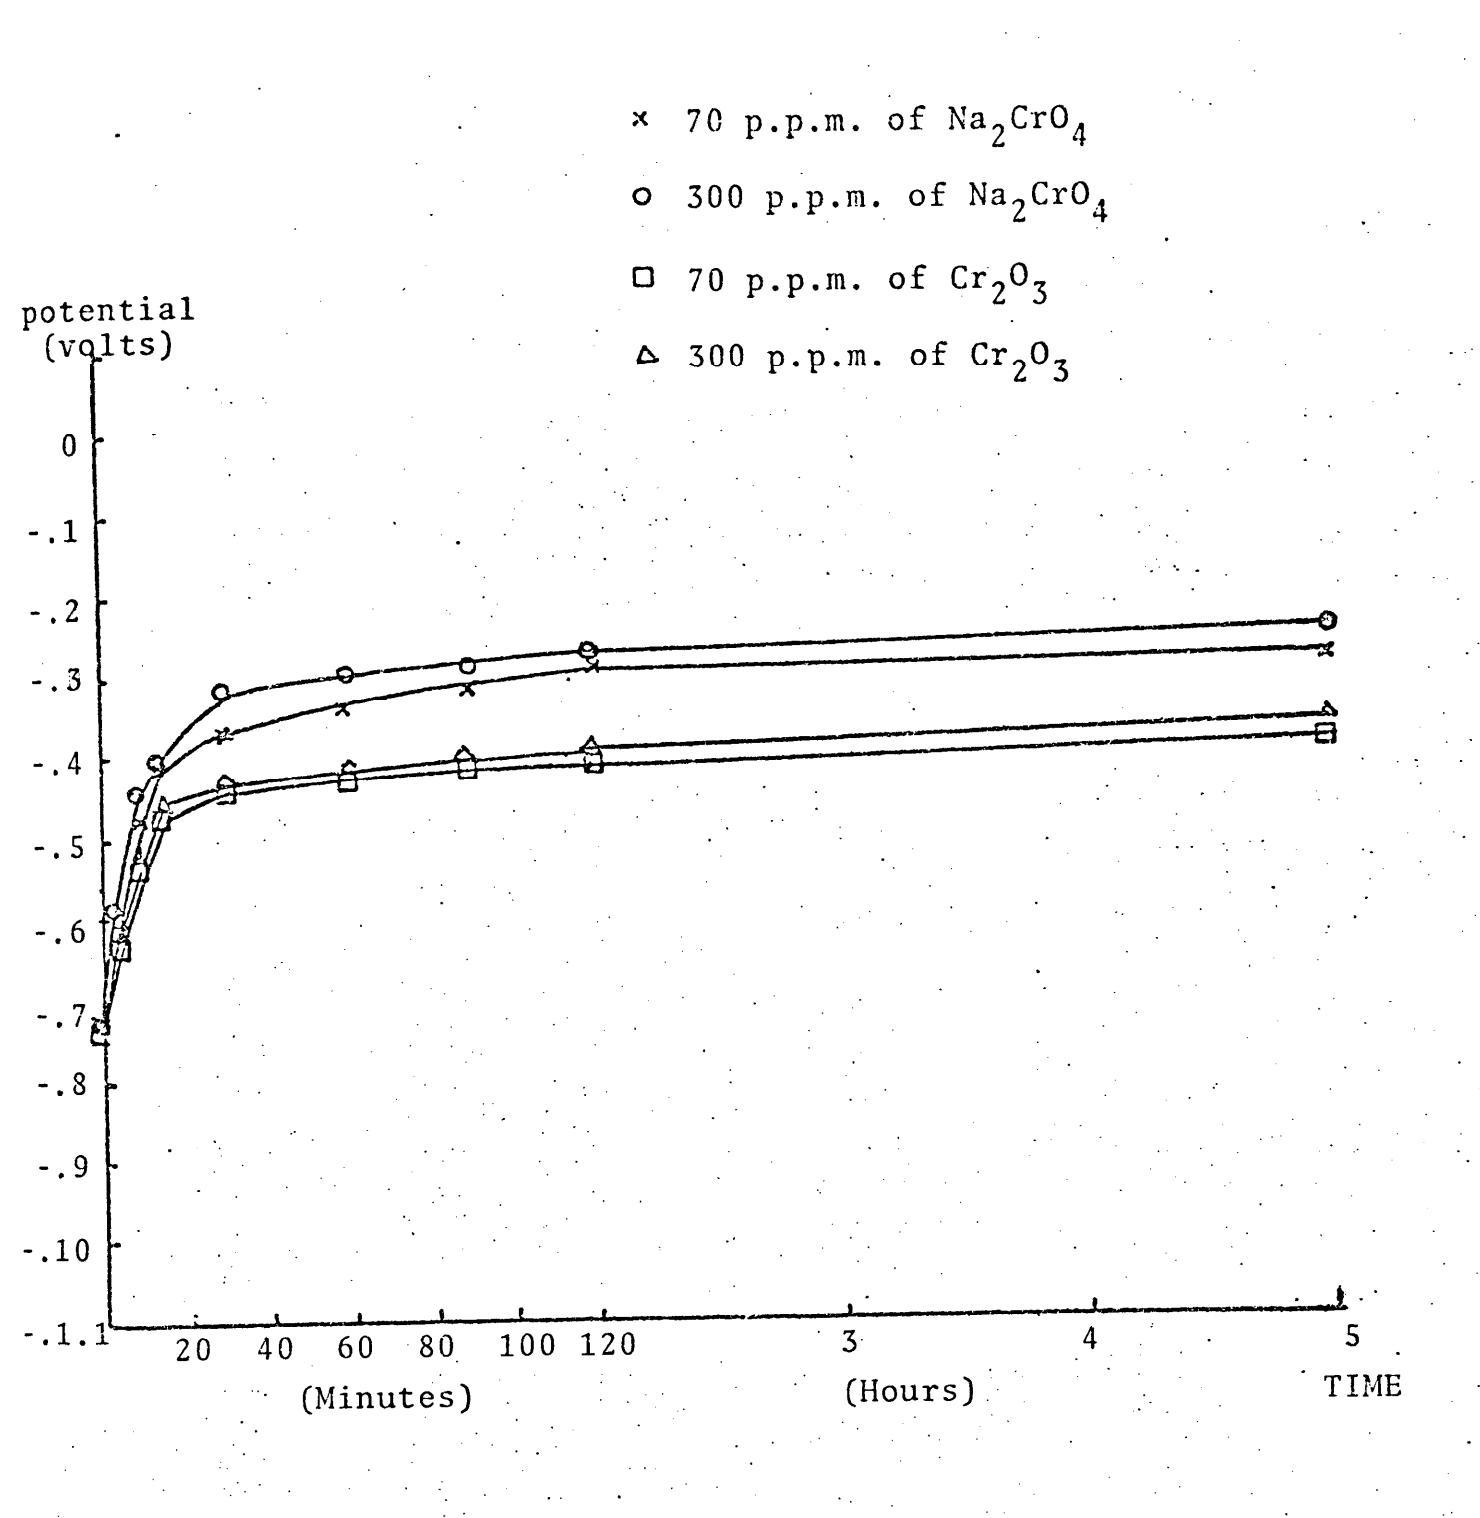
FIGURE 7.18 Measurements of potential with respect to time of zinc in a saturated calcium hydroxide solution with additions of different amounts of sodium chromate and chromic oxide.

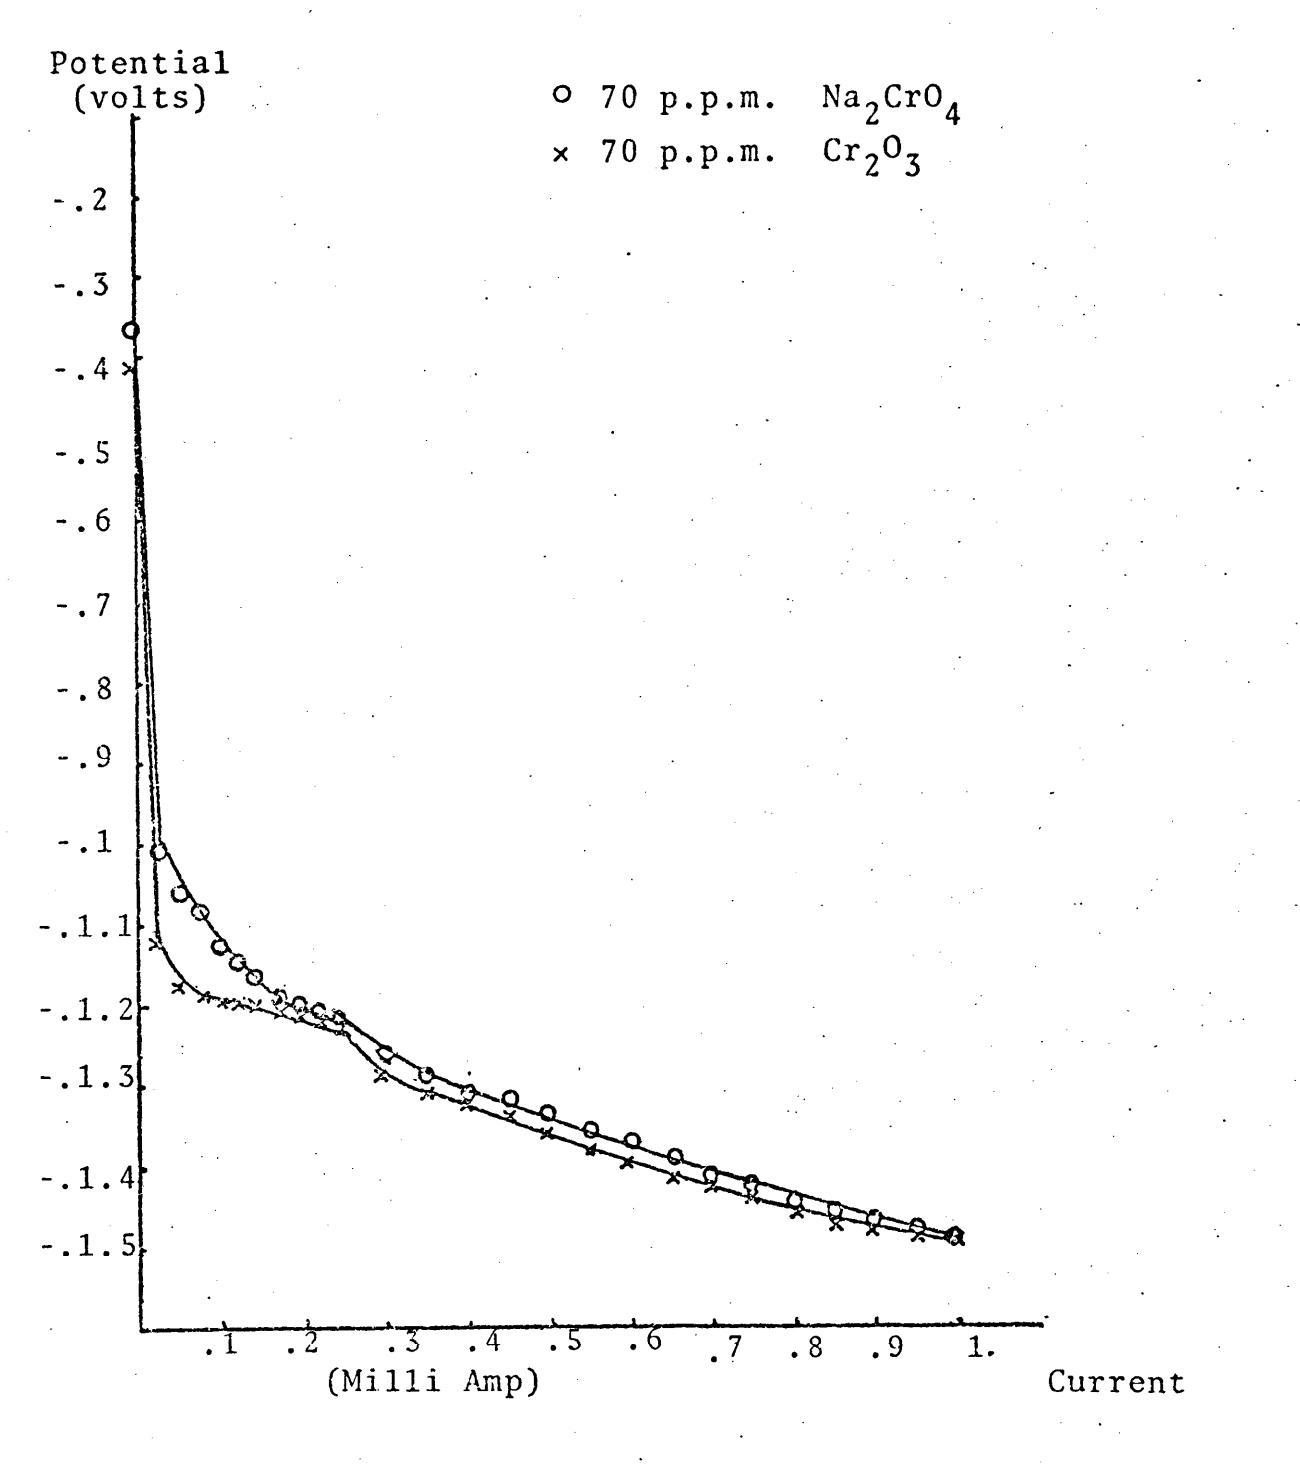
FIGURE 7.19 Measurement of potential with respect to current of zinc in a saturated calcium hydroxide solution with additions; sodium chromate and chromic oxide.

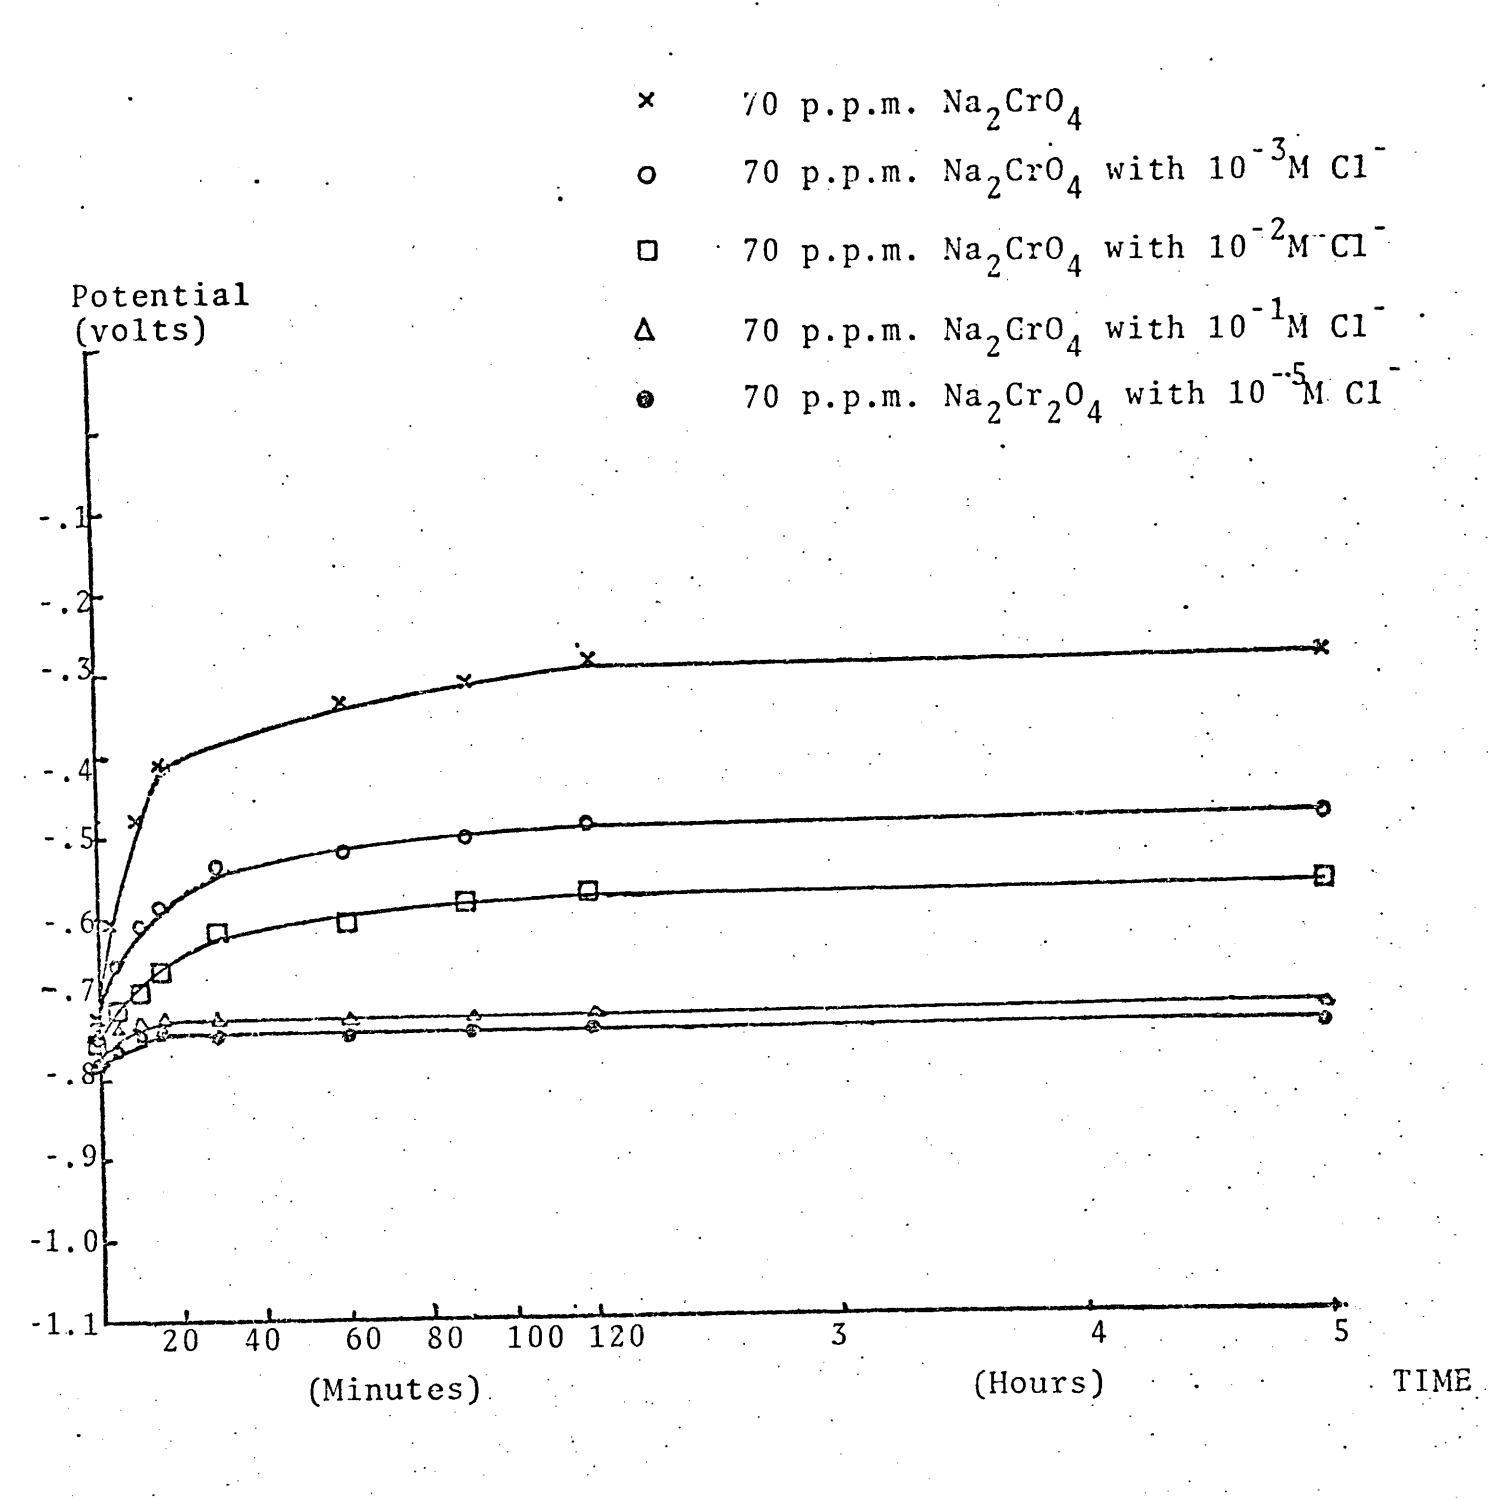
FIGURE 7.20

Measurements of potential with respect to time of zinc in a saturated calcium hydroxide solution with a 70 p.p.m. addition of sodium chromate and different additions of sodium chloride.

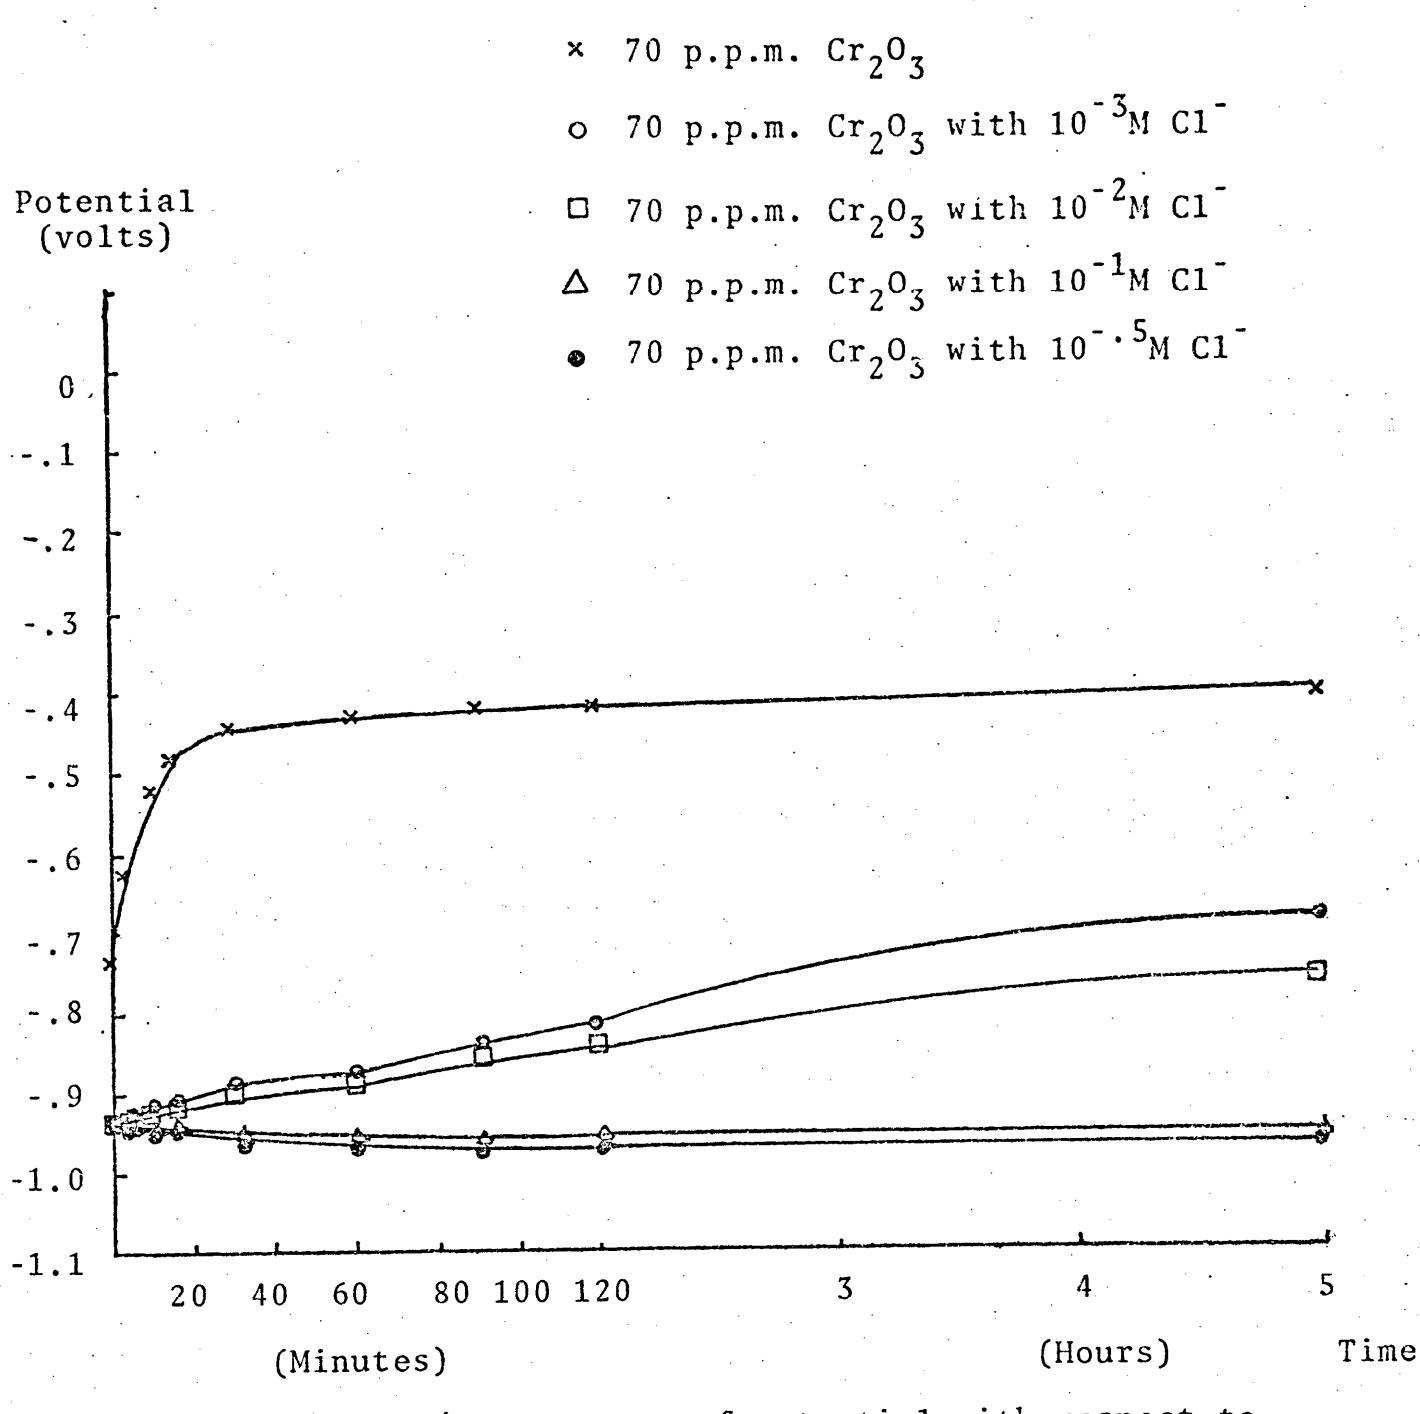
Measurements of potential with respect to time of zinc in a saturated calcium hydroxide solution with a 70 p.p.m. addition of chromic oxide and different additions of sodium chloride.
