The corrosion characteristics of galvanized reinforcing bars

THESIS

FOR THE DEGREE OF MASTER OF ENGINEERING

HENRY HERZOG, B.E December, 1976

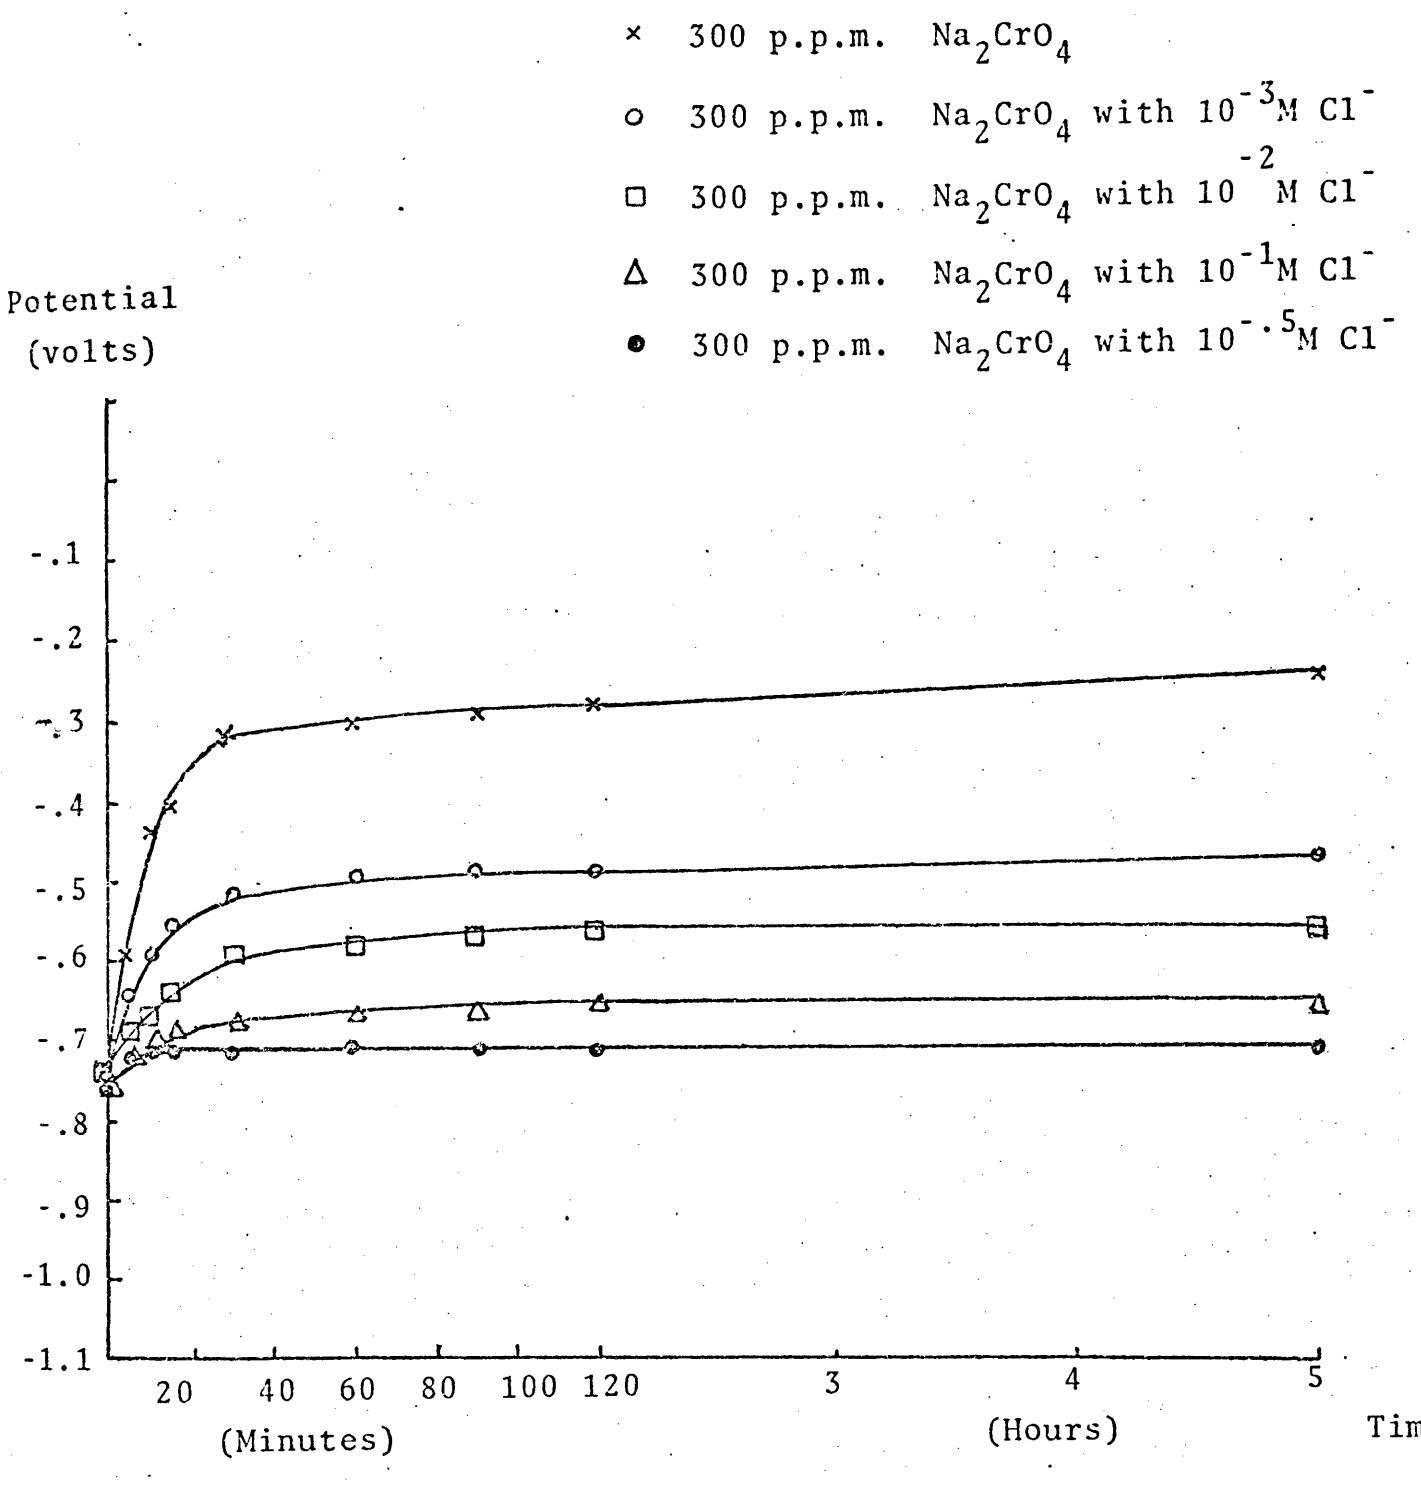
Measurements of potential with respect to time of zinc in a saturated calcium hydroxide solution with FIGURE 7.22 300 p.p.m. addition of sodium chromate and different additions of sodium chloride.

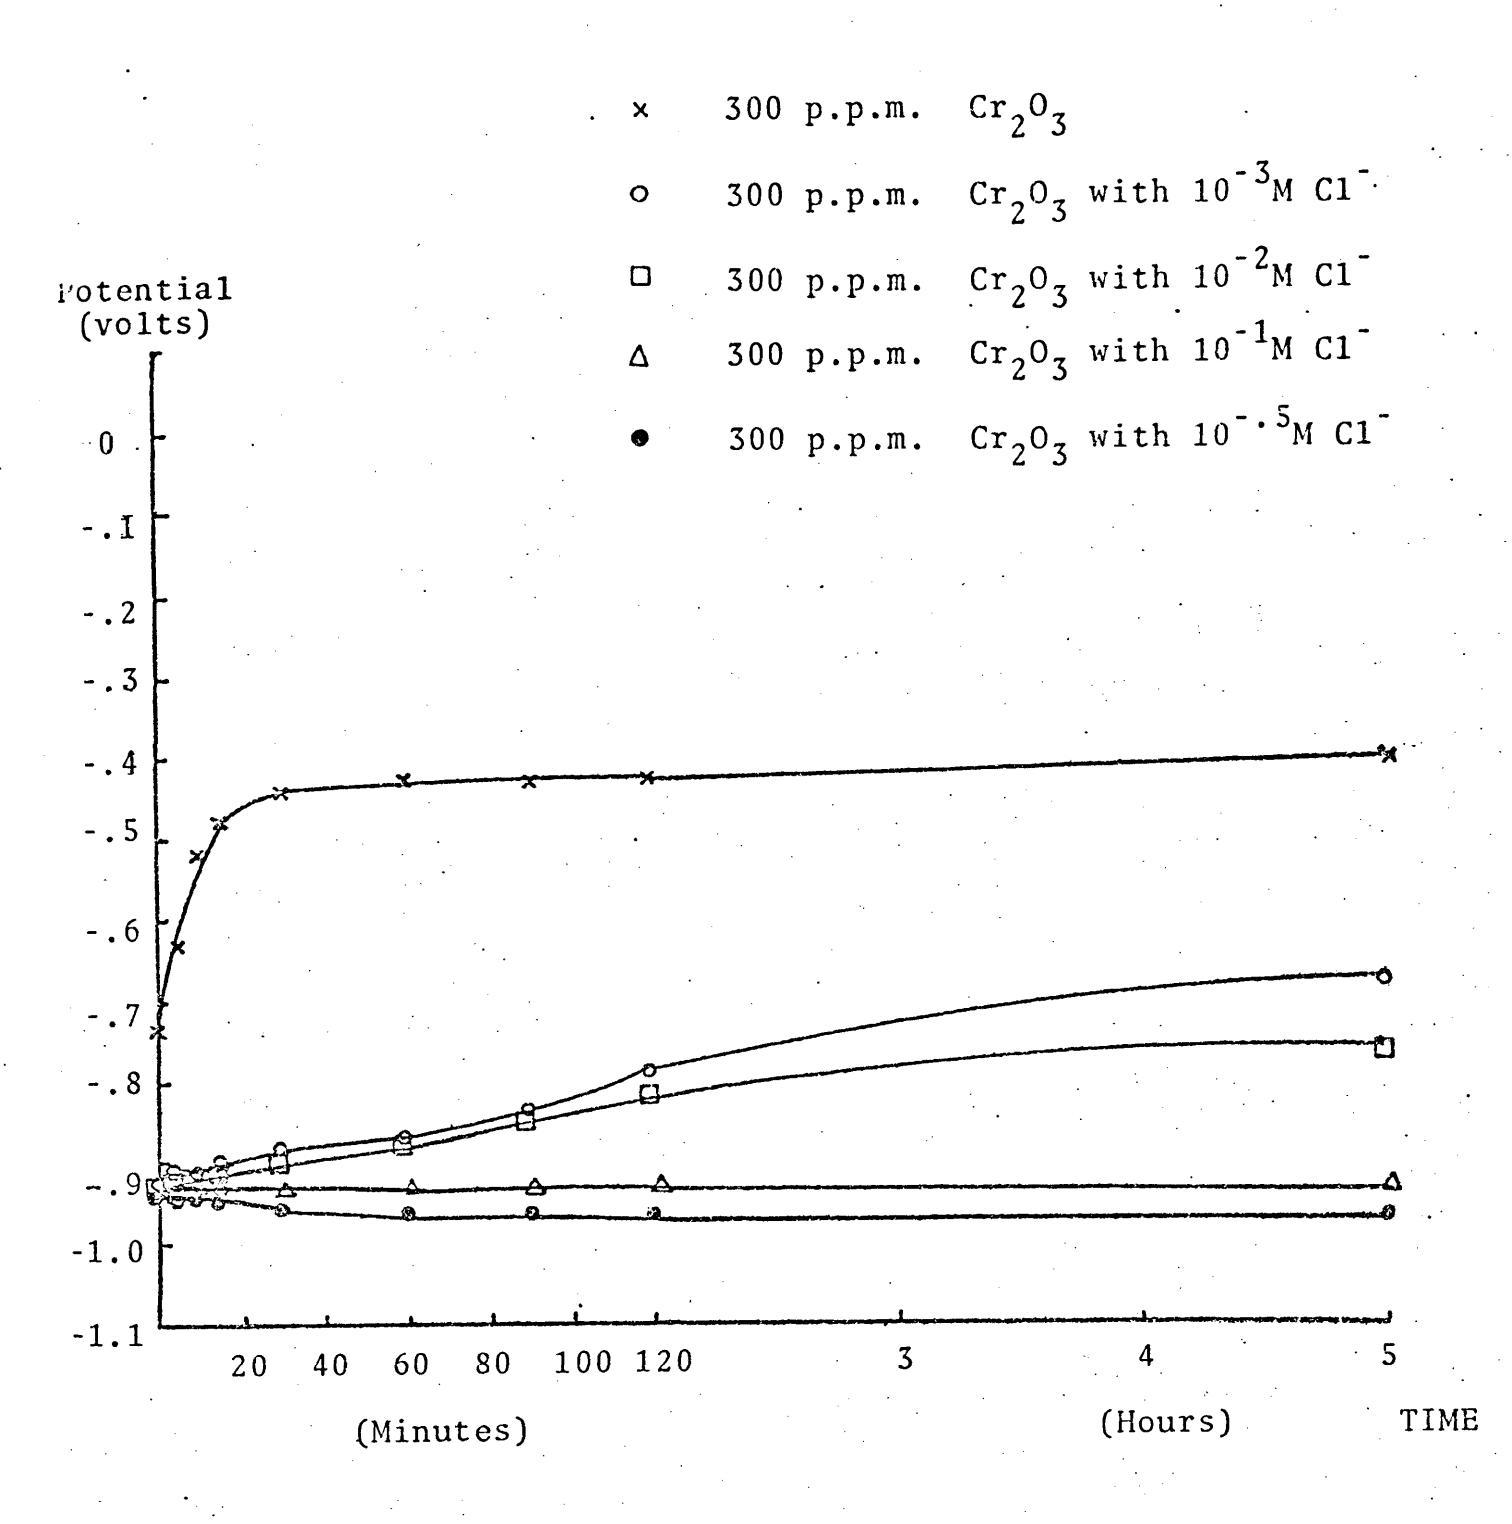
FIGURE 7.23

Measurements of potential with respect to time of zinc in a saturated calcium hydroxide solution with 300p.p.m. additons of chromic oxide and different additions of sodium chloride.

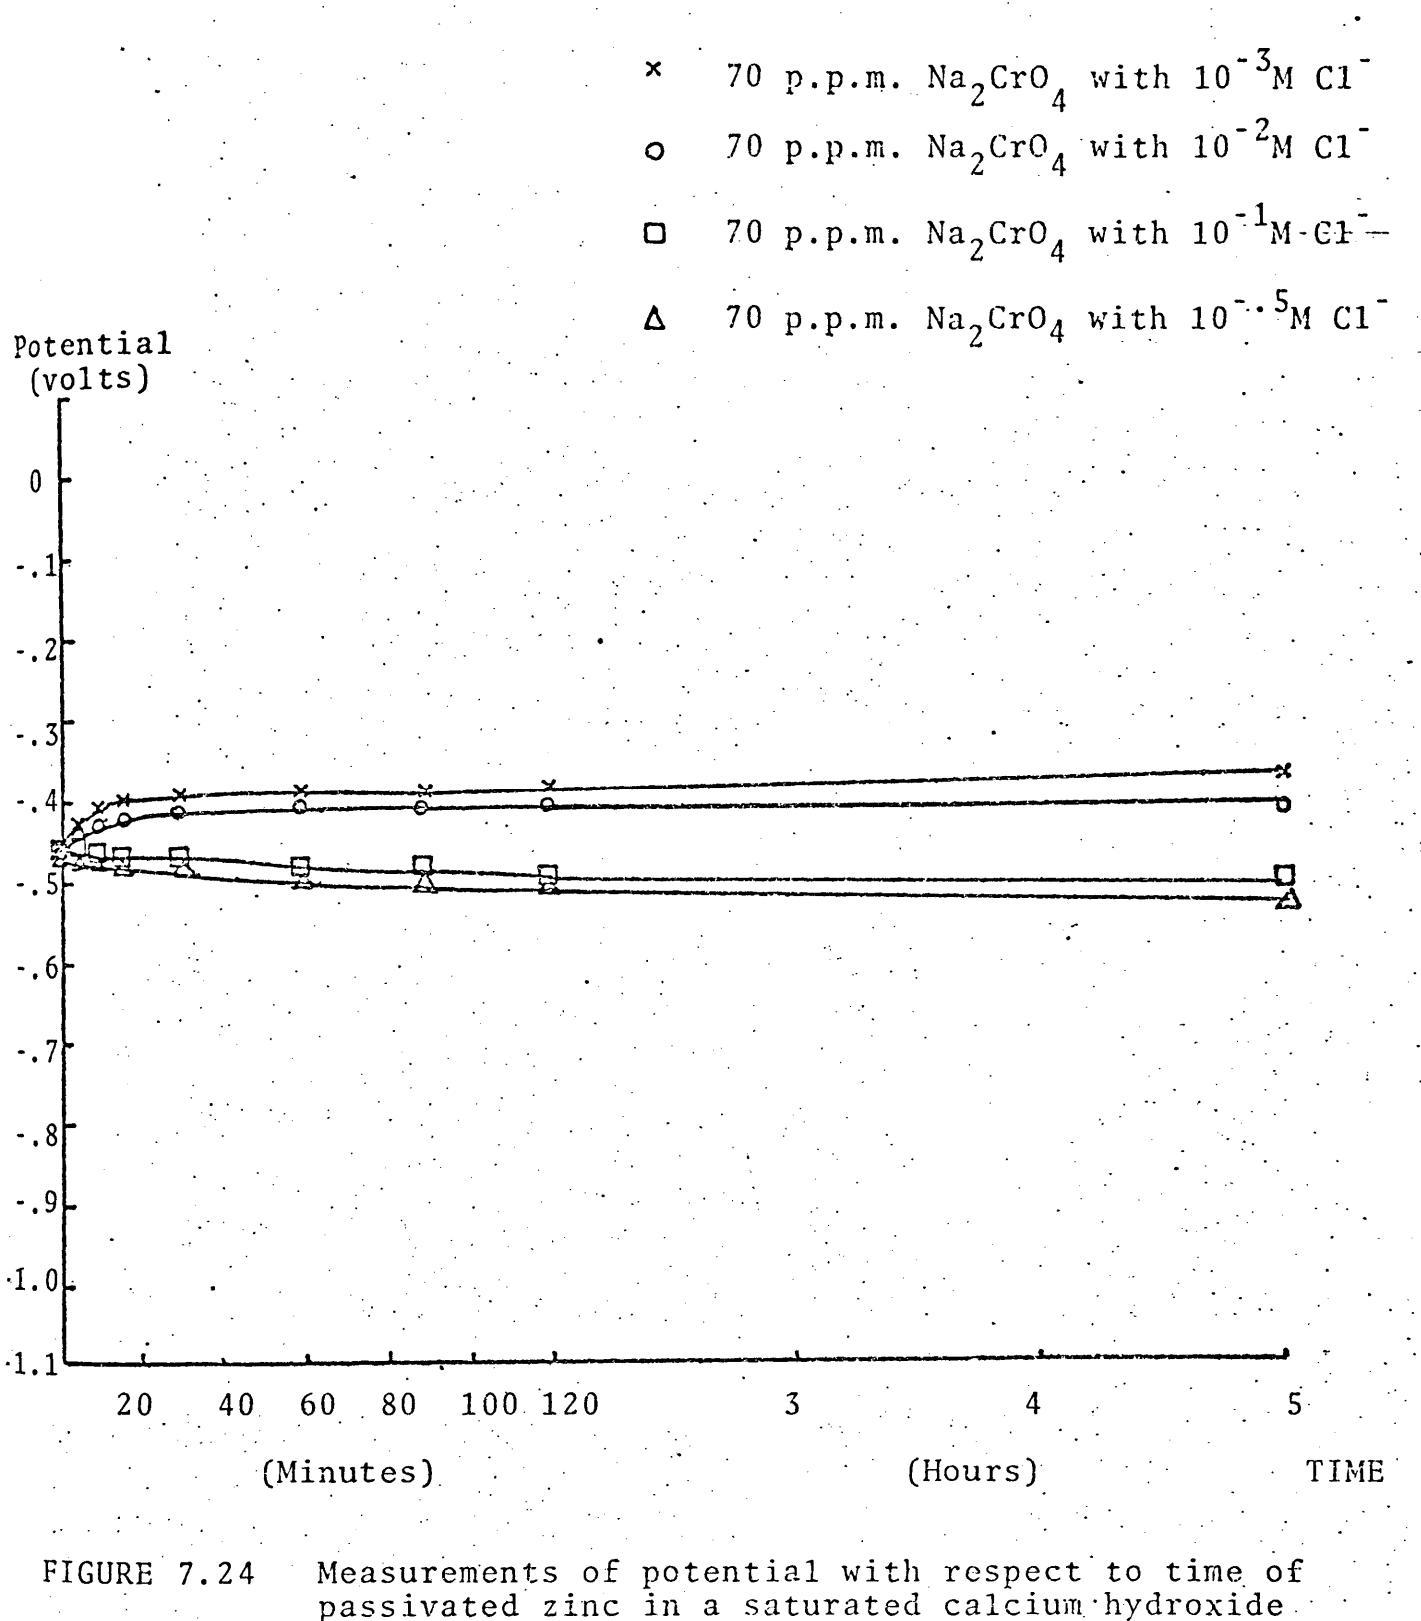
Measurements of potential with respect to time of passivated zinc in a saturated calcium hydroxide solution with 70 p.p.m. addition of sodium chromate and different additions of sodium chloride.

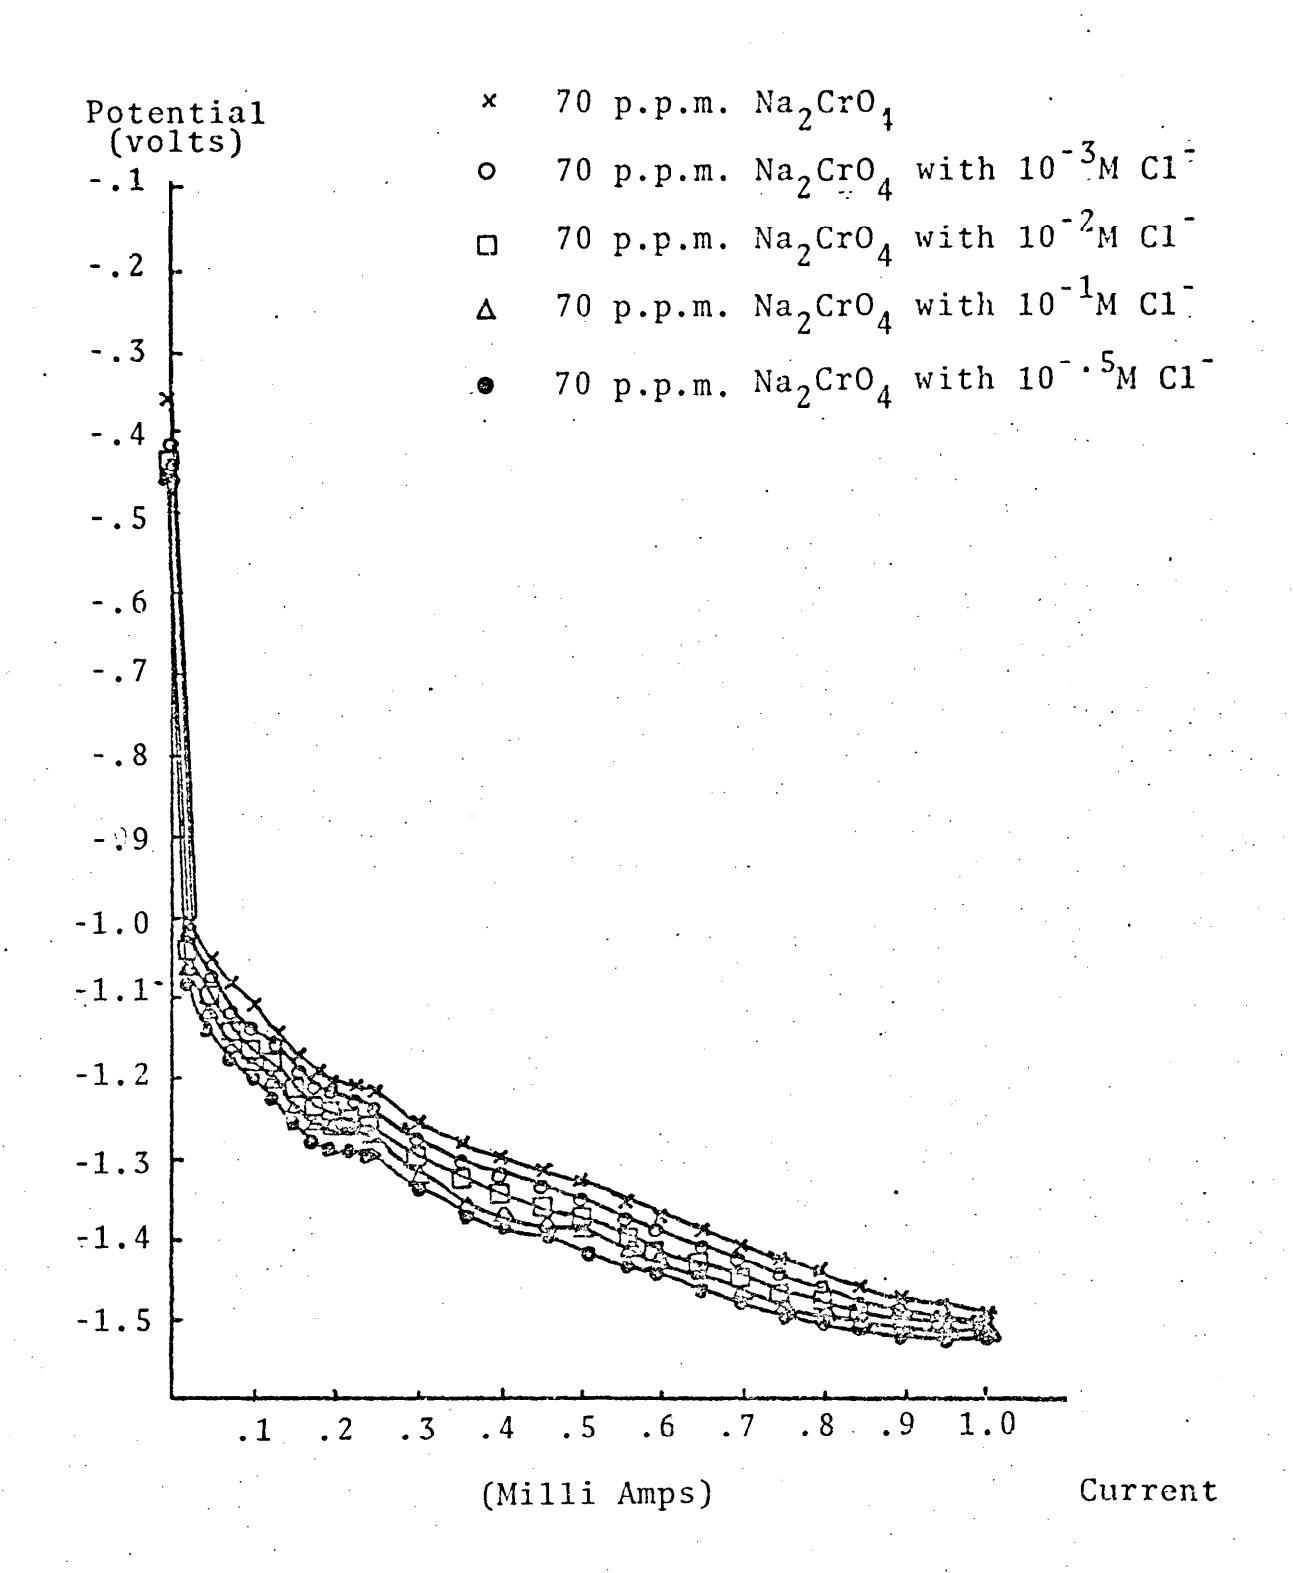
FIGURE 7.26

Measurements of potential with respect to current of zinc in a saturated calcium hydroxide solution with 70 p.p.m. of sodium chromate and different additions of sodium chloride.

Figures 7.26 and 7.27 show series of plots of potential measured with respect to correctfor different chloride ion concentrations in a calcium hydroxide solution of a pH value of 12.5 with 70 p.p.m. of sodium chromate and 70 p.p.m. of chromic oxide added respectively.

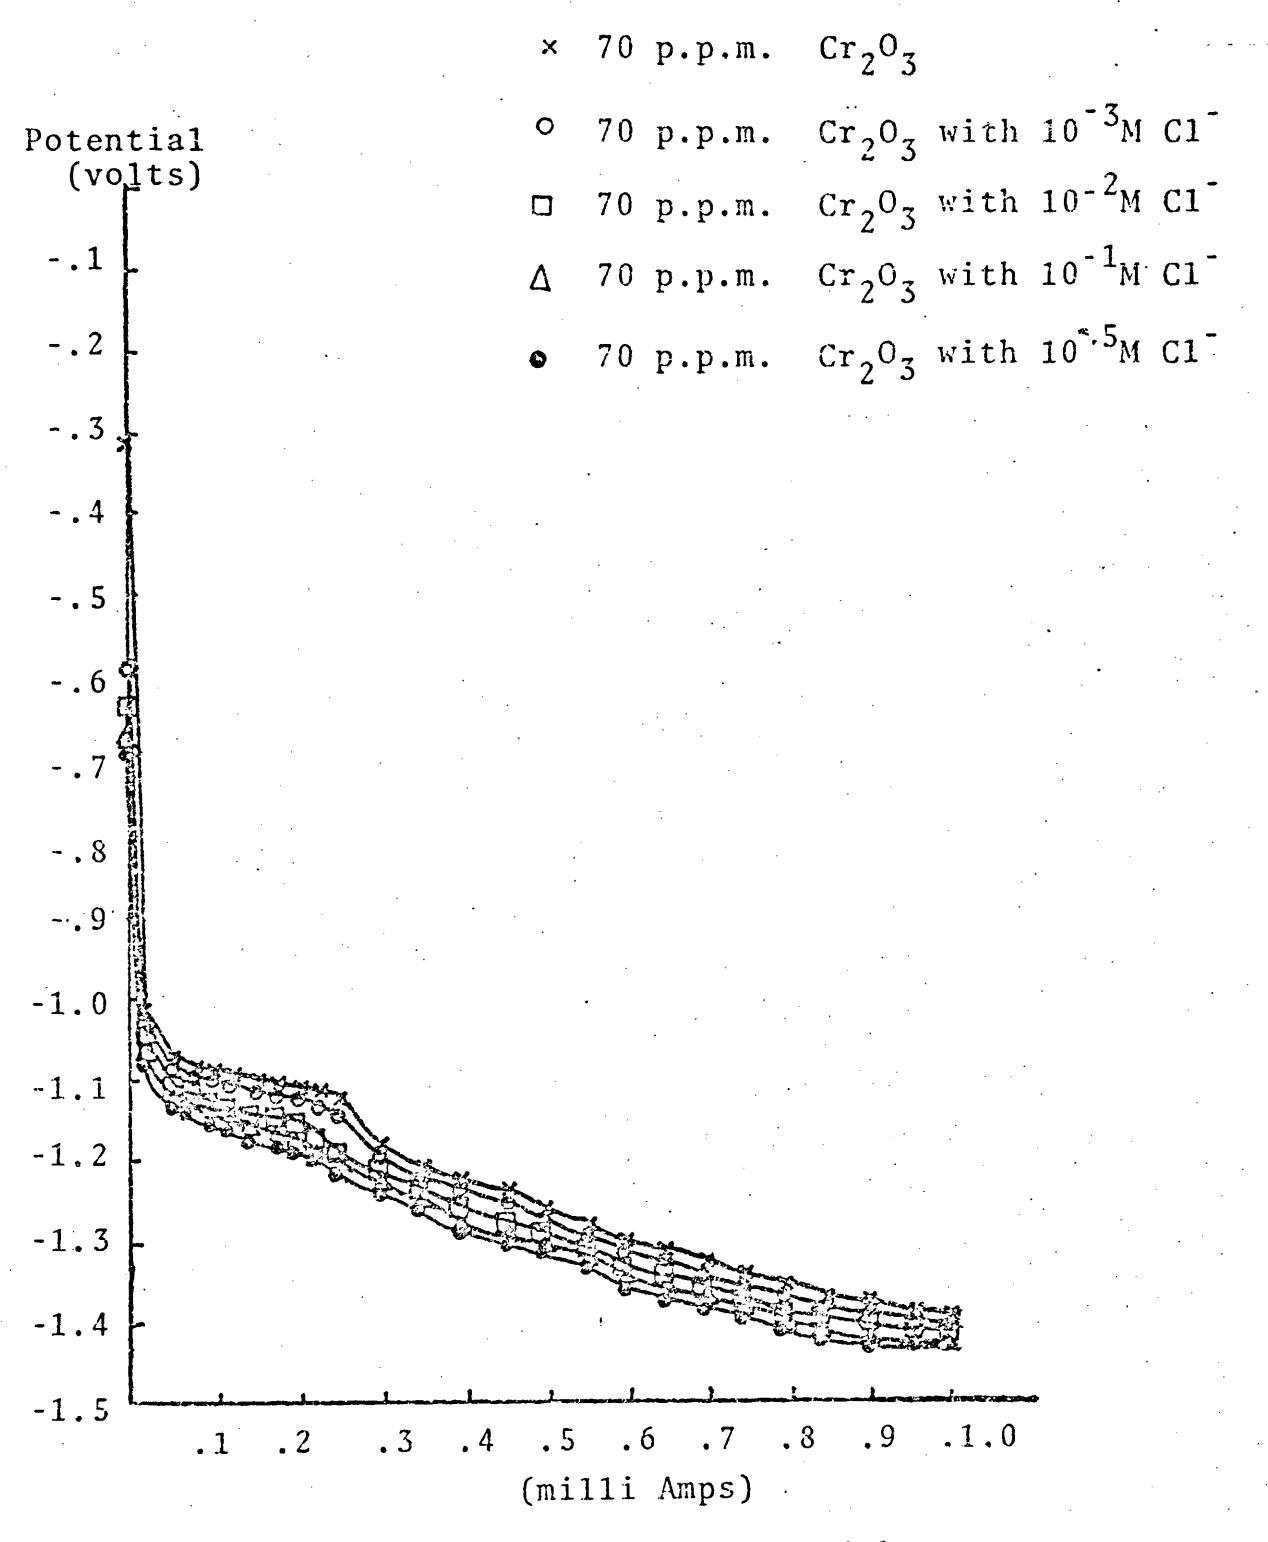
FIGURE 7.27 Measurements of potential with respect to current of zinc in a saturated calcium hydroxide solution with 70 p.p.m. of chromic oxide and different additions of sodium chloride.
